Ministry of Transportation
Standards and Contracts Branch
Structures Office Report

Guidelines for Inspection and Field Acceptance of Glass Fibre Reinforced Polymer (GFRP) Reinforcing Bars

STR-00X

September 2022

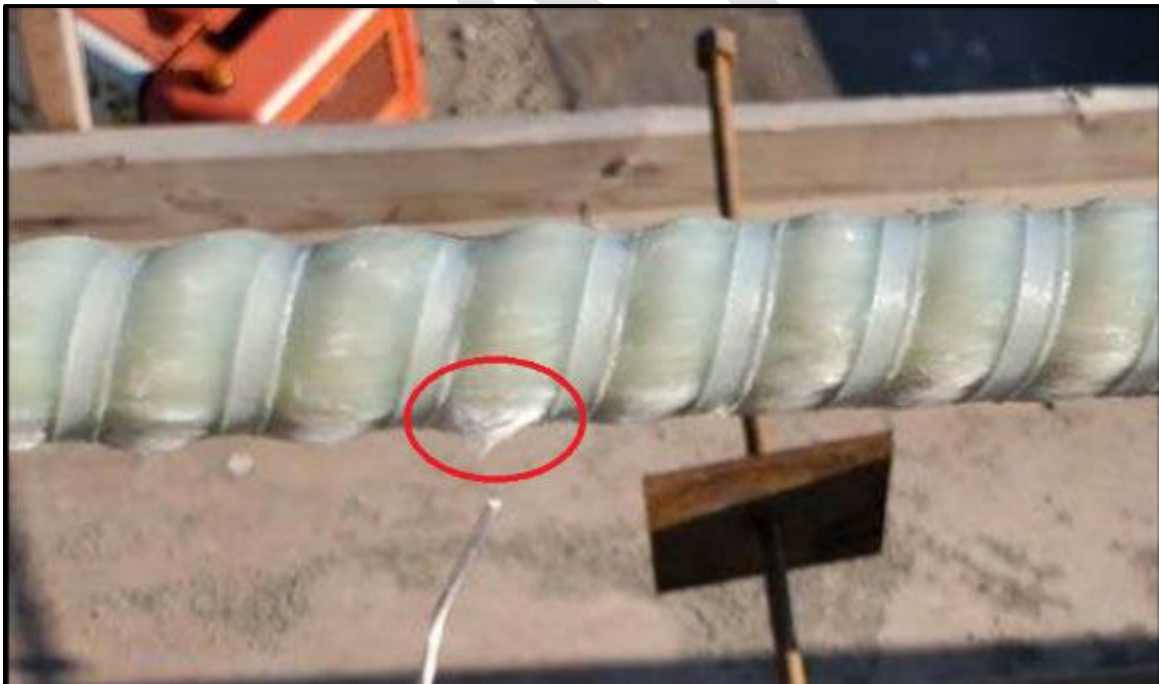
Figure 38 shows dry, visible fibres in a straight bar. A small quantity of visible surface fibres such as the defect circled in red may be acceptable. The visible fibres shall be surface fibres and the defect shall not penetrate the bar more than 0.7 mm deep. A larger quantity of visible fibres or runs are unacceptable; reference Figure 66.

Figure 38 – Dry, visible fibres

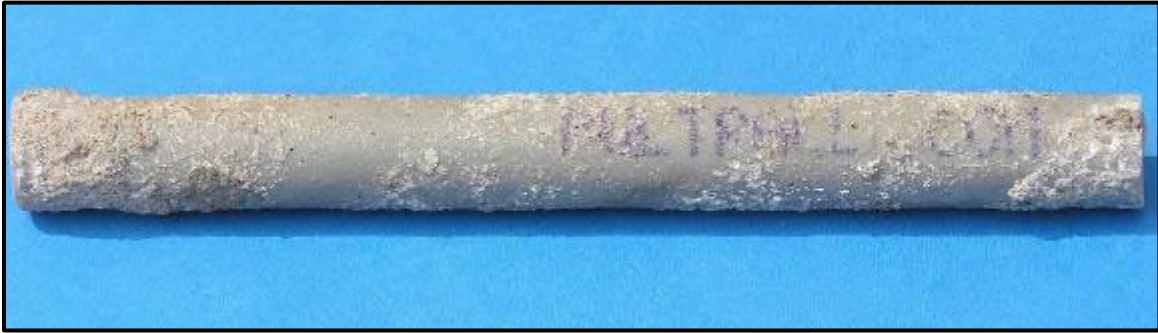
For sand coated bars, the sand is the main bonding mechanism between the FRP reinforcing bar and concrete. The bar in Figure 58 does not have enough sand coating for acceptable bond and is rejectable. Bars may have multiple defects, Figure 71 and Figure 72 also includes an unacceptable loss of sand coating.

Figure 58 – Non-uniform sand coating

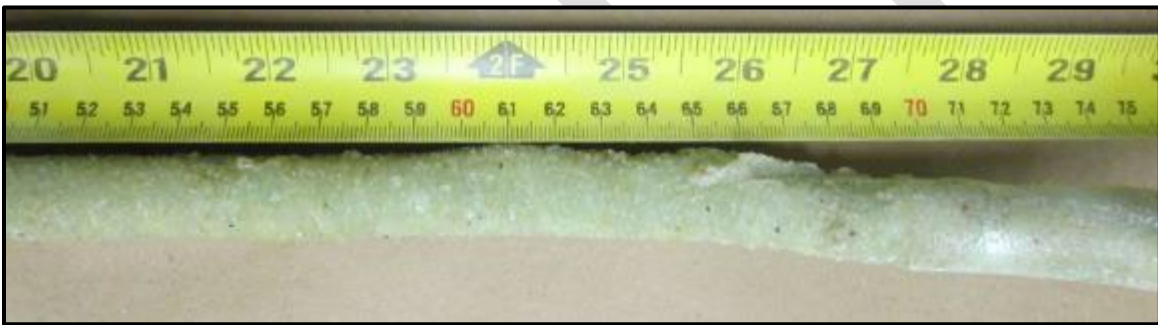
The following examples involve bars with bulges exceeding the bulging limit of 4mm or 25% of the bar diameter, whichever is smaller. These bulging bars cannot be repaired and are rejectable.

Figure 59 – Out-of-plane bulging larger than 4mm

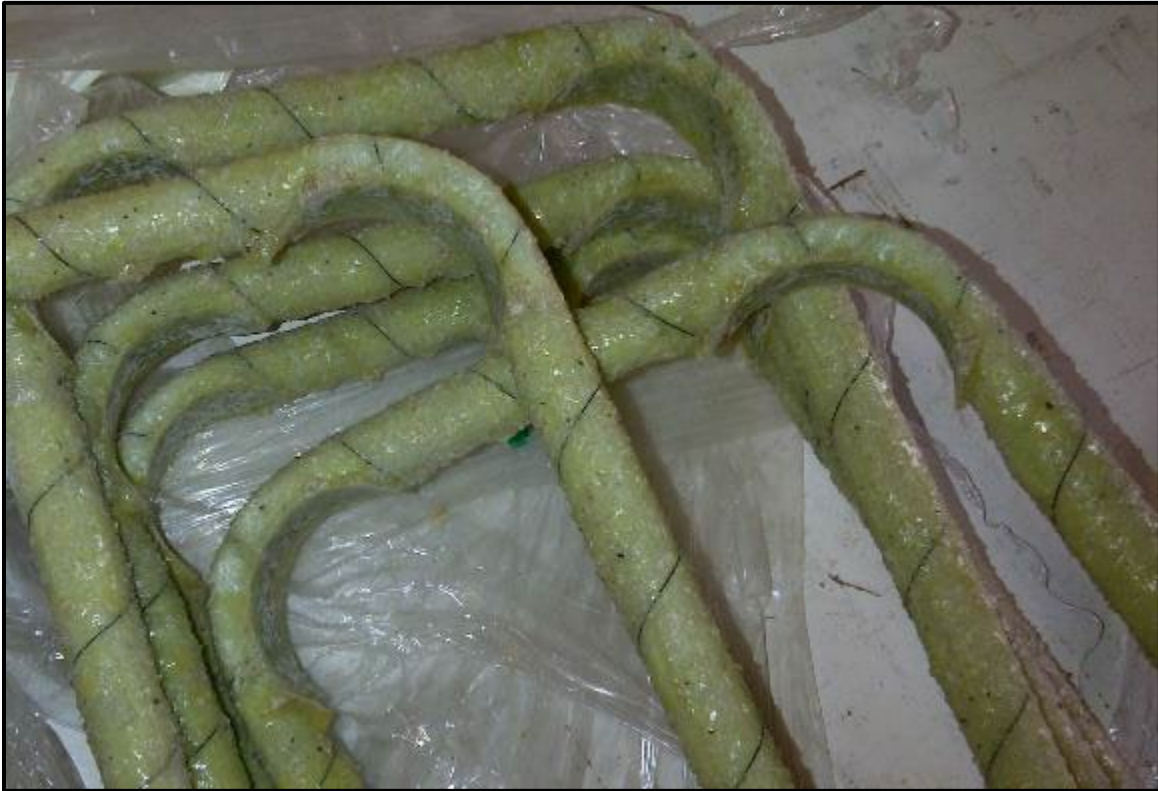
The bends of the bent bars shown in Figure 61 exhibit excessive flattening about the curves. This condition cannot be repaired, and the bars must be rejected.

Figure 61 – Excessive flattening

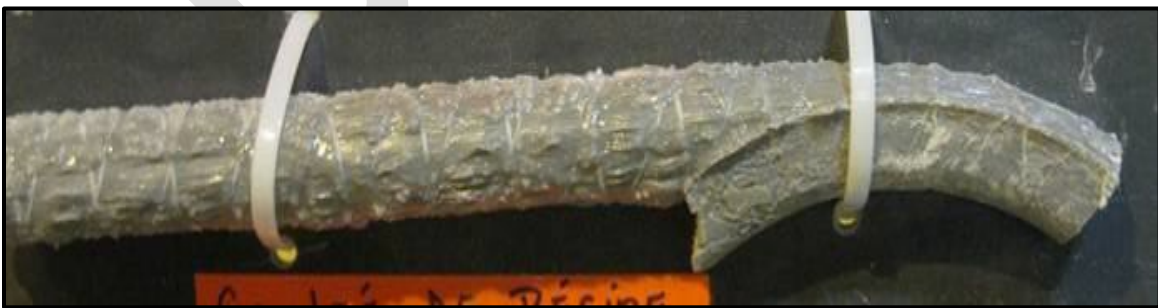
The bar shown in Figure 62 has non-homogeneous resin coverage and is therefore an unacceptable GFRP reinforcing bar. This defect is also greater than the maximum allowable area of the nominal cross-sectional area for bar diameters 13 mm to 20 mm. The defect cannot be repaired, and the bar must be rejected.

Figure 62 – Non-homogeneous resin distribution

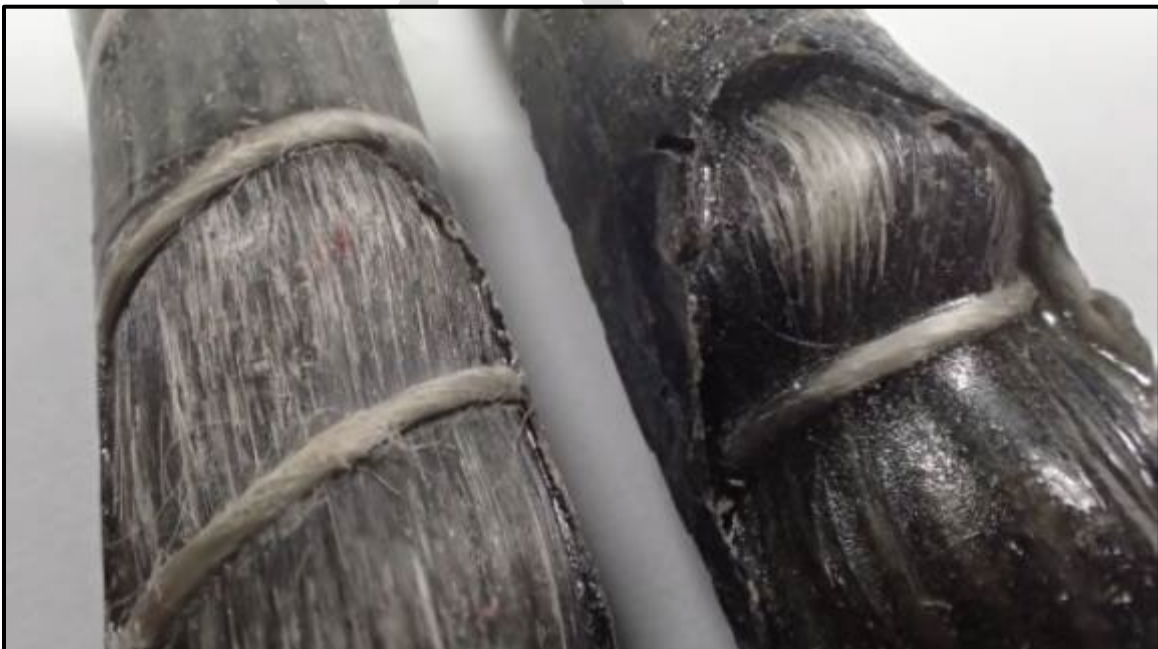
Half of the surface area of the bars in Figure 64 has exposed fibres with no resin. The dryness of the surface fibres is excessive, and the bars are rejectable.

Figure 64 – Exposed and dry fibres

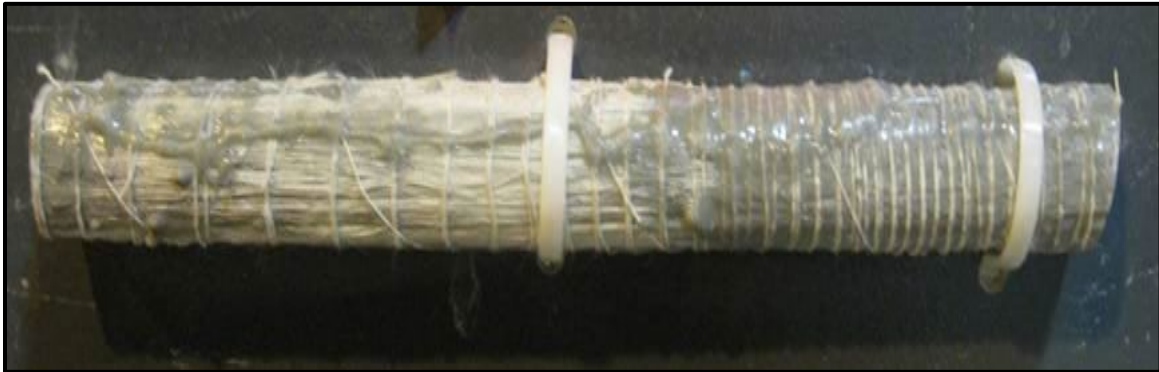
Figure 65 is an example of an unacceptable GFRP reinforcing bar. There is a noticeable inconsistency with resin embedment and coating of the glass fibres that make up the bar, which may negatively affect the performance of this GFRP reinforced bar. This bar cannot be repaired and must be rejected.

Figure 65 – Exposed glass fibres and inconsistent resin

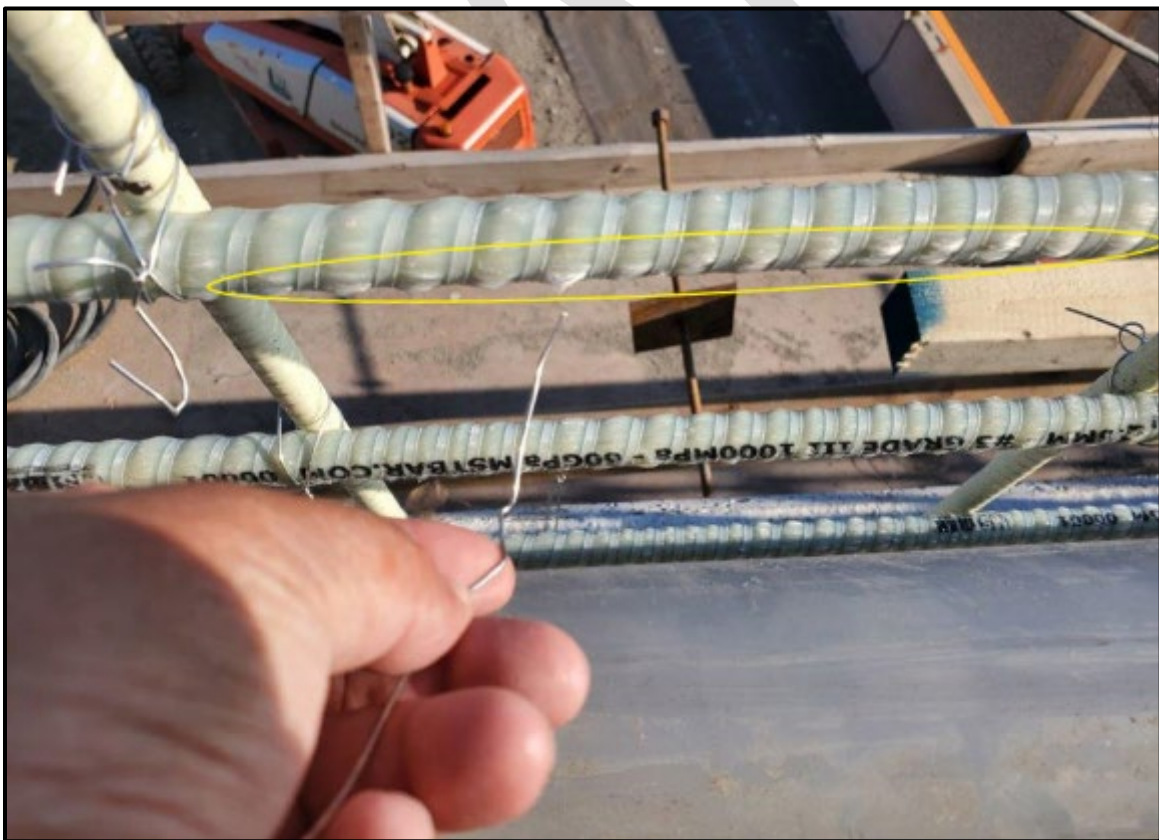
Figure 66 includes exposed and dry fibres. A single rib was used as an example in Figure 38 from the same photo as acceptable exposed fibres. However, there is a run on this bar resulting in a consistent defect. The quantity of bar defect is more than 50 mm or two consecutive ribs per 300mm length of bar, can be considered too high, and the bar is rejectable.

Figure 66 – Exposed, dry fibres

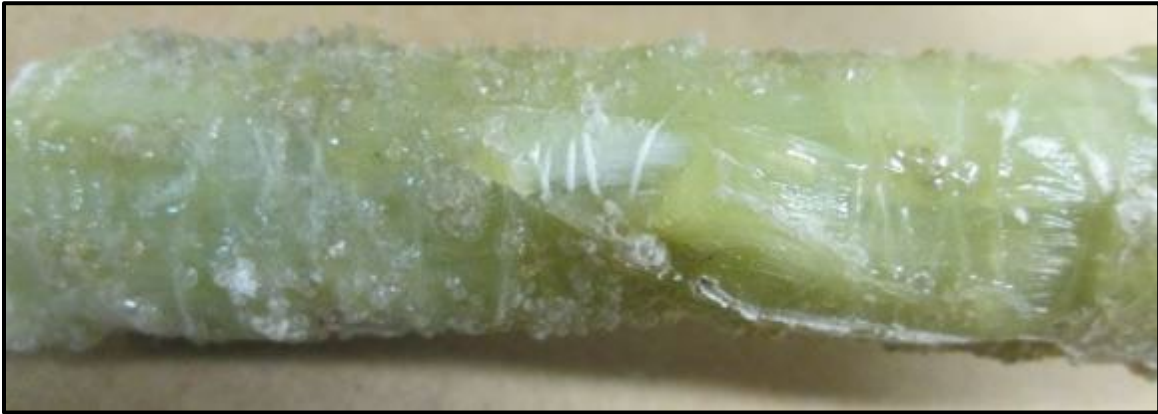
Figure 67 also shows exposed core fibers and is rejectable.

Figure 67 – Repairable exposed fibres

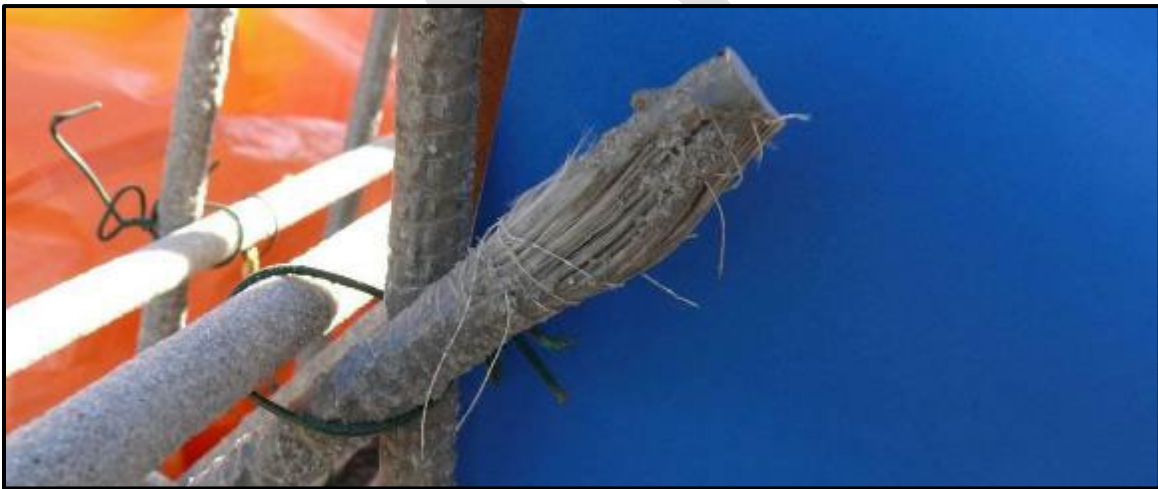
Figure 68 shows an unacceptable GFRP reinforcing bar with frayed, loose fibres and inconsistent resin coverage. Surface finishes are required to be uniform, and without exposed fibres. This bar cannot be repaired and must be rejected.

Figure 68 – Loose fibres

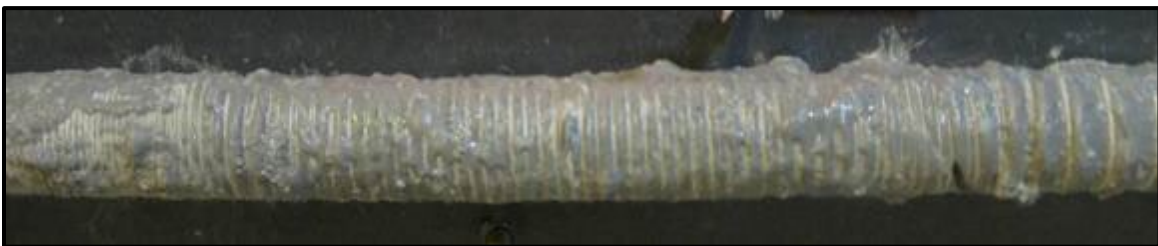
Figure 69 is a bar with inconsistent and insufficient resin coverage, resulting in exposed glass fibres, and is therefore an unacceptable GFRP reinforcing bar. This bar cannot be repaired and must be rejected.

Figure 69 – Inconsistent resin coating and exposed fibres

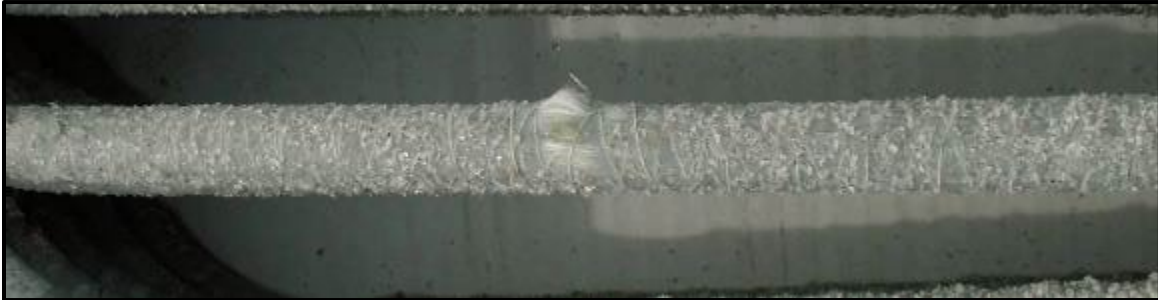
Figure 70 shows a bar with frayed, exposed fibres. The exposed fibres include core fibres, and the bar is therefore an unacceptable GFRP reinforcing bar. This bar cannot be repaired and must be rejected.

Figure 70 – Exposed and frayed glass fibres

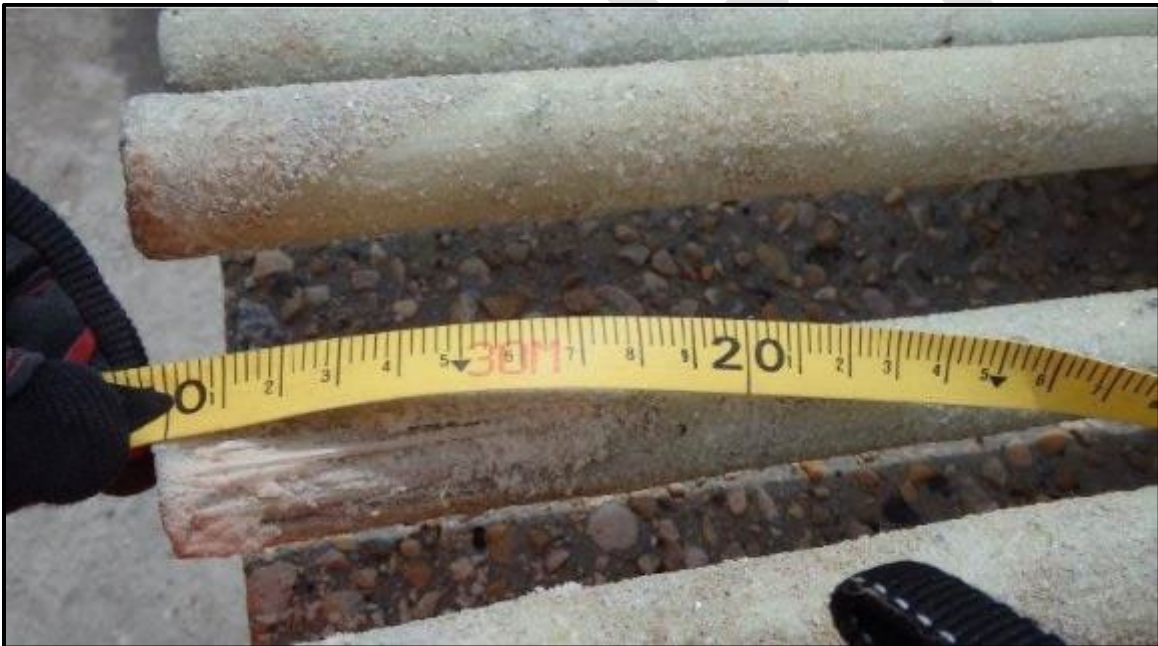
The bars shown in Figure 71 and Figure 72 have a noticeable loss of sand coating and lack of resin on the exposed glass fibres and are examples of unacceptable GFRP reinforcing bars. These bars cannot be repaired and must be rejected for use on MTO contracts.

Figure 71 – Sand and resin loss and exposed fibres

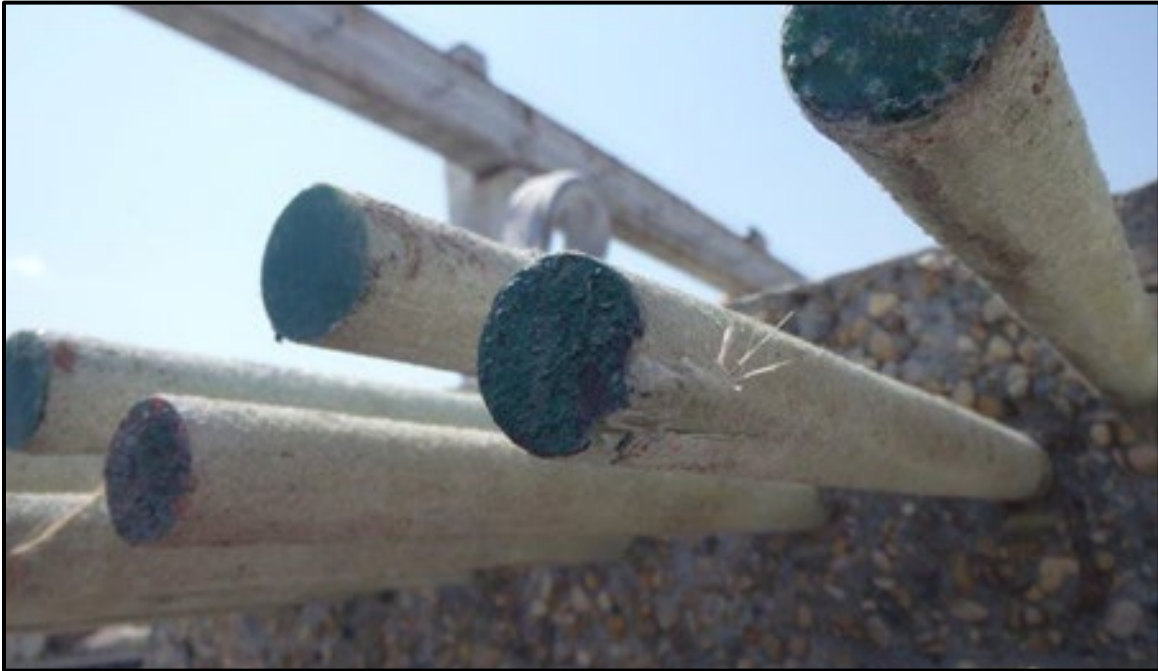
Figure 72 – Sand and resin loss and exposed fibres

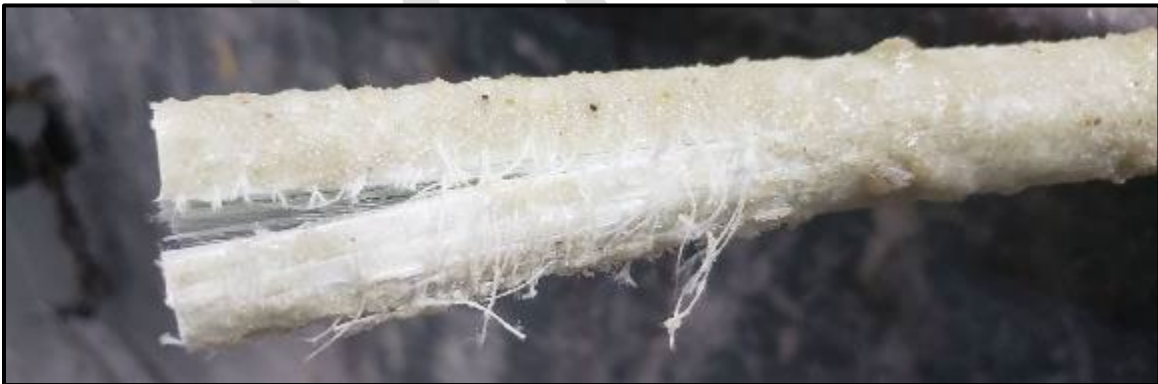
Splits and cracks cannot be repaired, and these bars are always rejectable. The length and depth of splits may vary. The ripped off nylon strands in Figure 73 are not considered an issue.

Figure 73 – Rejectable split bar

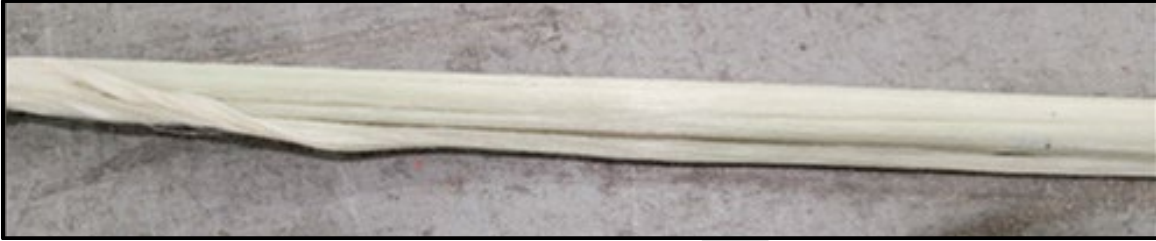
Kinks cannot be repaired, and these bars are always rejectable. Figure 74 is an example of a kinked bar.

Figure 74 – Kinked bar

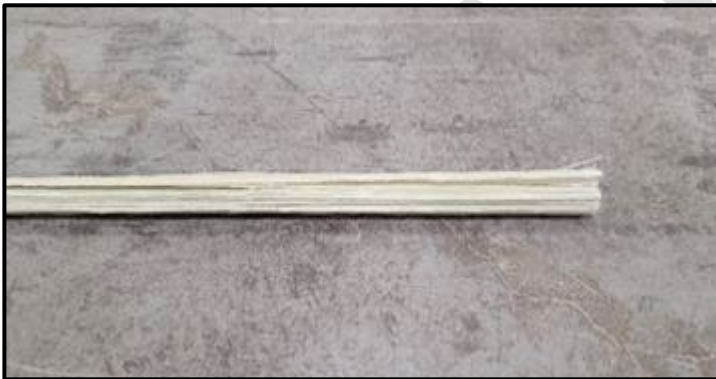
The bar in Figure 75 and Figure 76 has not been cut properly and the end is frayed. The manufacturer could repair this type of defect if sufficient bar length is available. This particular bar cannot be repaired because of other defects.

Figure 75 – Cut bar with frayed ends

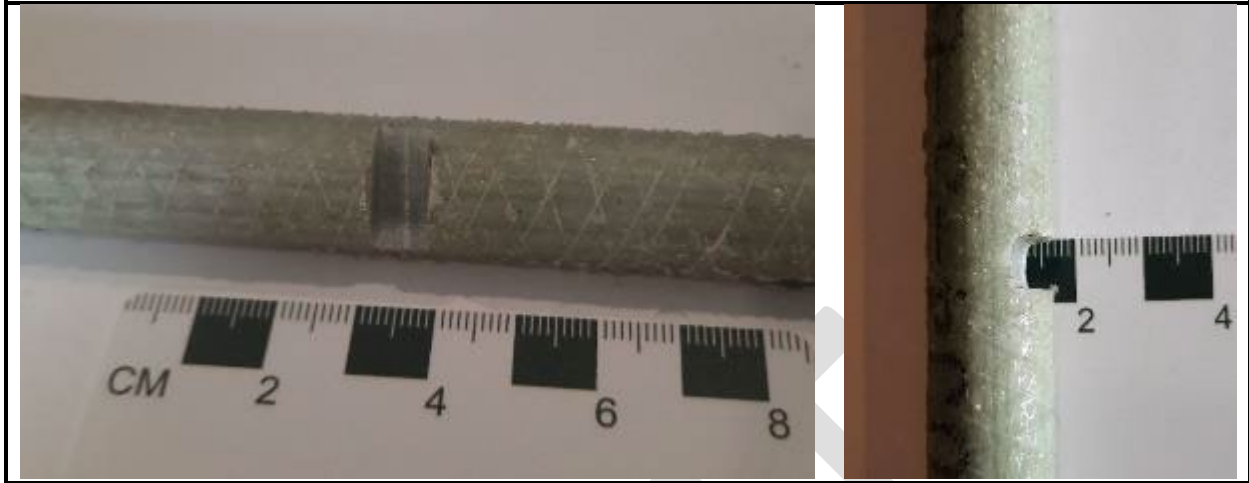
Figure 78 – Deep cut in rejectable bar

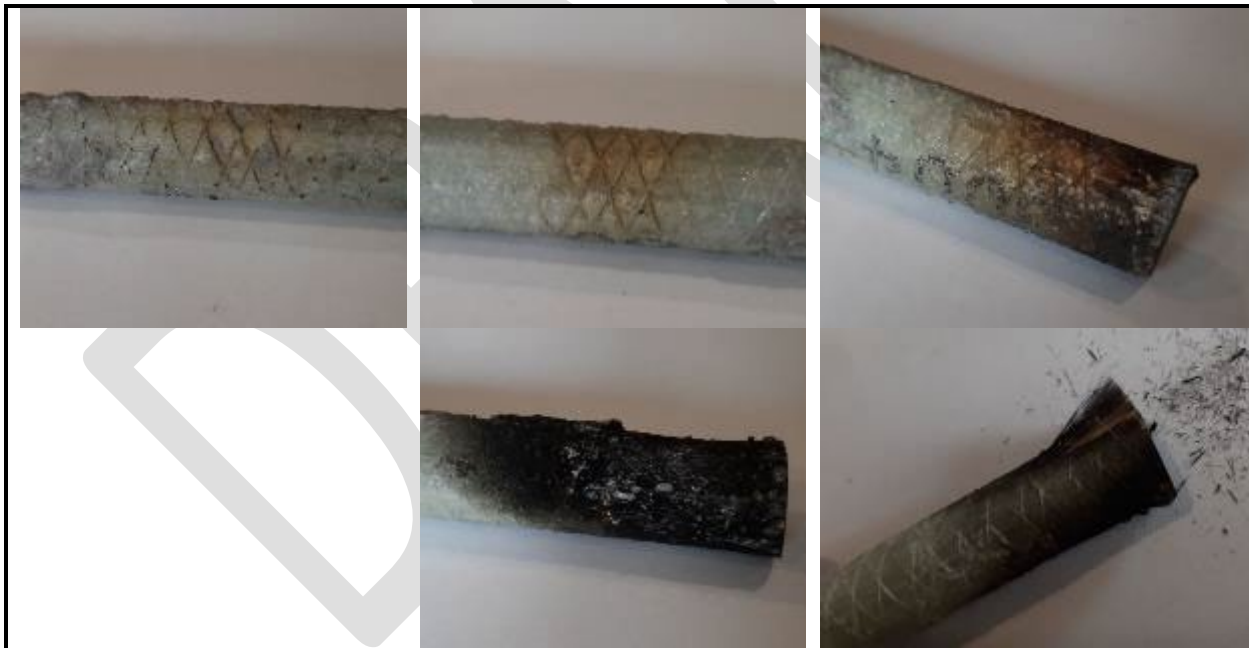
Various burn marks to GFRP bars are shown clockwise in Figure 79 with increasing severity. The first two photos have heat damage to the resin and nylon strands. The last three photos have experienced flame damage with blistered resin and dry/burned fibres.

Figure 79 – Various unacceptable burn marks

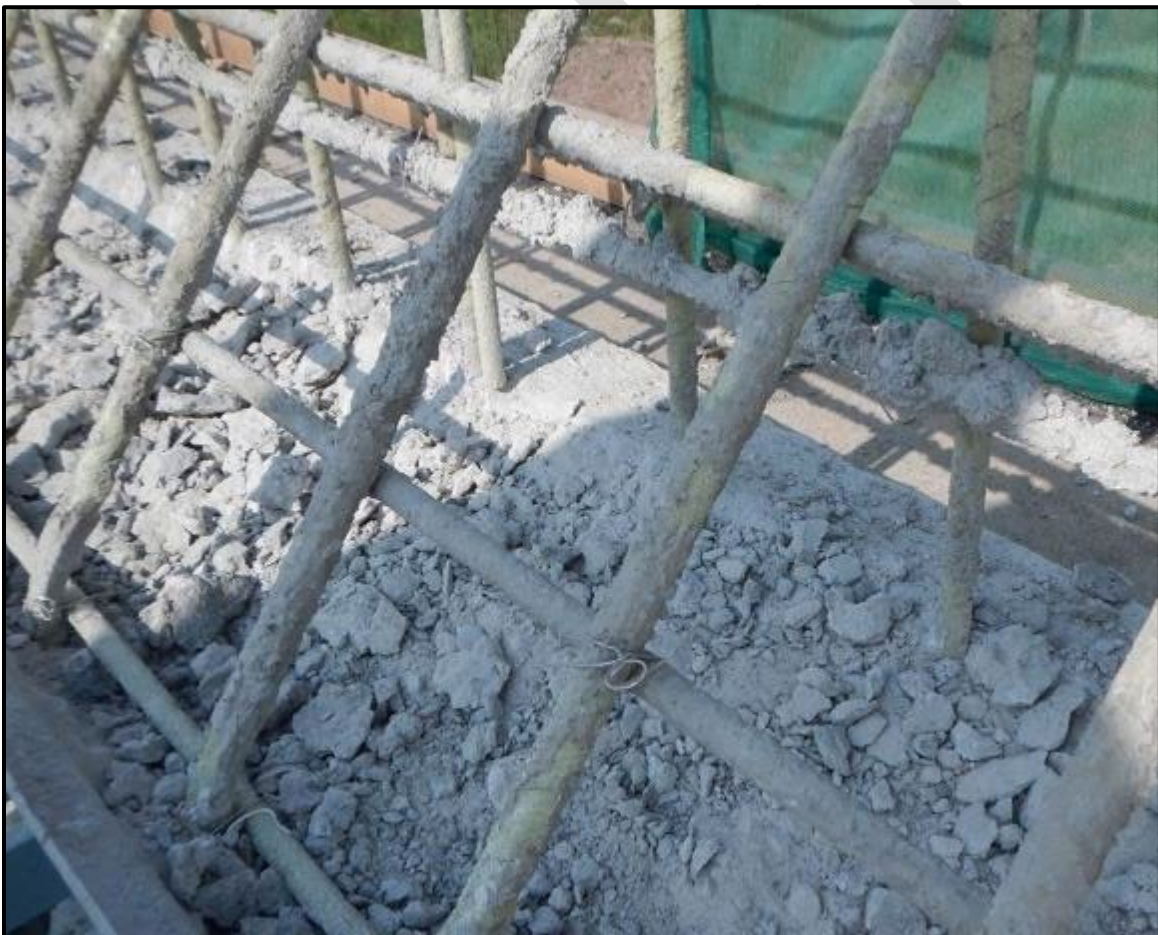
Figure 81 – Concrete contamination

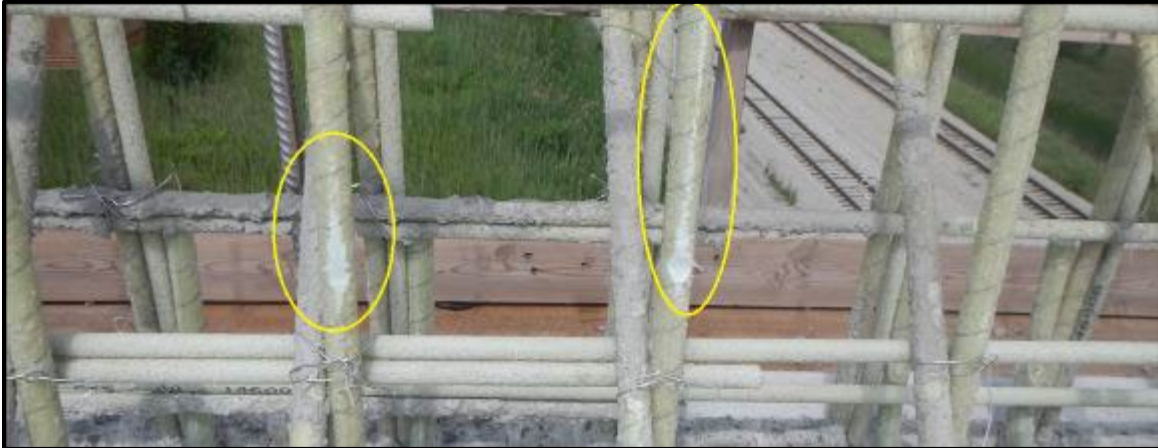
Visible damage can be seen in Figure 82 where contaminated longitudinal bars rubbed against vertical bars as they were removed from the cage and replaced with new ones. These bars must now also be replaced.

Figure 82 – Damage from bar rubbing

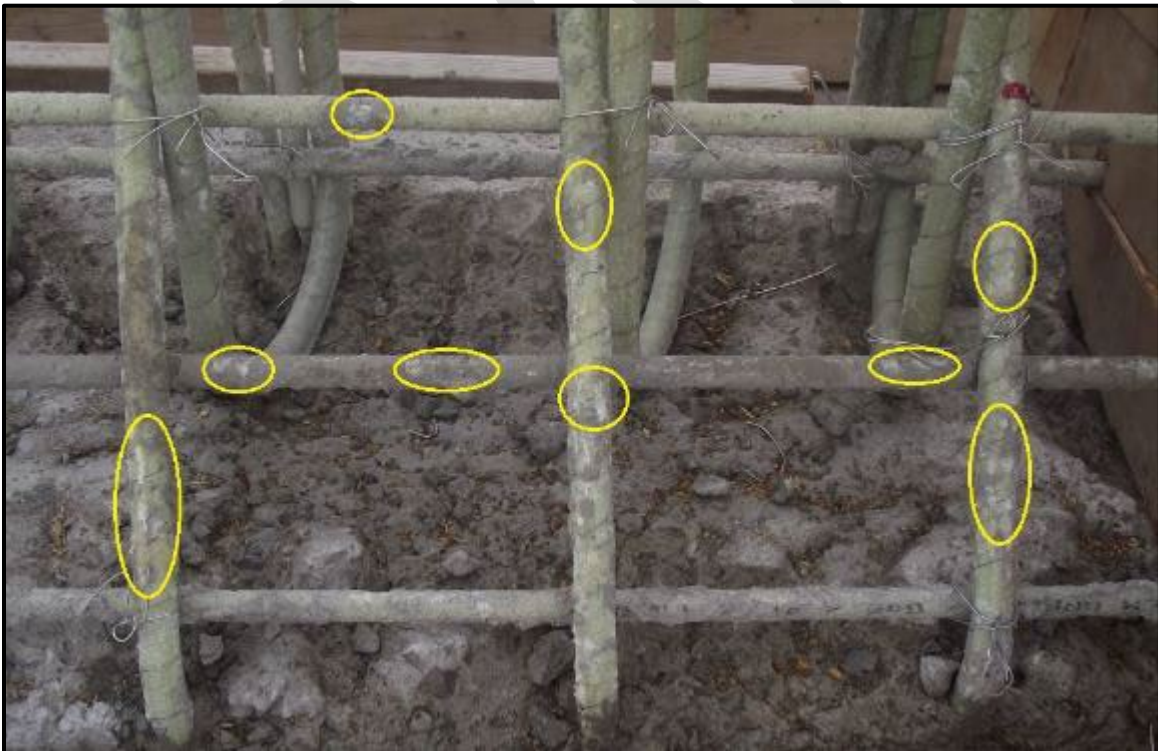
Figure 83 and Figure 84 show damage to bars which were ‘cleaned’ of concrete contamination. There is still visible concrete contamination; concrete paste may act as a bond breaker between the bars and the concrete placed for the rest of the component.

Figure 83 – Contamination and hammer strike damage

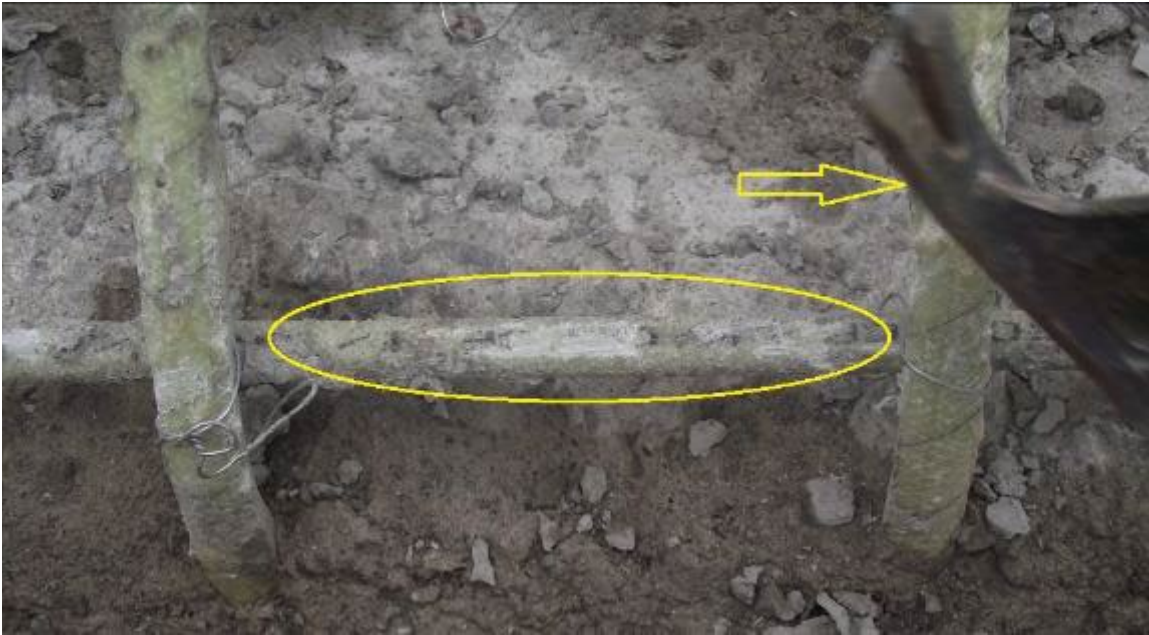
There is also visible damage to the bars from removal of concrete using a hammer. These bars are easily rejectable because of the visible damage on the exterior of the bar. However, GFRP bars are brittle and hammer strikes can cause internal damage to the bar which may not be visible. Any bars struck with hammers shall be rejected and replaced.

Figure 84 – Hammer strike damage to bars (arrow pointing to hammer)

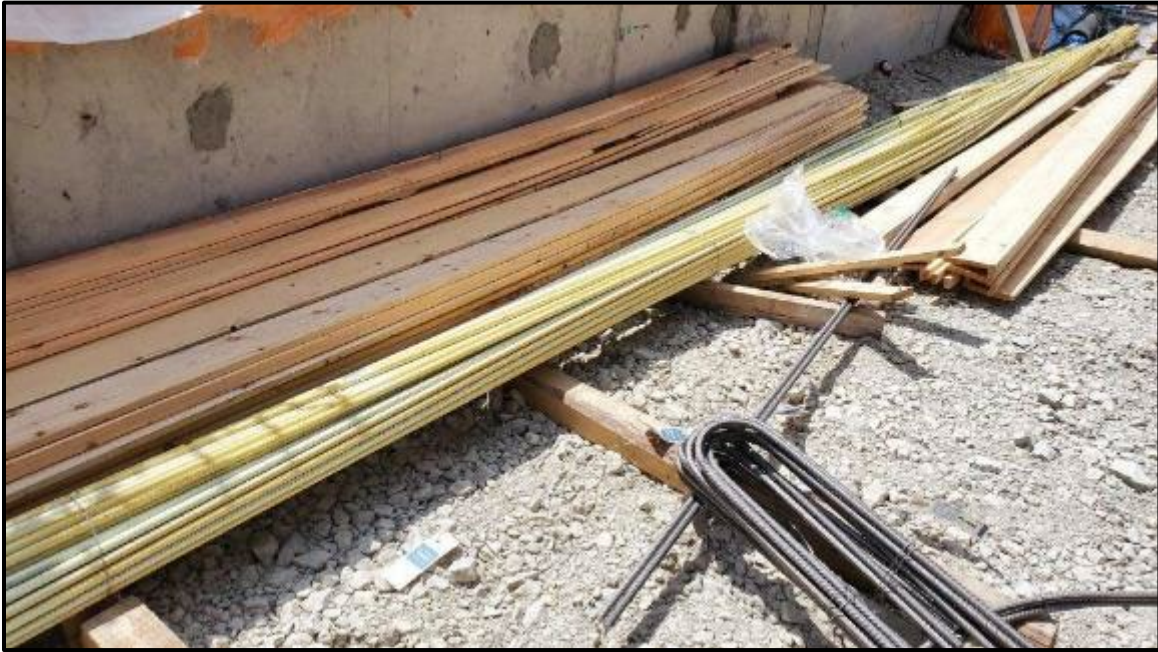
Figure 86 – UV exposure discolouration

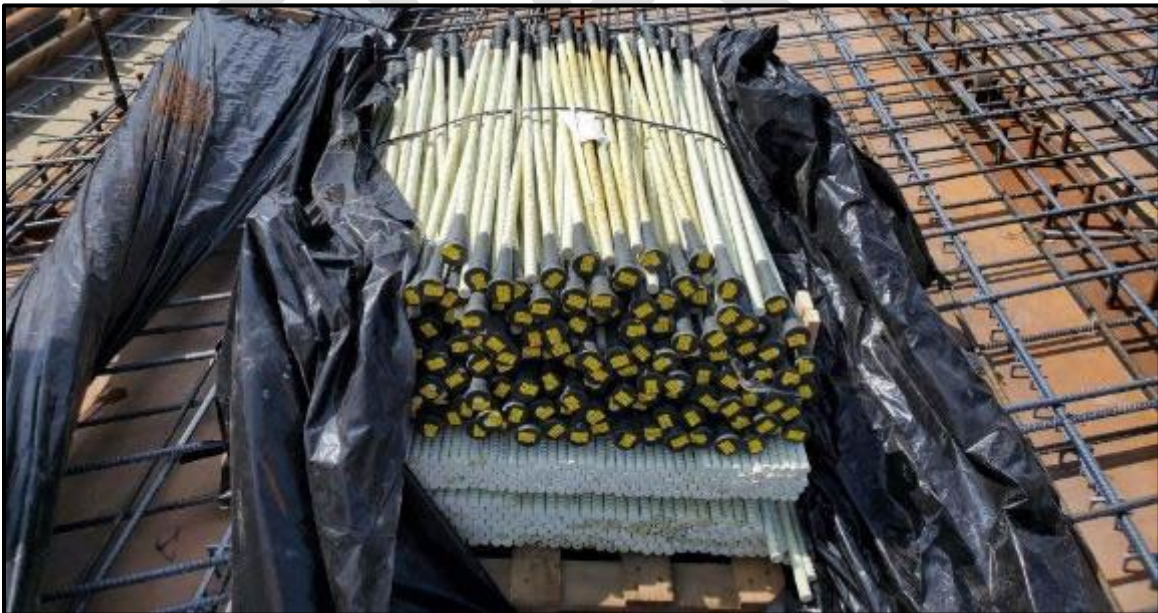
Figure 87 is another example with a colour change in the same bar where one side is darker than the other and there is a more well-defined contrast line. This defect only applies to a few of the bars on the top of the skid.

Figure 87 – UV exposure discolouration

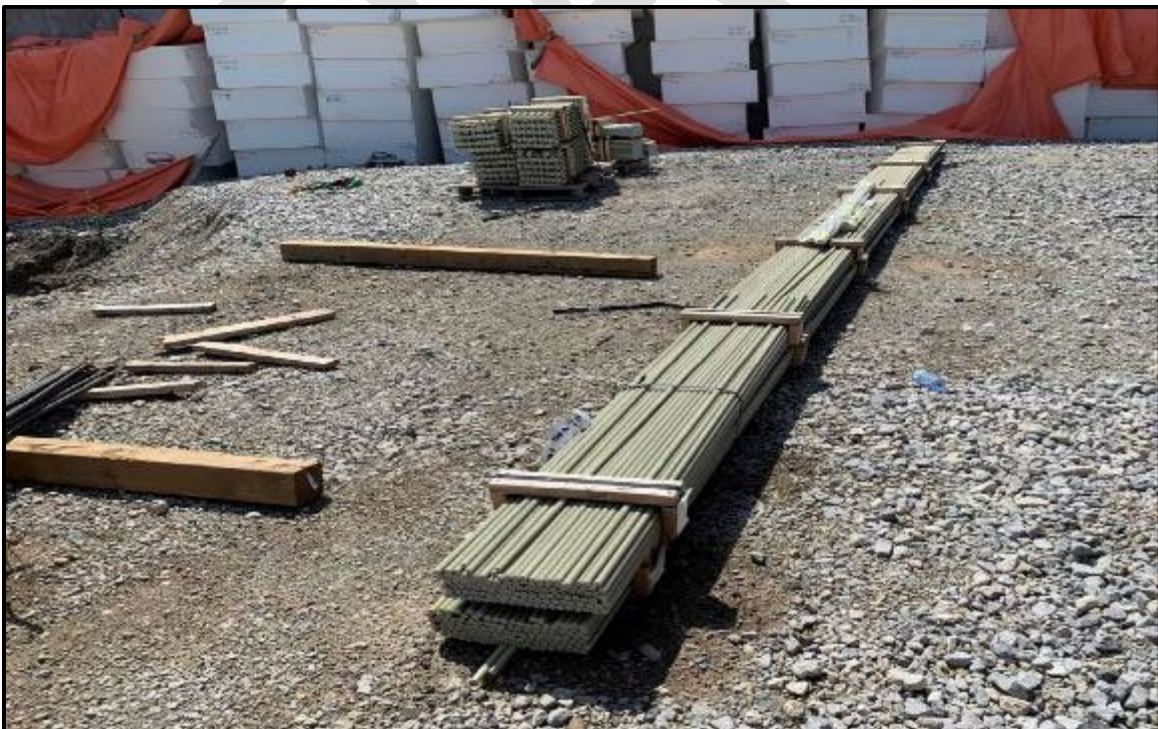
Figure 89 – Bars not covered with polyethylene

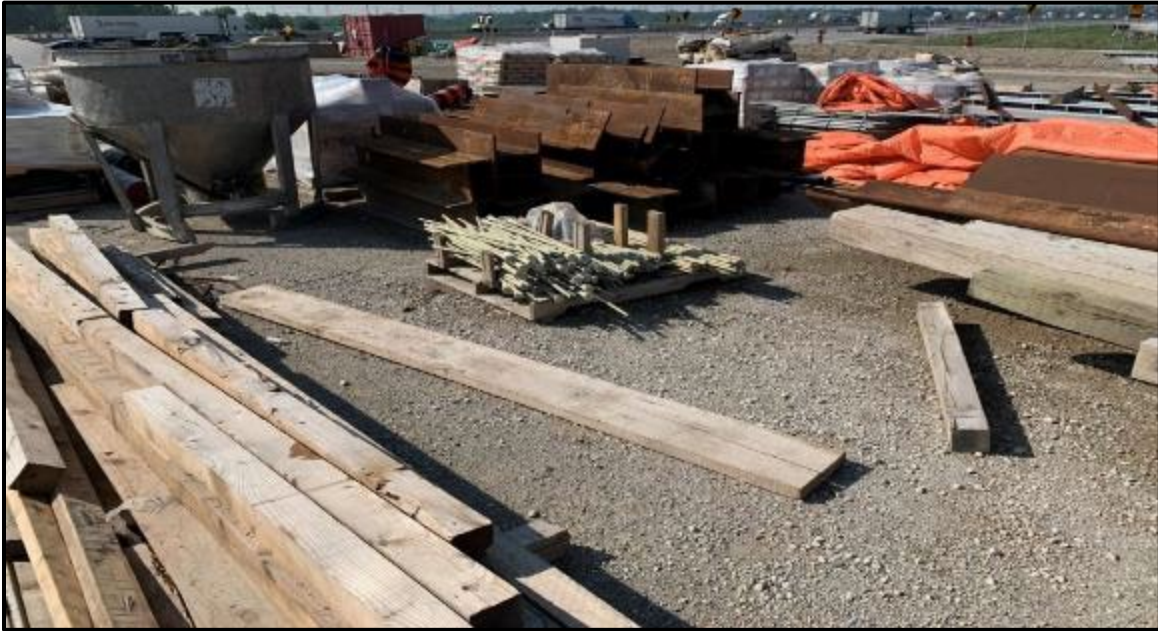
Figure 90 – Bars not covered with polyethylene

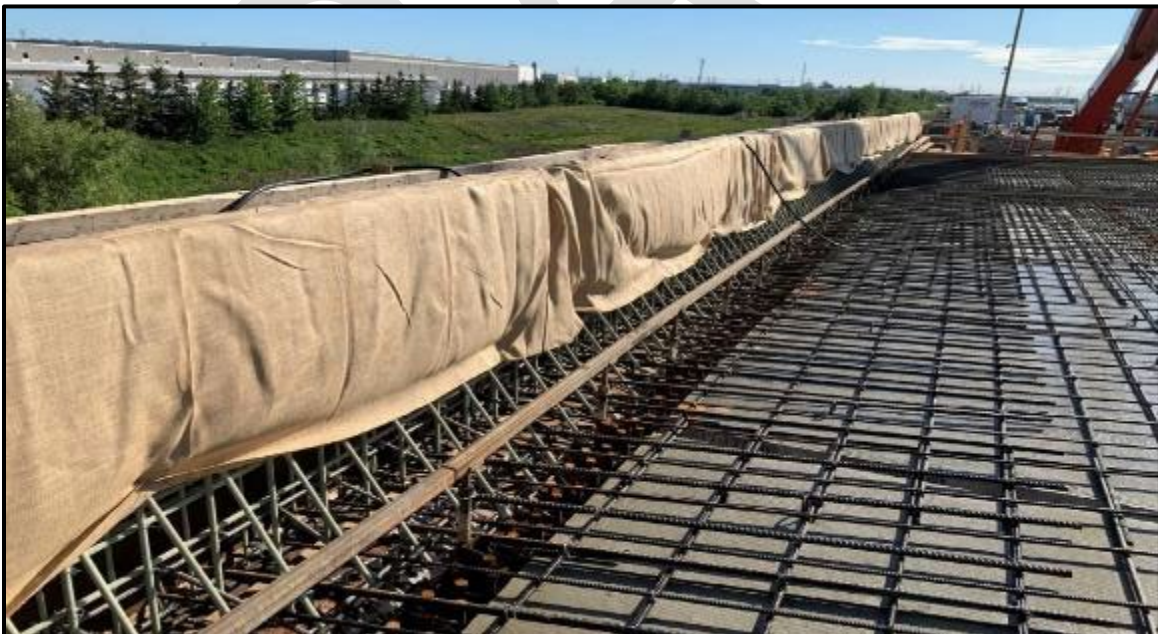
The bars in Figure 91 are covered with burlap, but they are not completely covered, and burlap permits sunlight transmission. This is not considered acceptable for 'storage' until concrete placement and they should be covered with polyethylene sheeting. However, it is better than the Figure 92 condition.

Figure 91 – Installed bars with improper and incomplete coverage

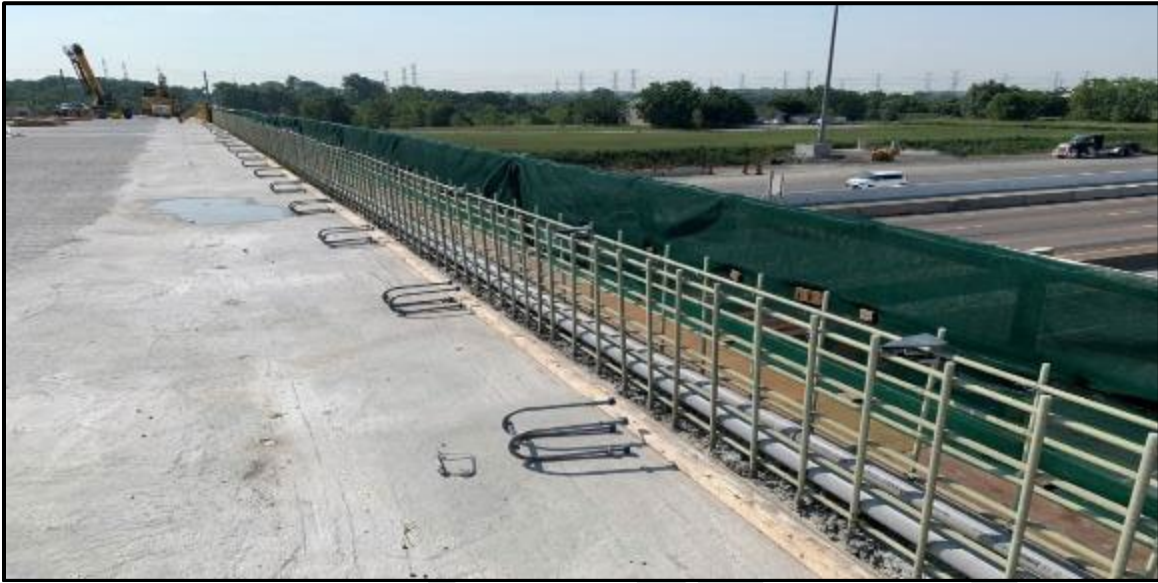
Figure 92 does not have any protection for installed bars. This condition is not acceptable.

Figure 92 – Installed bars not covered with polyethylene

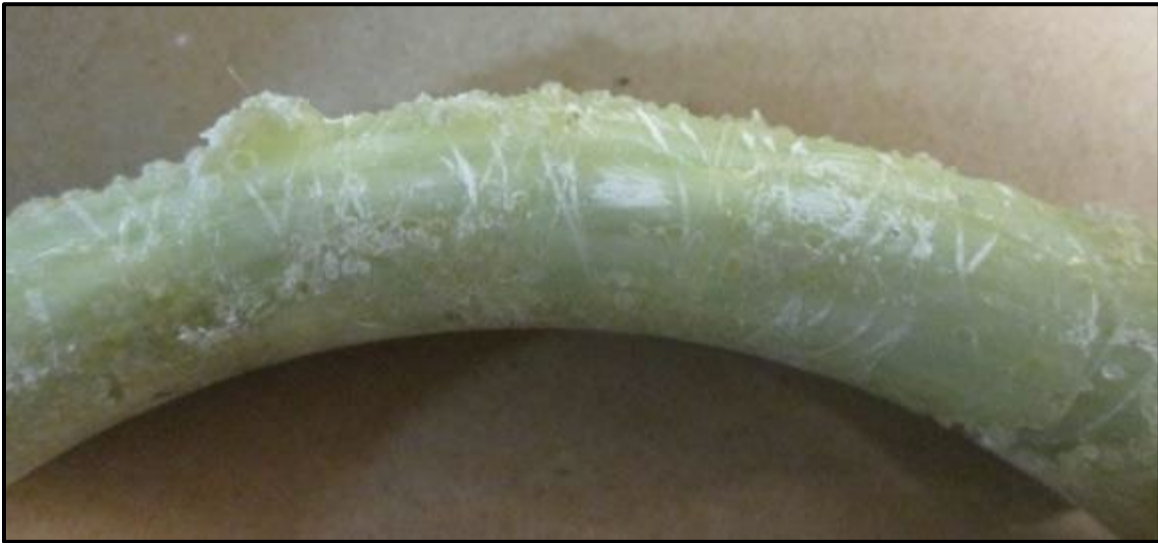
Figure 93 – Visible fibres (may be repaired by the manufacturer)

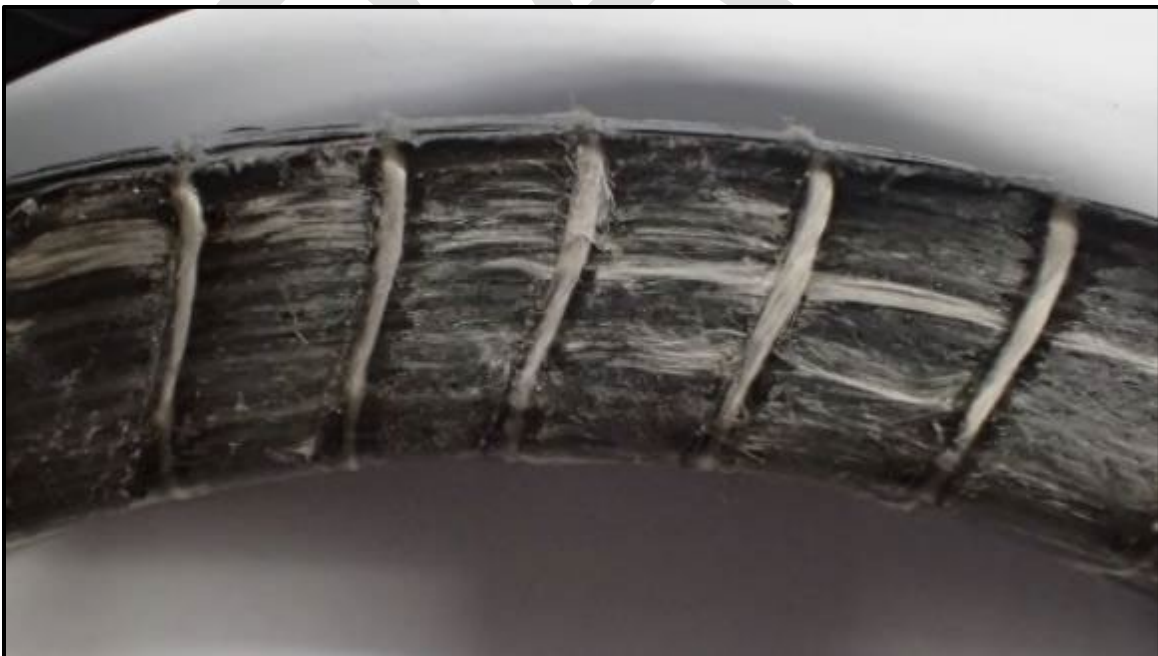
Figure 94 – Dry and exposed fibres

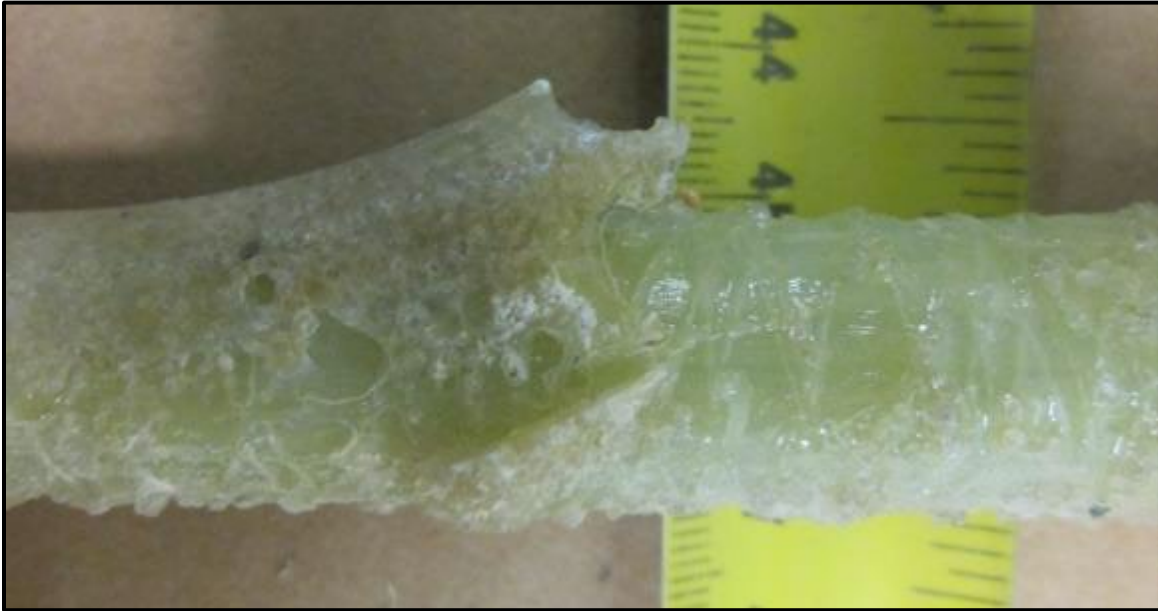
Figure 95 – Resin accumulation at the start/end of bend larger than 4mm (may be repaired by the manufacturer)

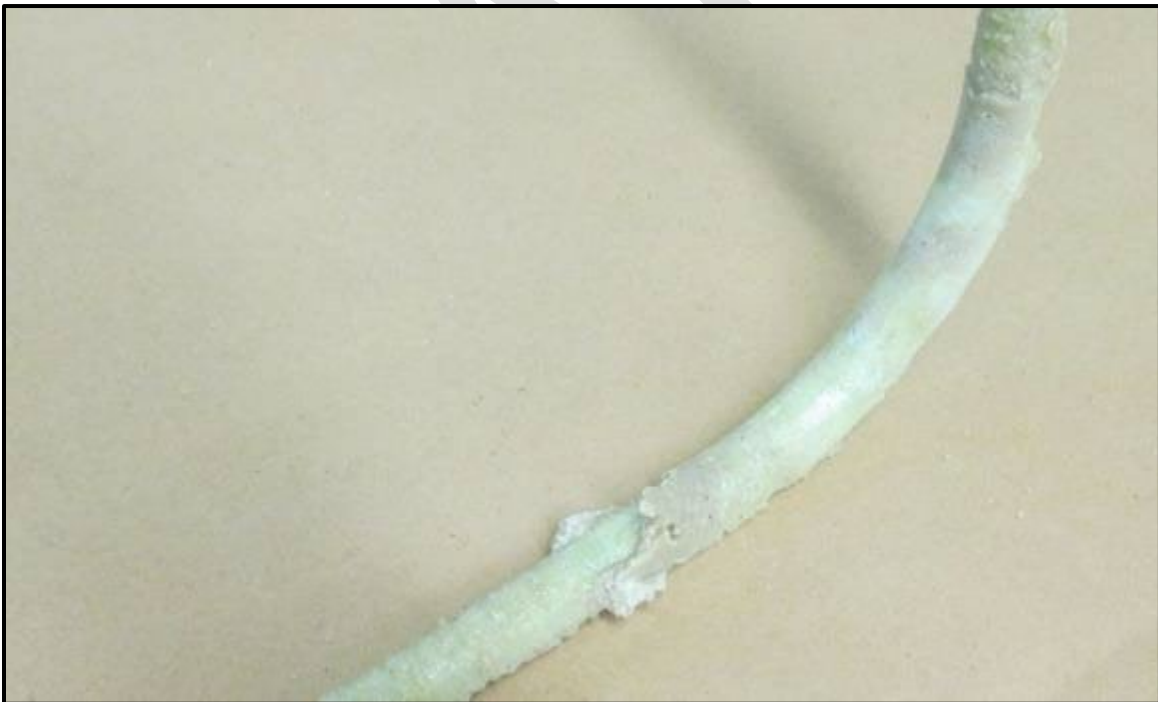
Figure 96 – Resin accumulation at the start/end of bend larger than 4mm (may be repaired by the manufacturer)
