Ministry of Transportation
Standards and Contracts Branch
Structures Office Report

Guidelines for Inspection and Field Acceptance of Glass Fibre Reinforced Polymer (GFRP) Reinforcing Bars

STR-00X

September 2022

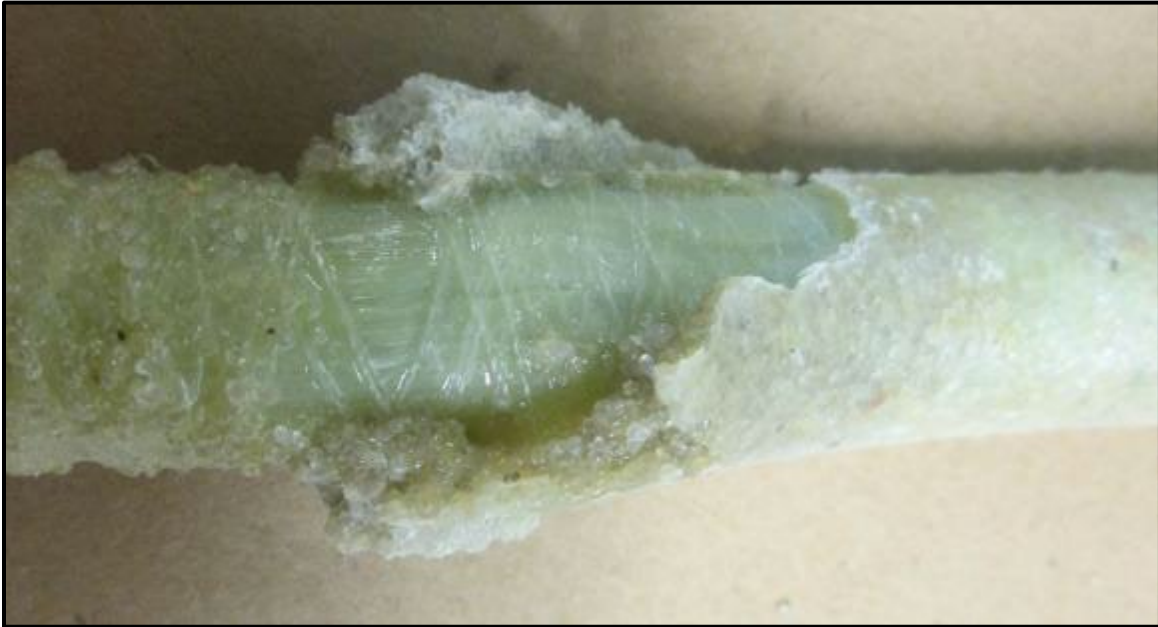
Figure 97 – Resin accumulation at the start/end of bend larger than 4mm (may be repaired by the manufacturer)

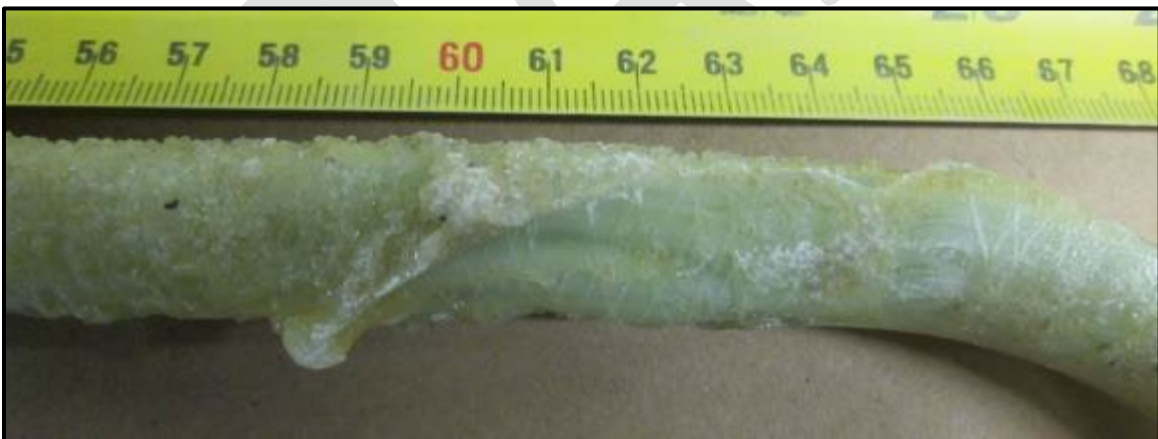
The defects in Figure 98 and Figure 99 are from mis-aligned tooling coming into contact with the bend. This defect is usually accompanied with a large bulging defect, not shown here.

Figure 98 – Mis-aligned tooling print into the bend

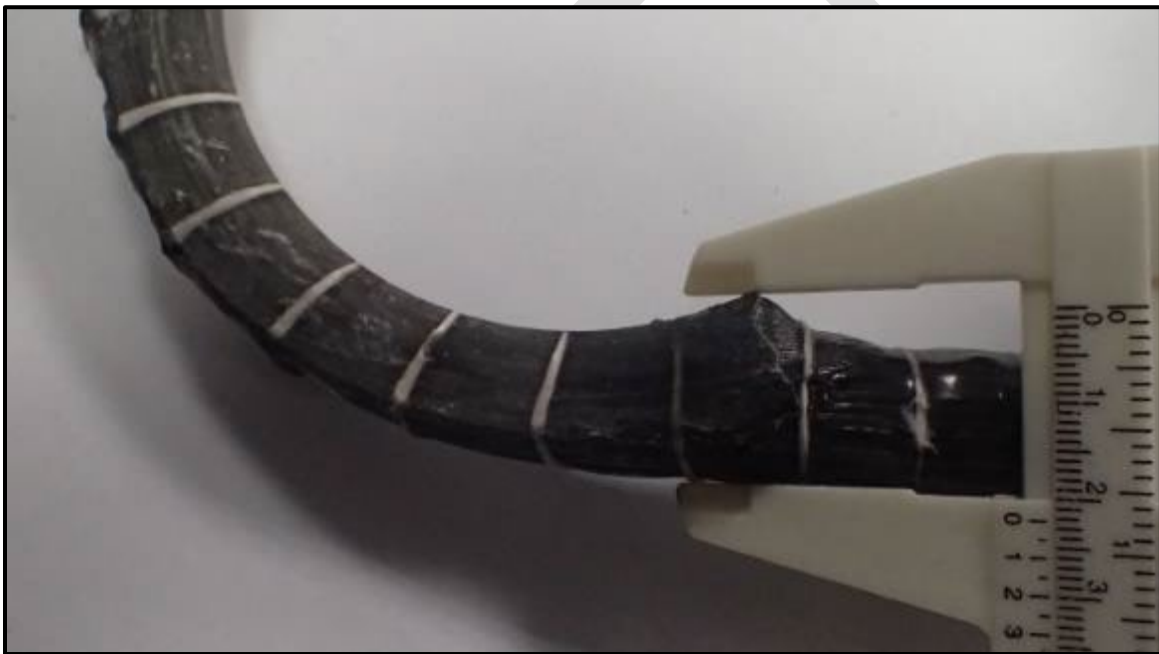
Figure 100 – Bend bulge more than the lesser of 4mm or 25% of diameter (17mm bar shown)

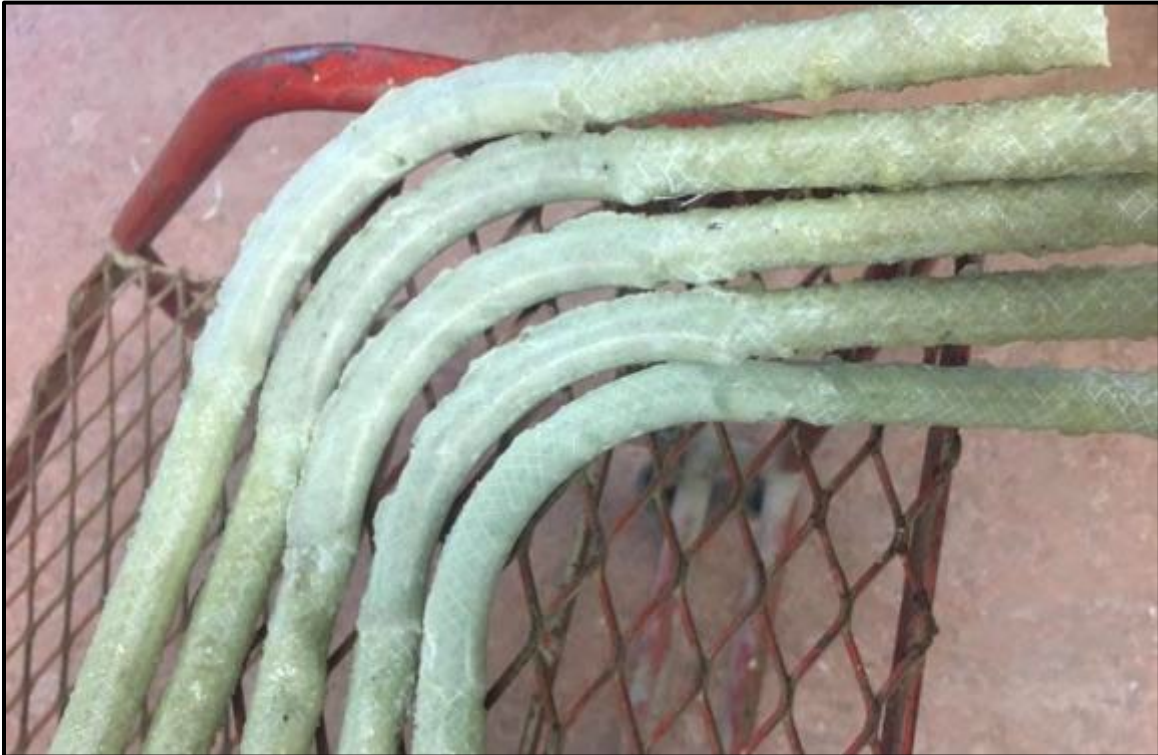
There is an excess of resin built up in multiple locations on the bars in Figure 101 to Figure 103. This inconsistent resin distribution causes the bar not to be homogeneous throughout its cross-section. The guideline for acceptability of excess resin or bulging of fibres on the inside of the bend is 4mm, or 25% of the bar diameter, whichever is smaller, beyond which the bar becomes unacceptable. This only applies to bulging or bumps, not flattening of the cross-section at the bend.

Figure 101 – Resin build-up and inconsistencies

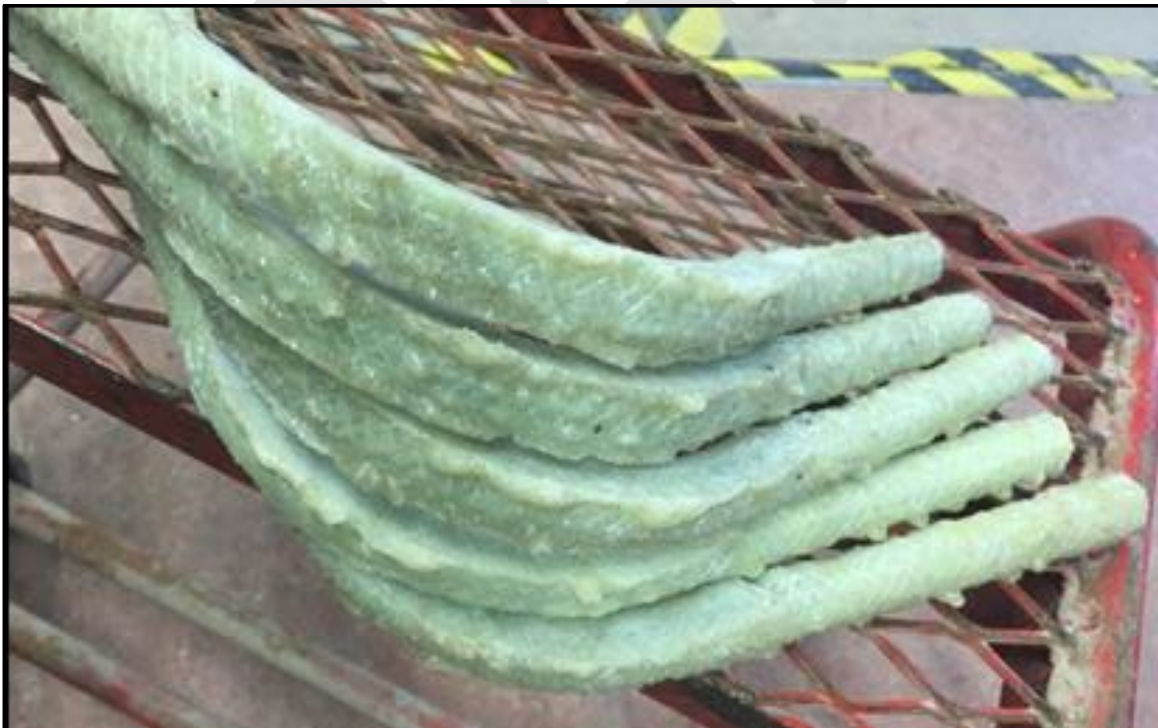
Figure 102 – Resin inconsistency (drips and runs)

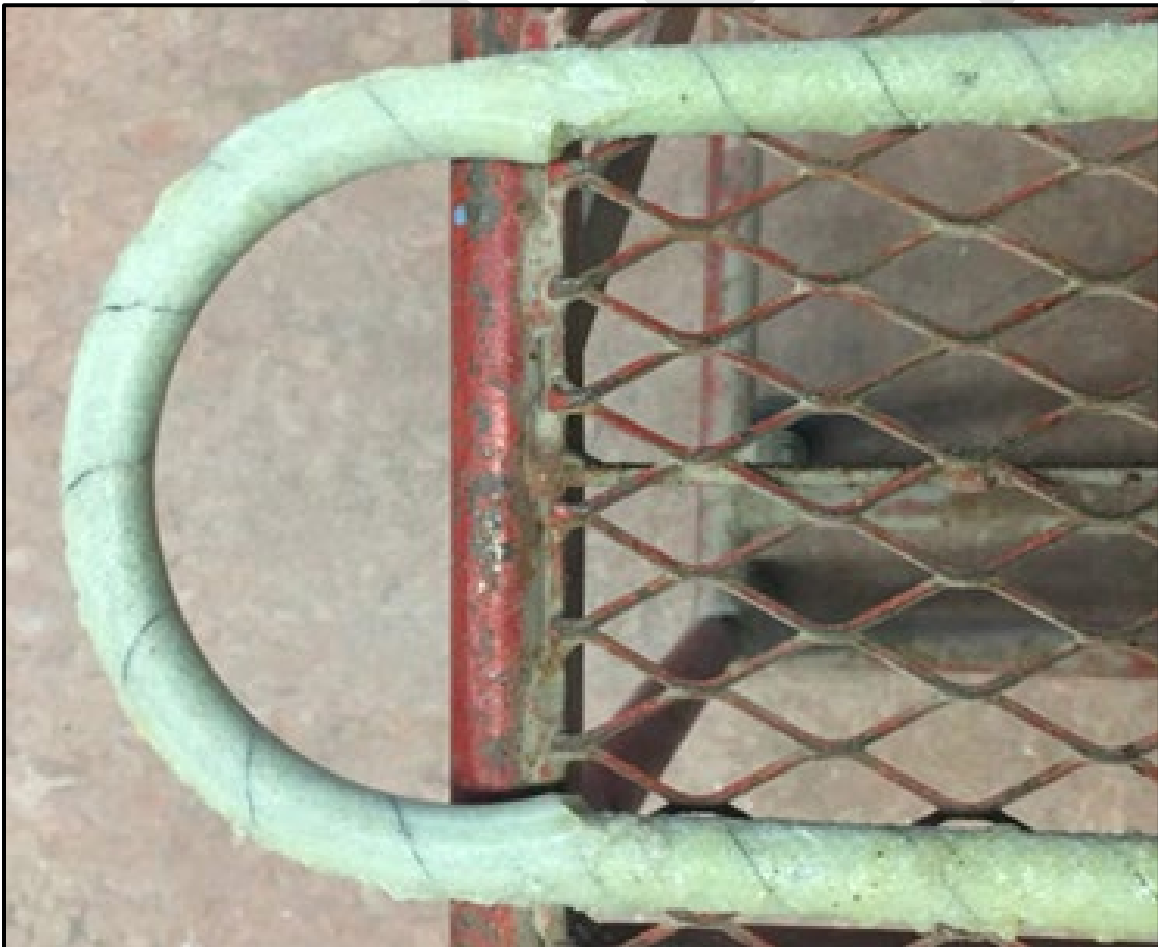
Figure 104 – Deformity at the start/end of bend

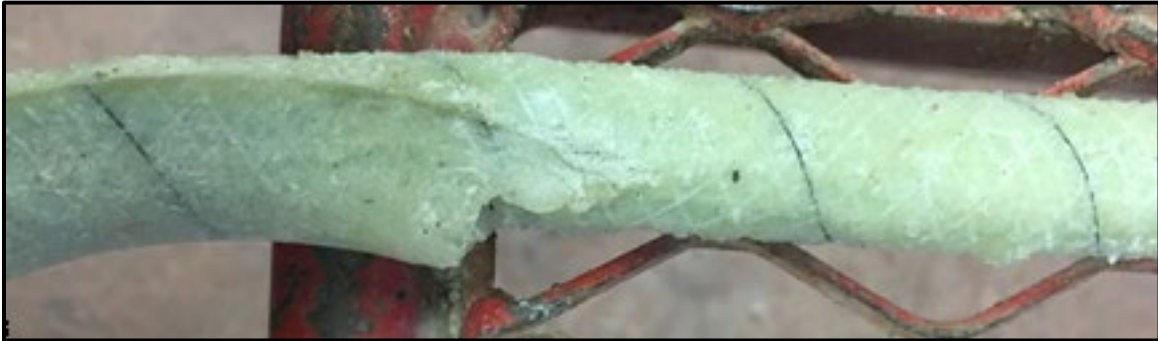
Figure 105 – Resin build-up at bend

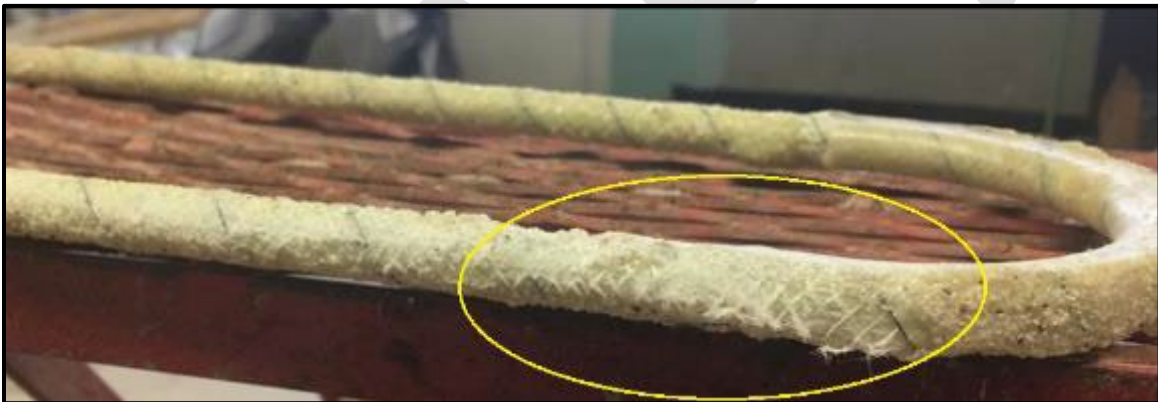
The same bar is shown in Figure 106 and Figure 107 which has loose and exposed fibres protruding on the outside of the bend. Also, the end of the bar has not been cleanly cut and shows excessive and frayed loose fibres as seen in Figure 107. This bar cannot be repaired and must be rejected because of the exposed fibres on the outside of the bend. For a similar bar with no loose fibres on the bend, and if it was long enough, it might be made acceptable by the manufacturer cutting the end properly before leaving the plant.

Figure 106 – Exposed fibres at bend

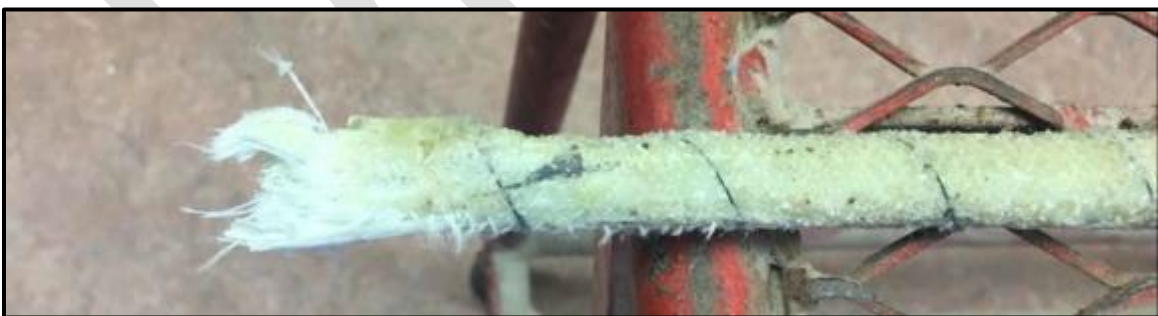
Figure 107 – Loose / frayed fibres at bar end

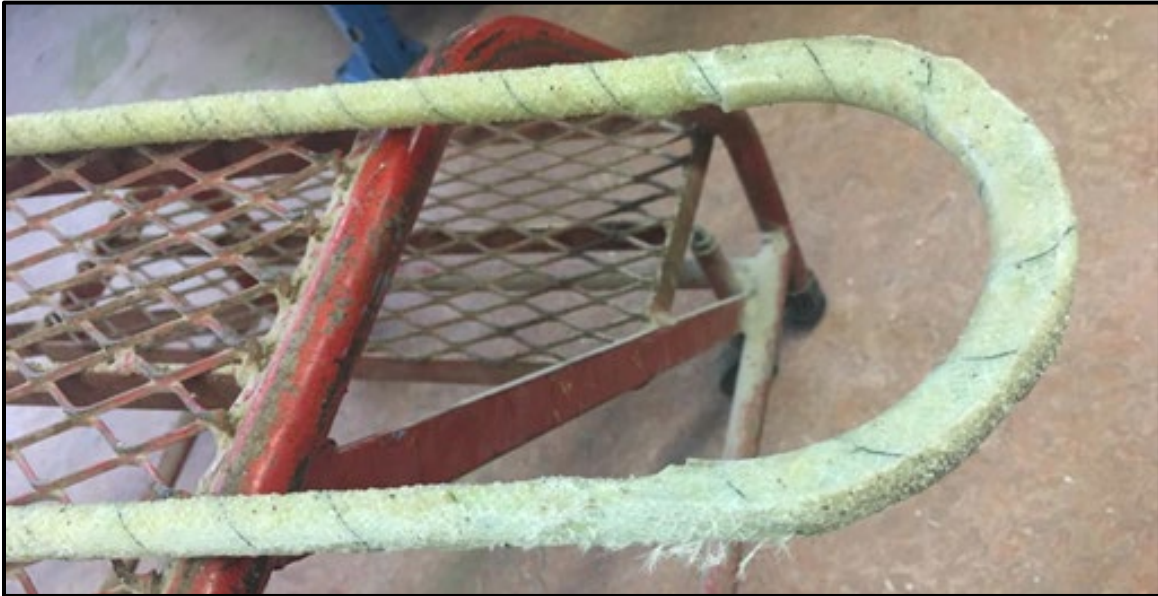
Figure 108 – Exposed fibres at bend

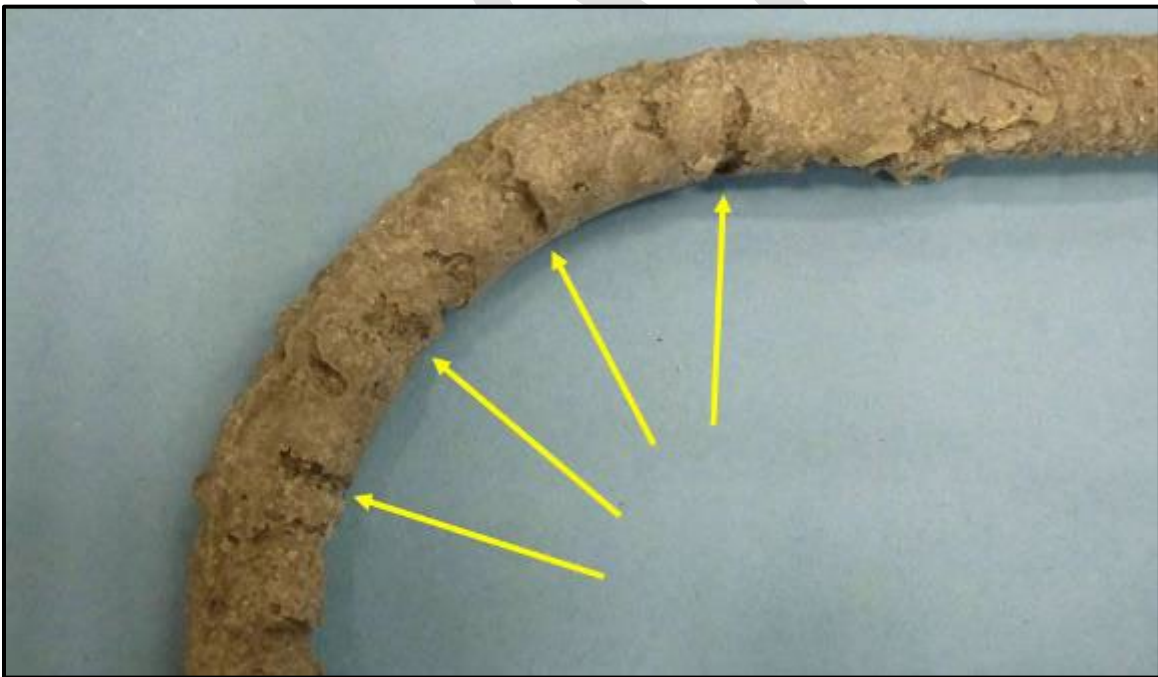
The bar in Figure 109 has excessive voids and cracks in the resin at the bend. This bar cannot be repaired and must be rejected.

Figure 109 – Rejectable bar, with arrows pointing to surface voids

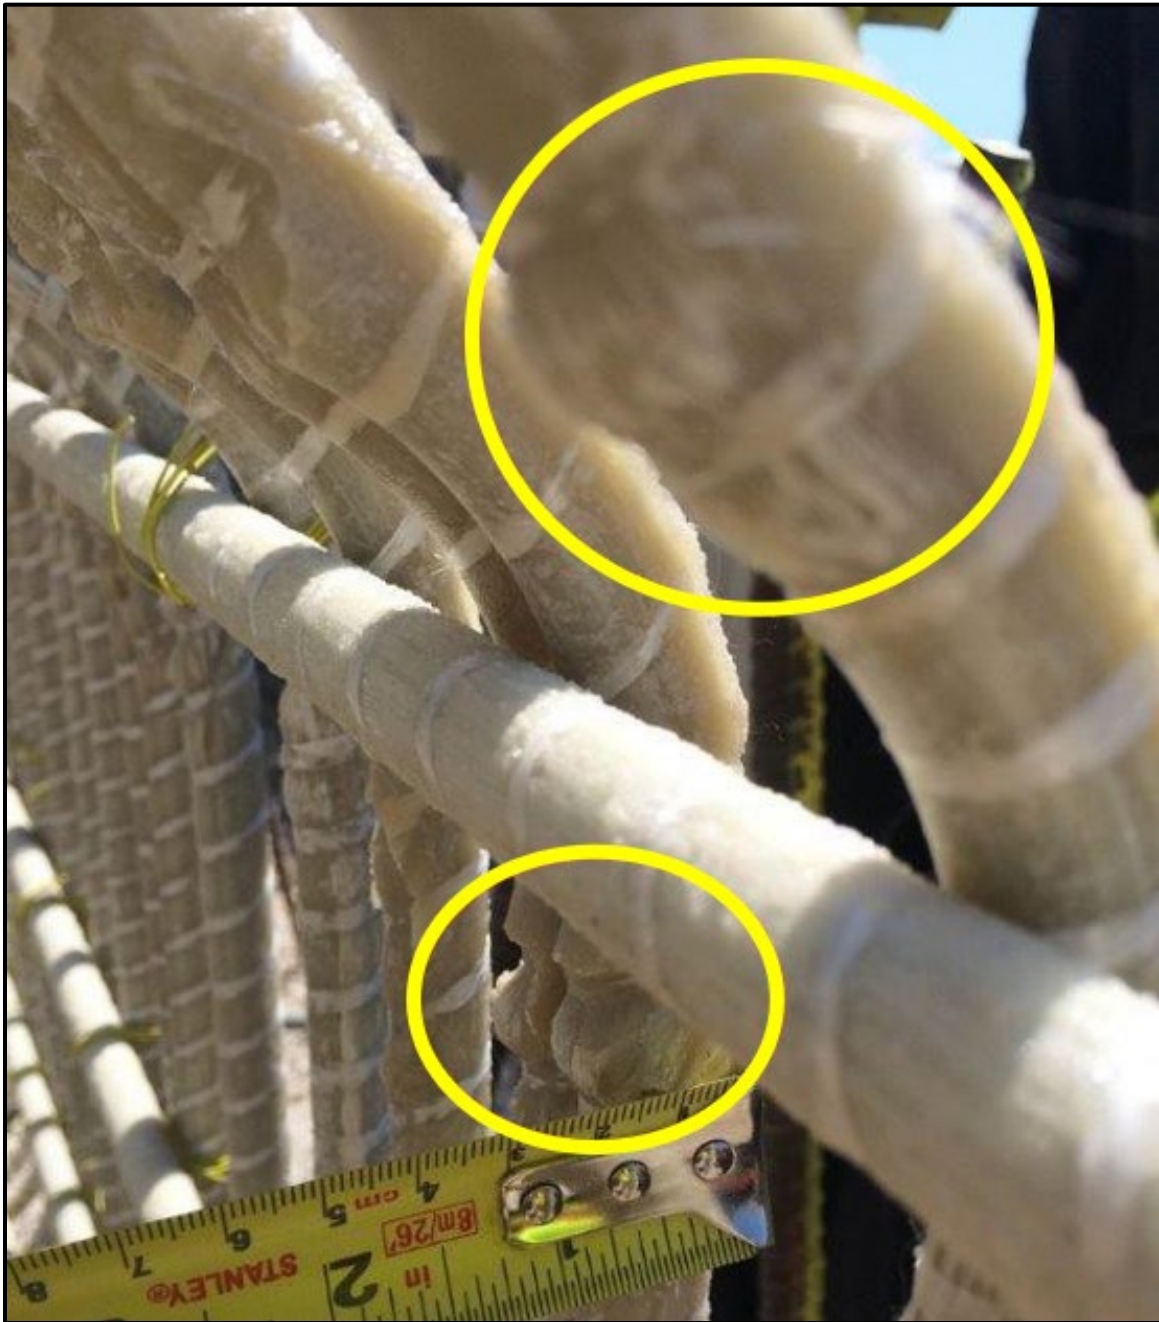
The group of bars in Figure 110 show cross-section inconsistencies and bulges on the inside of their bends. The guideline for acceptability of excess resin or bulging of fibres on the inside of the bend is 4mm, or 25% of the bar diameter, whichever is smaller. The bulges are too large and there is a non-homogeneous cross-section, making the bars unacceptable for use. These bars cannot be repaired and must be rejected.

Figure 110 – Unacceptable bar, showing bulges on the inside of their bends

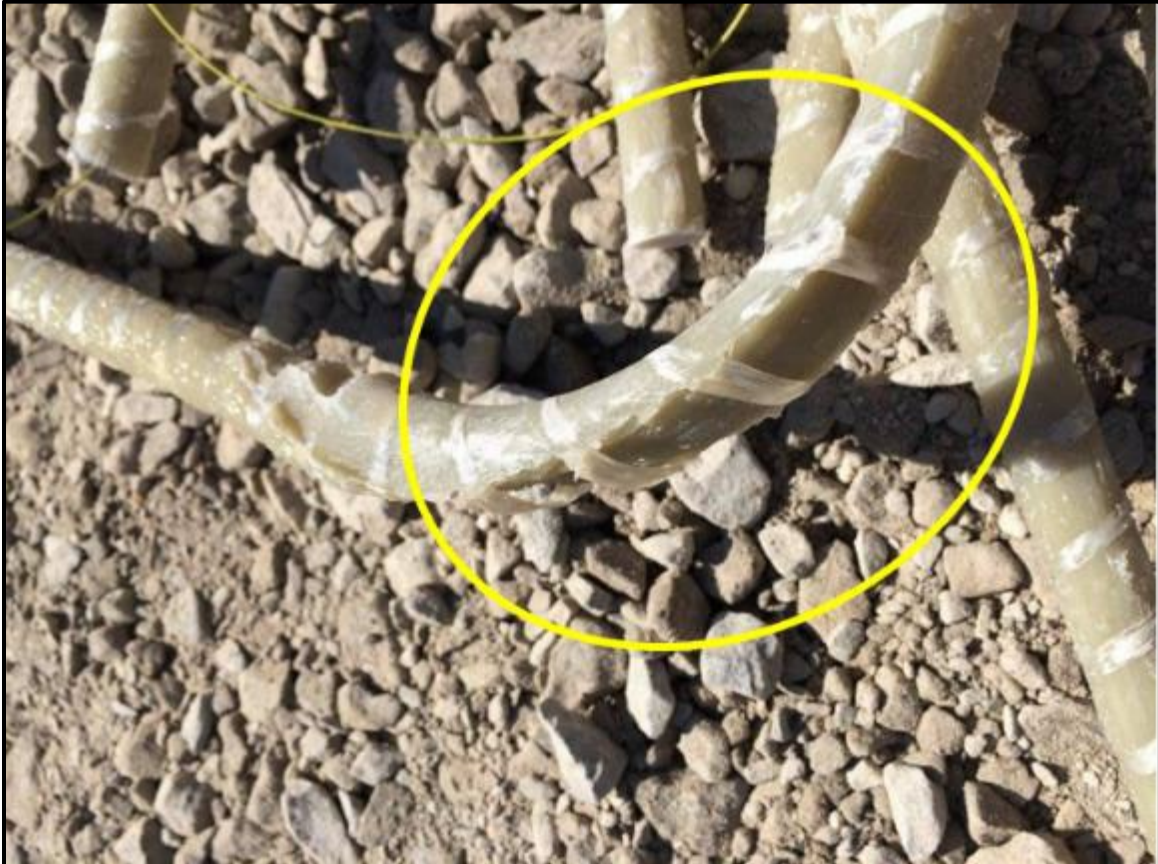
The bar in Figure 111 has crevices and a deformed section at the bend, which creates a non-uniform longitudinal cross section along the bar. Surface finishes are required to be free of voids and air pockets. As a result, this bar is unacceptable for use on MTO contracts. This deficiency was noticed after the bars were delivered to the construction site; therefore, this bar can no longer be repaired and must be rejected.

Figure 111 – Unacceptable bar with crevices and section loss at bend
