PART 2 – DETAILED VISUAL INSPECTION

A.2 APPROACHES

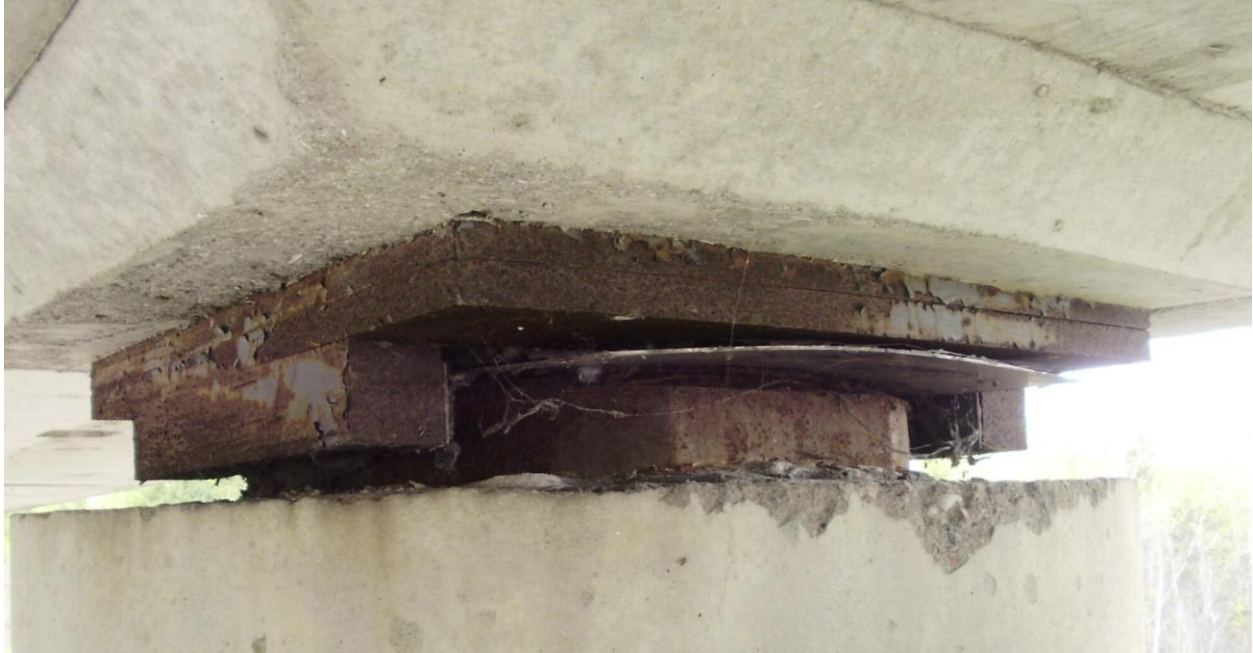
FigureA.1 (k) Pot Bearing

Condition State: Poor	Performance Deficiency: Seized Bearings
Stainless sliding surface debonded from shoe plate.	Bearing transferring unintended forces to substruction

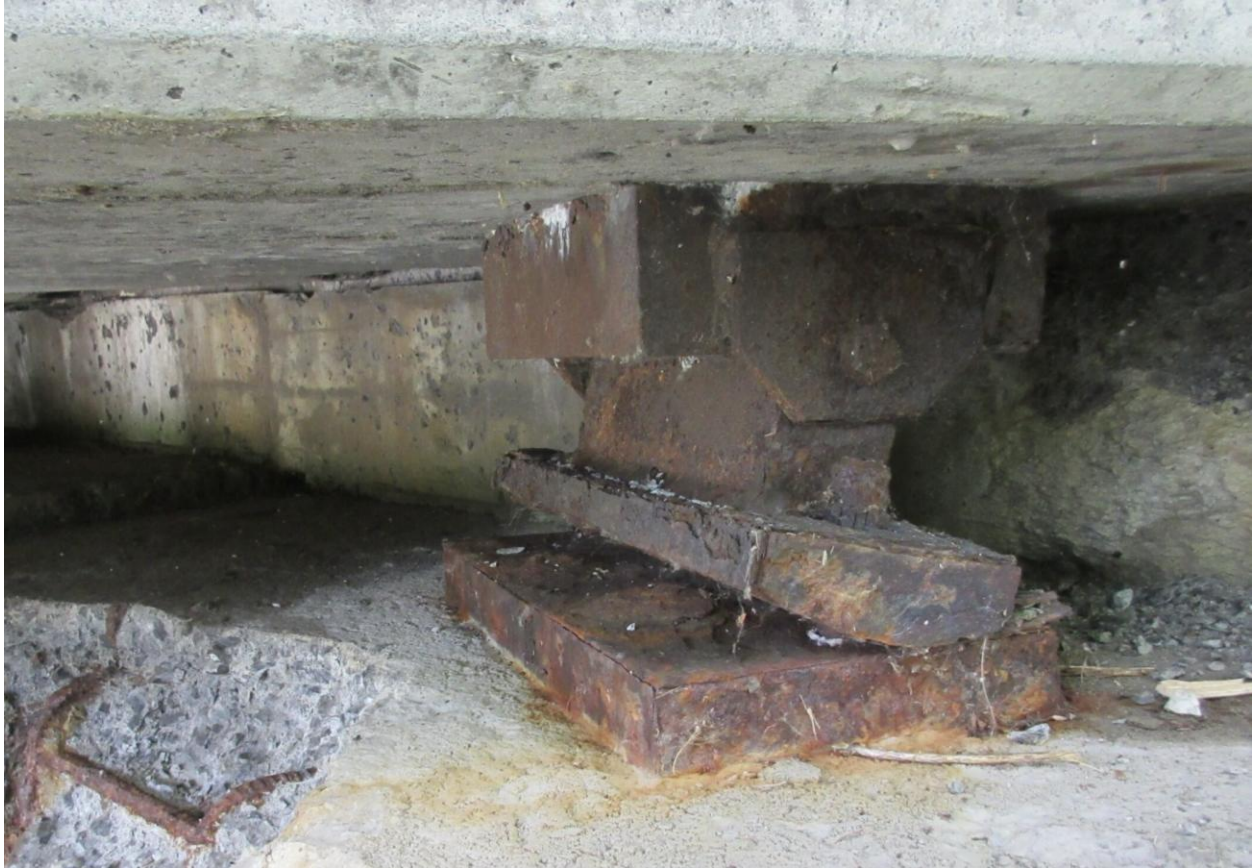
FigureA.1 (I) Steel Rocker Bearing

Condition State: Fair	Performance Deficiency: Bearing Not Uniformly Loaded/Unstable
Medium Corrosion.	Rocker corrosion products causing rocker to tilt more than warranted for inspection temperature. Alignment bolts severely corroded, filling slots in rocker with debris, limiting movement.

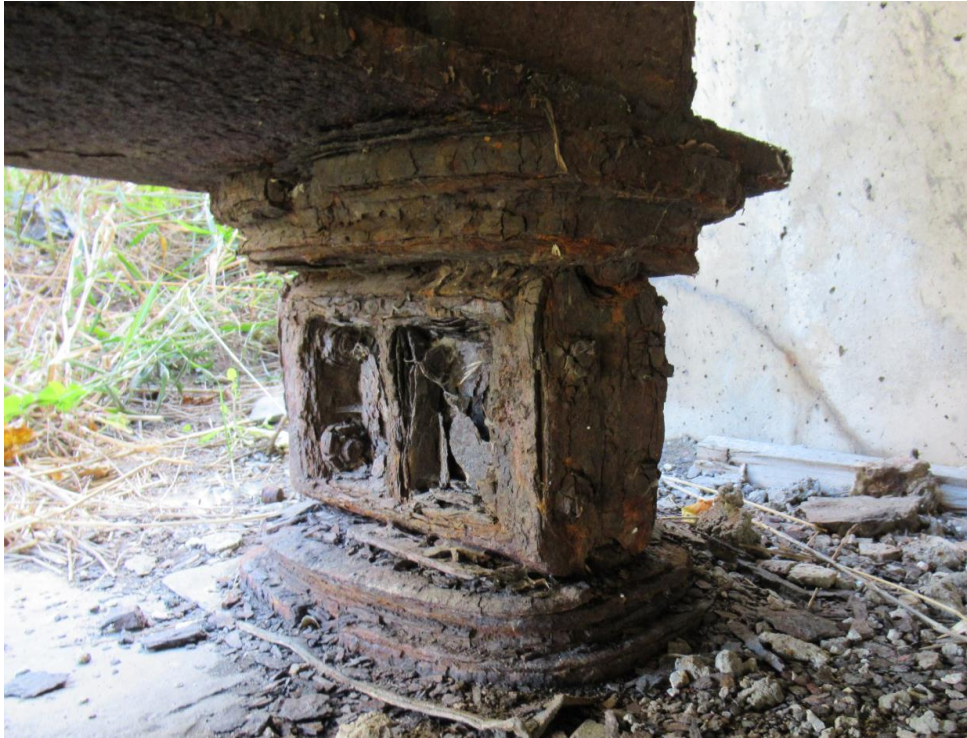
FigureA.1 (m) Steel Rocker Bearing

Condition State: Poor Severe corrosion and section loss of rocker, with excessive buildup of debris on contact surfaces. No evidence of bearing movement.	Performance Deficiency: Bearing Seized Expansion bearing at abutment causing redistribution of expansion/contraction forces.
---	--

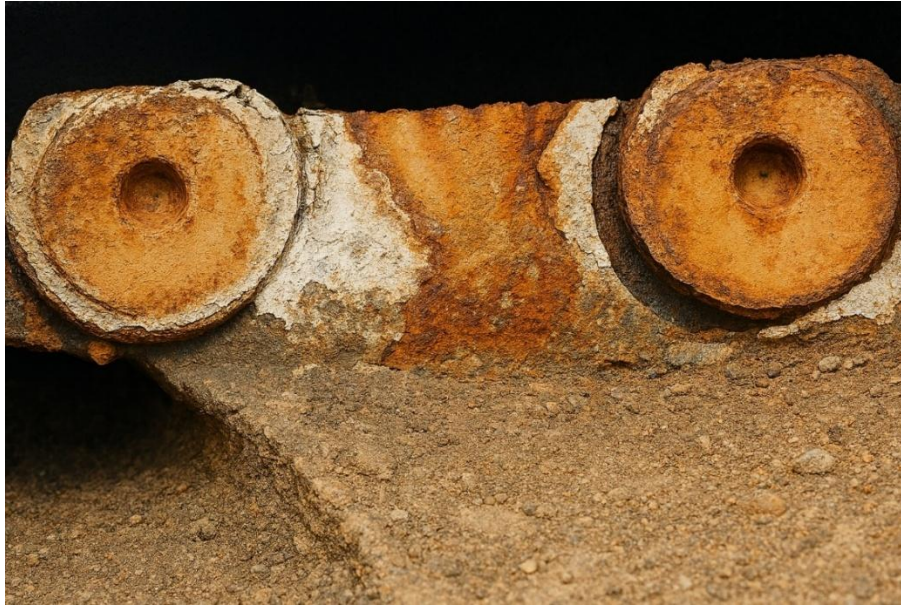
Figure A.1 (n) Roller Bearing

Condition State: Poor	Performance Deficiency: Seized Bearings
Very severe corrosion, debris filling space between rollers, alignment plate missing.	Rollers frozen with no capability for movement. Alignment of rollers compromised.

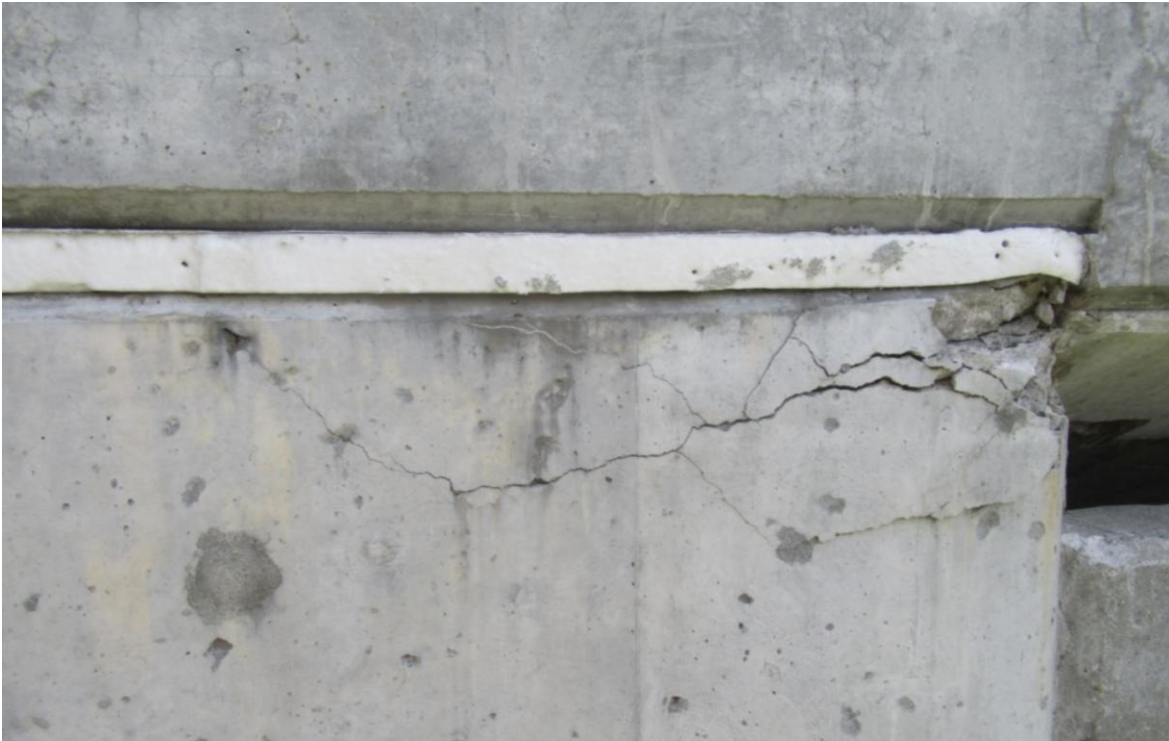
Figure A.1 (p)Concrete Wingwall

Condition State: Poor	Performance Deficiency: None
Wide Cracks and crushing of concrete	Deck appears to be crushing wingwall with expansion movements. Monitor.

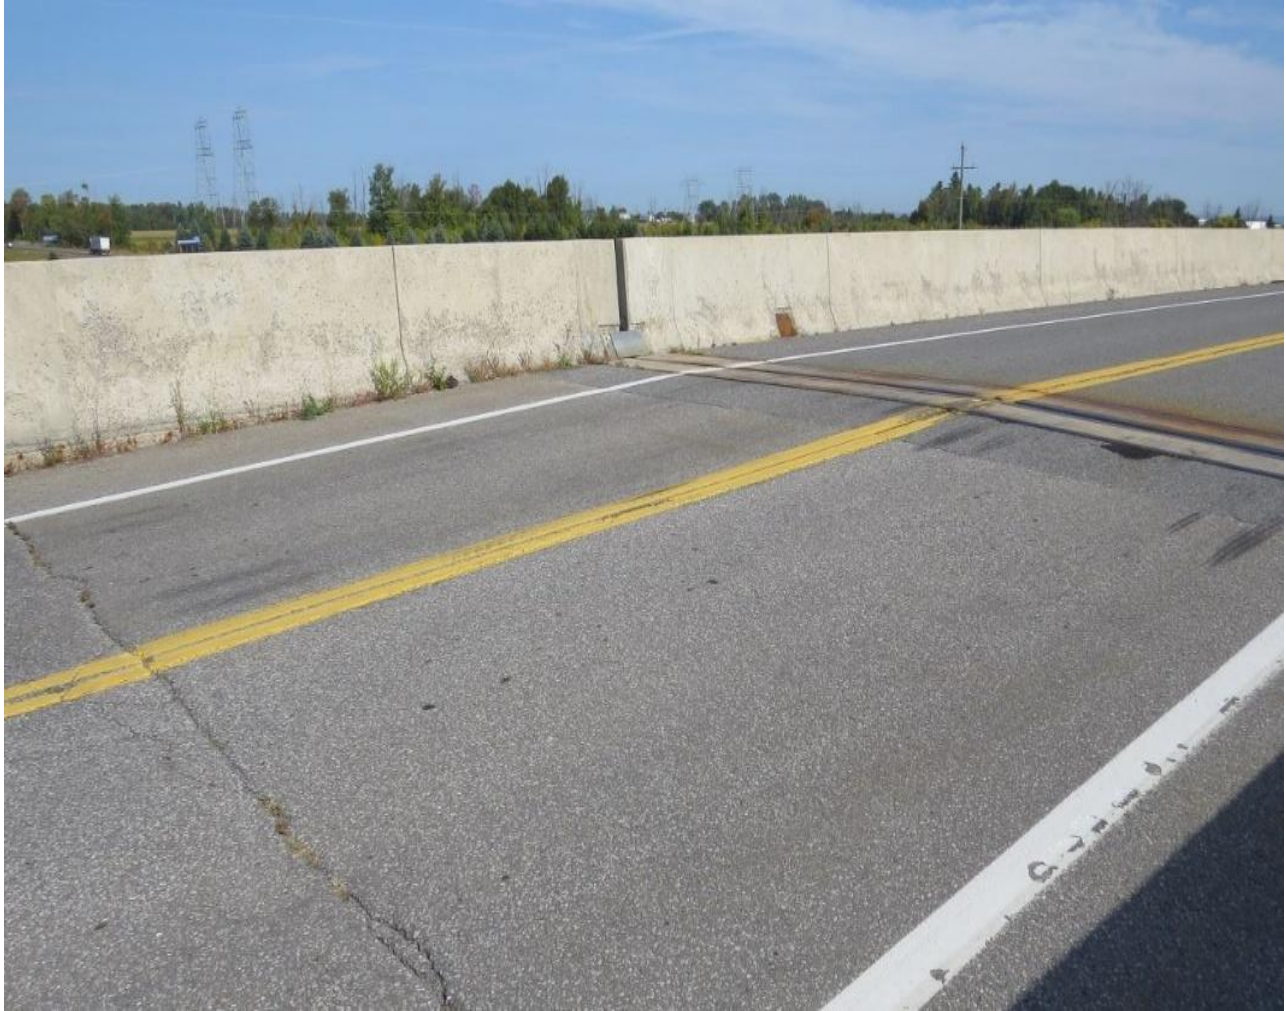
Figure A.2 (a) Concrete Approach Slab

<p>Condition State: Good</p>	<p>Performance Deficiency: Pedestrian/Vehicular Hazard / Rough Riding Surface</p>
<p>No visible defects in approach slab</p>	<p>Approach has settled by 125-150 mm adjacent to the bridge, causing lift axle tires to ground-out over joint.</p>

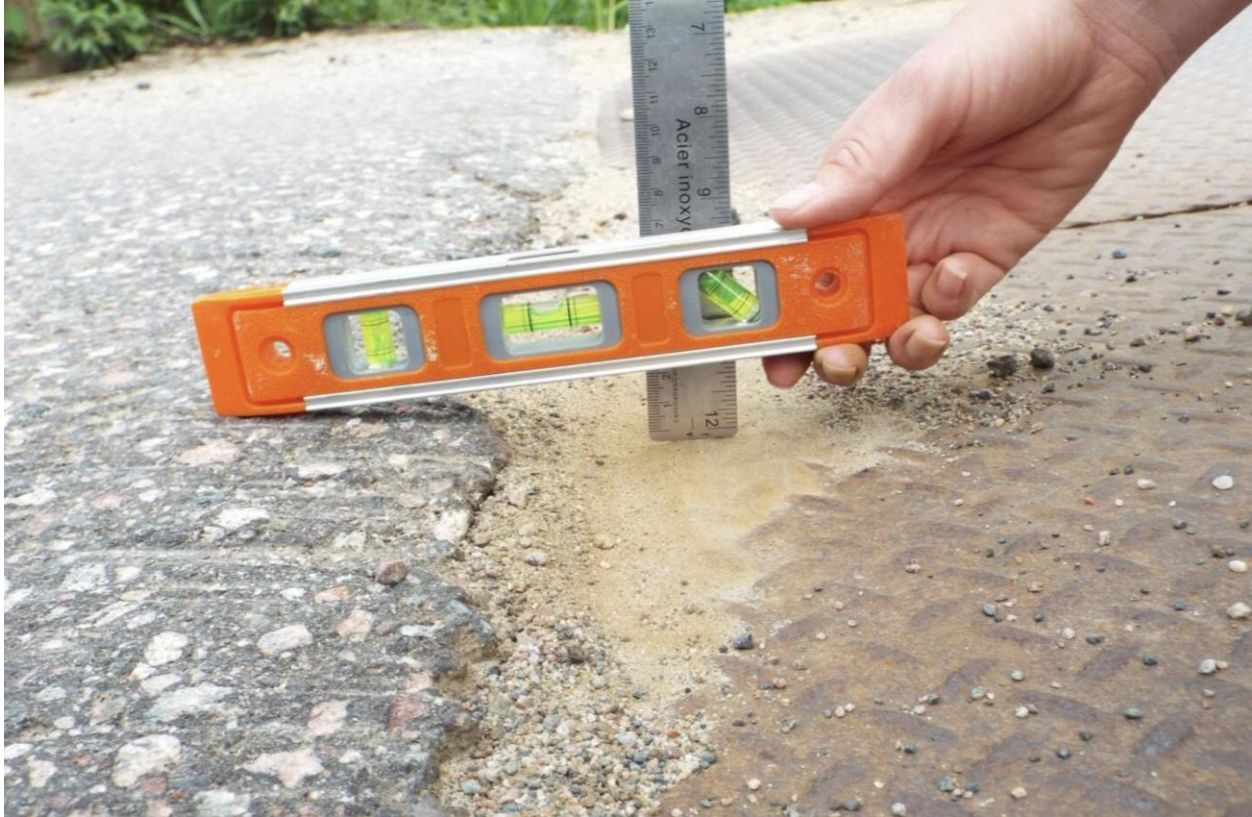
Figure A.2 (a new) Concrete Approach Slab

Condition State: Good	Performance Deficiency: Pedestrian/Vehicular Hazard / Rough Riding Surface
No visible defects in approach slab	Approach has settled by 25mm adjacent to the bridge, causing rough ride and tripping hazard.

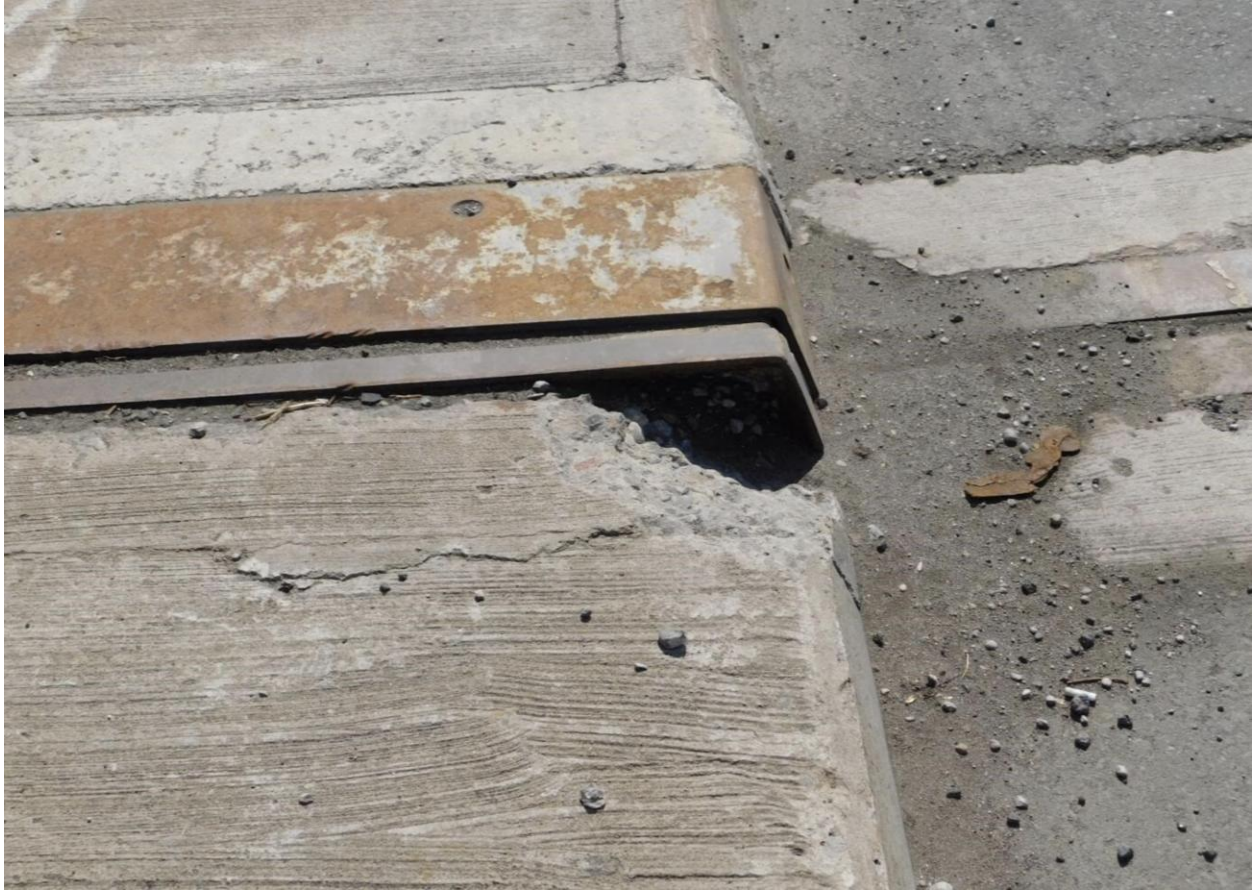
FigureA.2 (b) Approach: Concrete Sidewalk

Condition State: Poor	Performance Deficiency: None
Severe spall

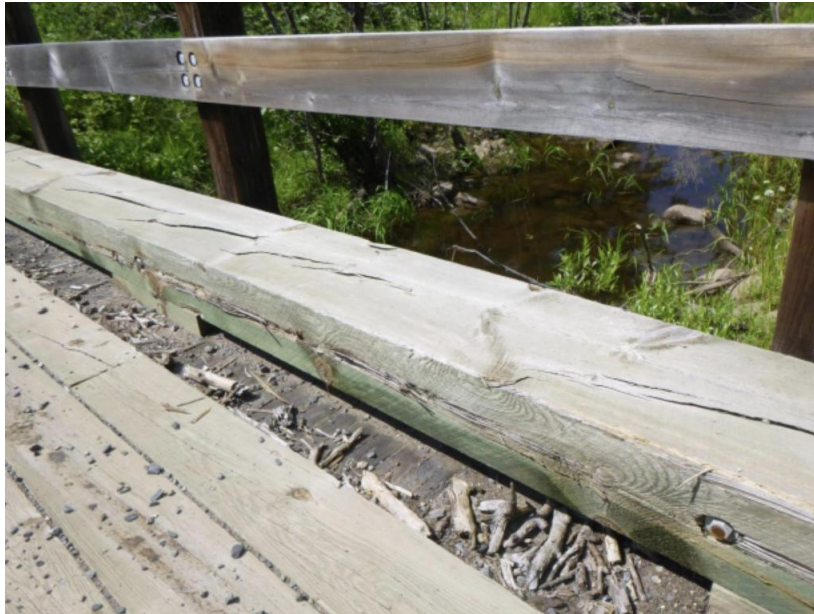
Figure A.2 (c) Wood Curb

Condition State: Good	Performance Deficiency: None
Light Checks	Satisfactory curb height, with no displacements or projections

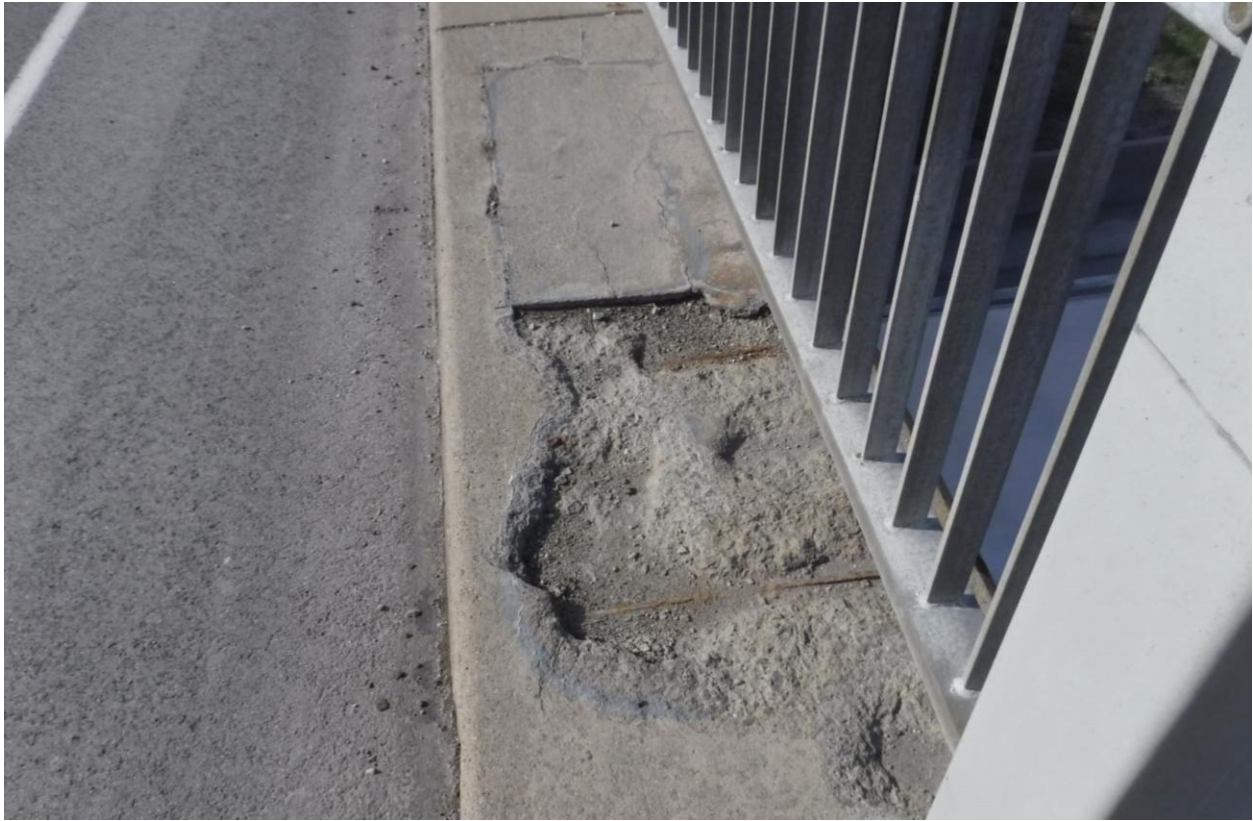
FigureA.2 (d) Concrete Sidewalk

Condition State: Poor	Performance Deficiency: Pedestrian/Vehicular Hazard
Severe spalling with exposed corroded reinforcement	Sidewalk surface irregular with large spalls presenting difficulty for pedestrian passage

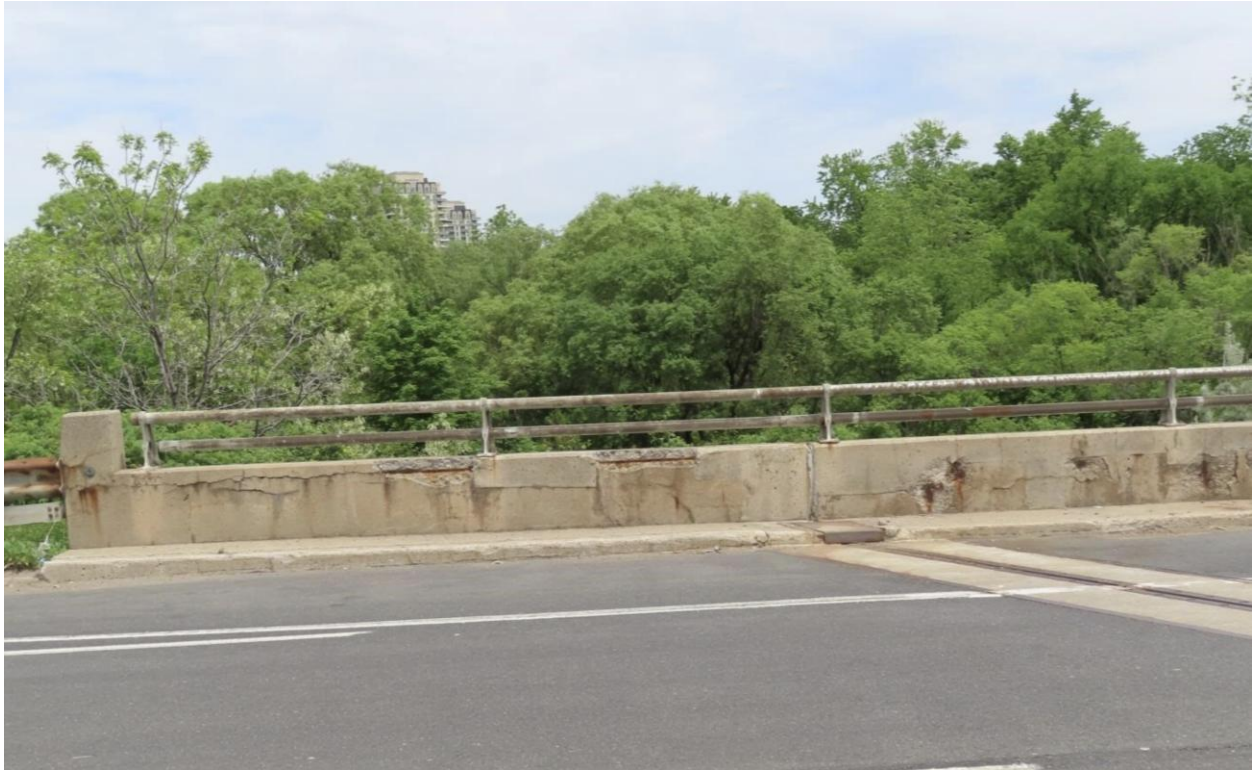
Figure A.3 (a) Parapet Wall

Condition State: Poor	Performance Deficiency: None
Wide stained cracks, large delaminations and spalls with exposed rebar	No performance defects

Condition State: Good	Performance Deficiency: Load Carrying Capacity
Anchorage of hand railing loose due to spalls and delaminations	An evaluation is required to determine the extent of strength reduction

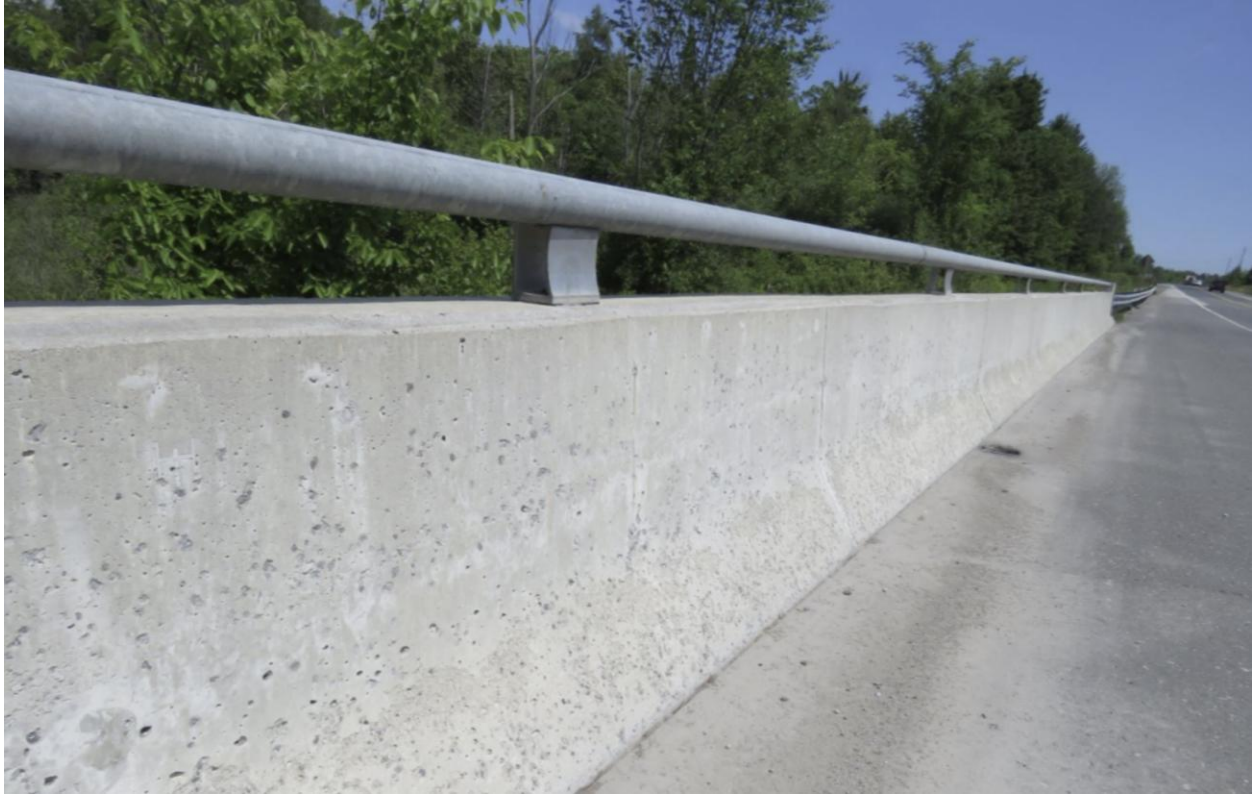
FigureA.3. (b) Barrier Wall

Condition State: Good	Performance Deficiency: None
Light scaling	No performance defects

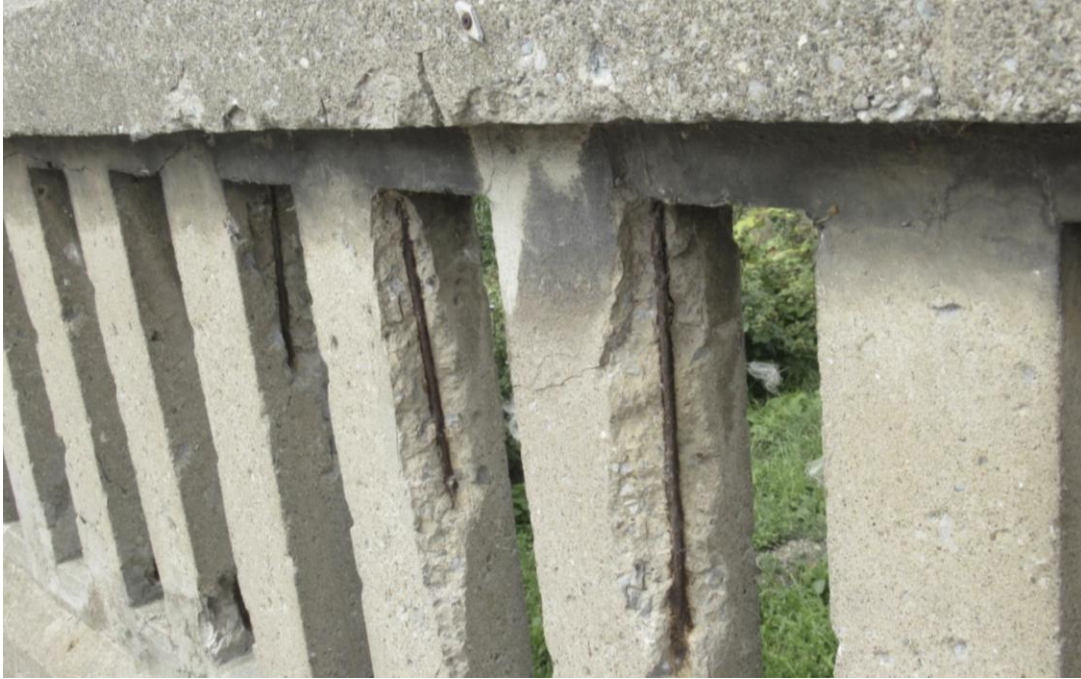
Figure A.3 (c) Concrete Railing

<p>Condition State: Poor</p>	<p>Performance Deficiency: Load carrying capacity</p>
<p>Severe spalling of concrete with exposed rebar</p>	<p>Reinforcing steel with considerable portions of its circumference exposed through spalling of concrete will significantly reduce the capacity of the section, due to the loss of bond and corresponding loss of composite action. Barrier system should be replaced with an approved crash-tested system.</p>

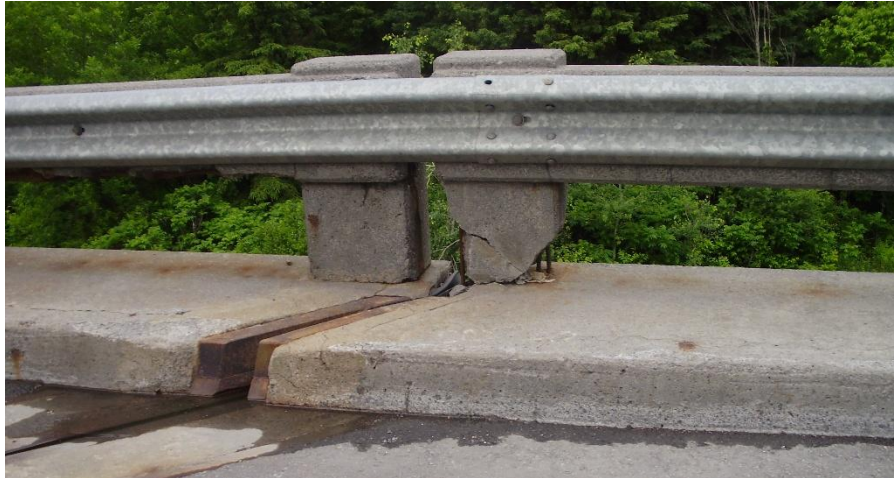
Figure A.3 (d) Concrete Railing

Condition State: Poor	Performance Deficiency: Load Carrying Capacity
Severe spall on concrete post, with section loss noted on reinforcing steel. Guiderail retrofitted for reinforcement.	Spalls on post and section loss of reinforcing severely limit capacity of barrier system. Retrofitted guiderail provides some reinstatement of capacity, but replacement of barrier with a crash tested barrier system should be planned.
