PART 2 – DETAILED VISUAL INSPECTION

A.4 BEAMS / MAIN LONGITUDINAL ELEMENTS

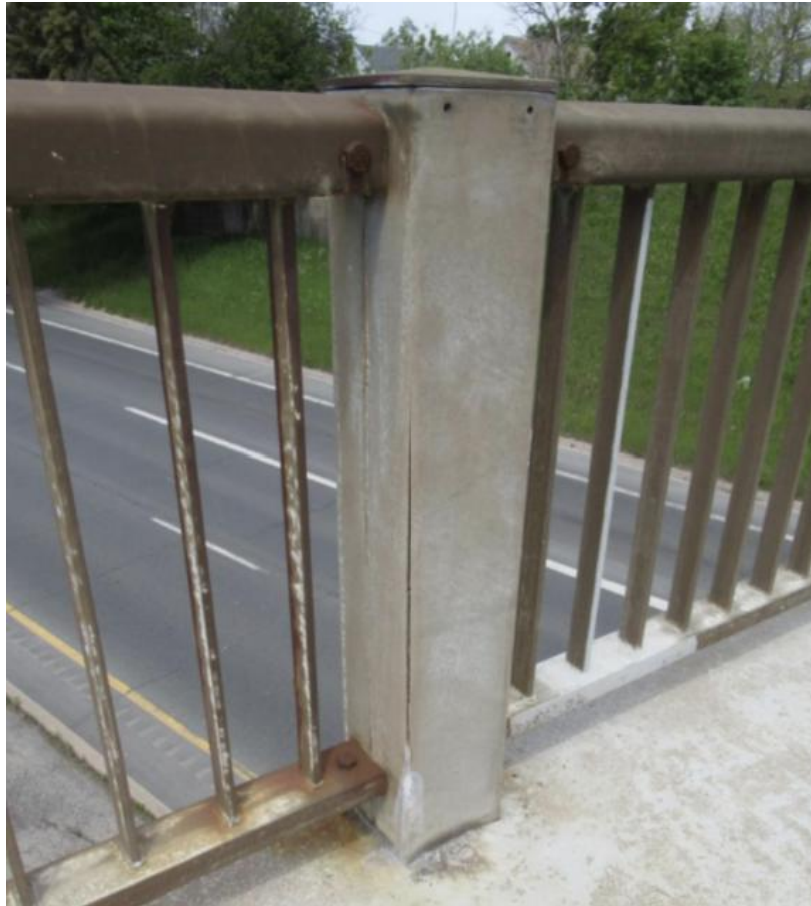
Figure A.3 (e) Steel Railing with Steel Posts (Concrete-Filled)

Condition State (for posts): Poor	Performance Deficiency: Load Carrying Capacity
Post split in corner.	This design of post has concrete filled interior, to top of reinforcing steel projecting up from curb (~600mm). With split in post due to freeze-thaw, bond between post and its concrete interior is compromised. Barrier system should be replaced with an approved crash-tested system.

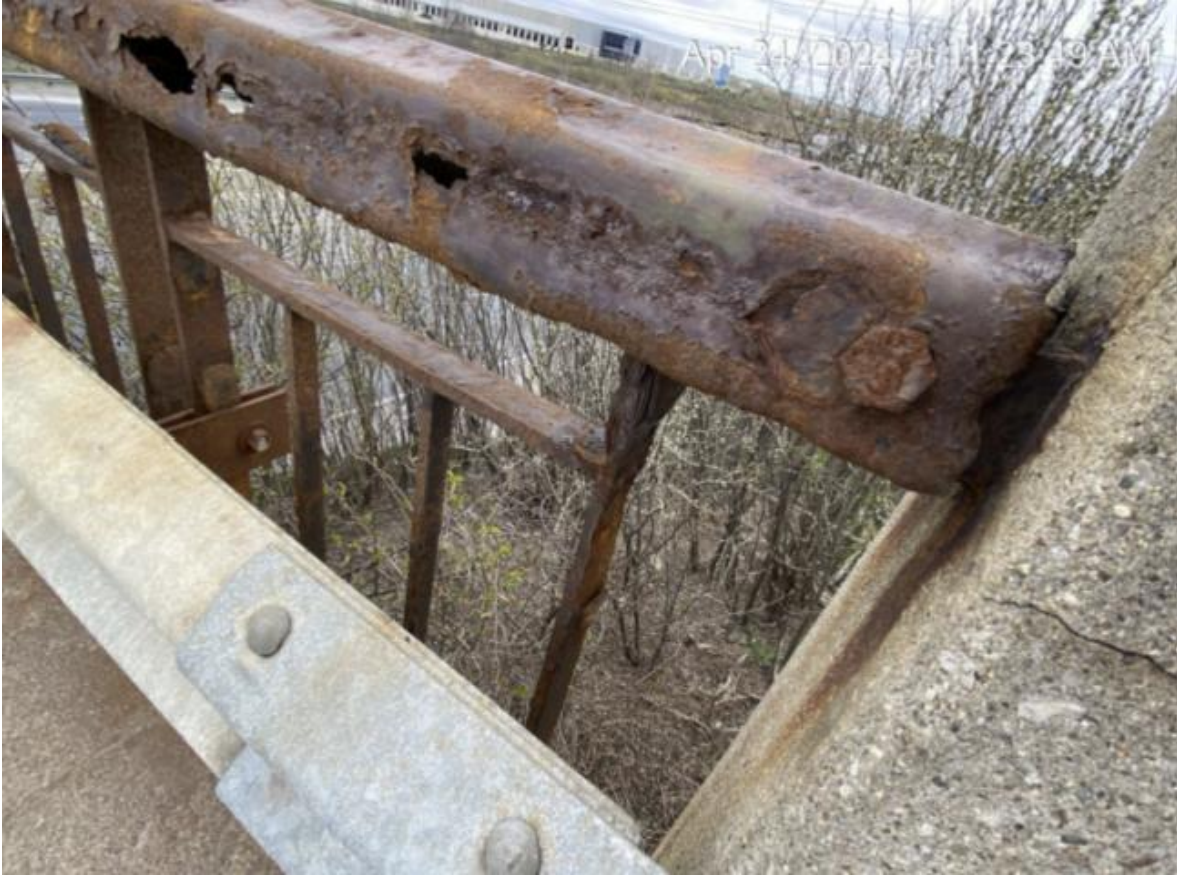
Figure A.3 (f) Steel Railing

Condition State: Poor	Performance Deficiency: Load Carrying Capacity
Severe corrosion with perforations.	Although guiderail has been added to increase capacity of barrier, the usual spacing of the posts in original installation is substantially larger than that normally used with guiderail, creating potential for extreme deflections of barrier, prior to mobilizing strength of posts. Barrier should be replaced with an approved crash-tested system.

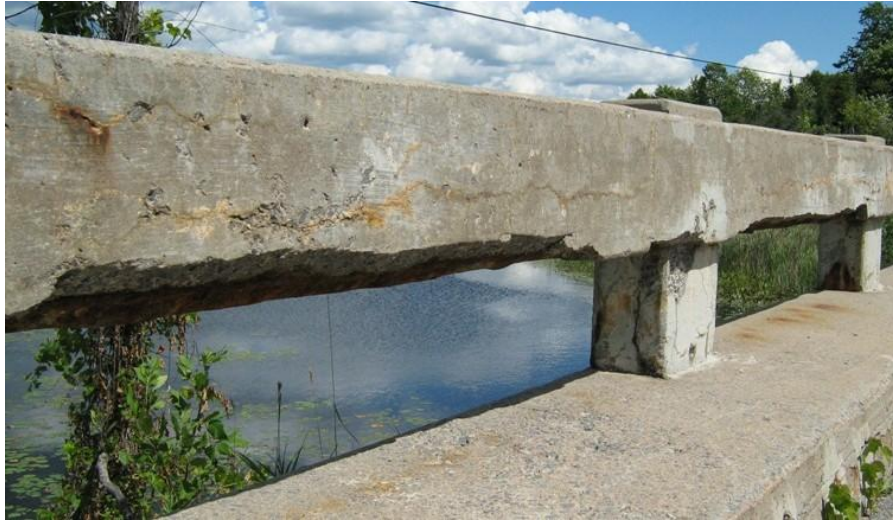
**Figure A.3 (g) Concrete Guiderail**

Condition State: Poor	Performance Deficiency: Load Carrying Capacity
Severe spalls with exposed reinforcing.	Concrete post and rail system does not meet current standards when in good condition. Barrier system should be replaced with an approved crash-tested barrier system.

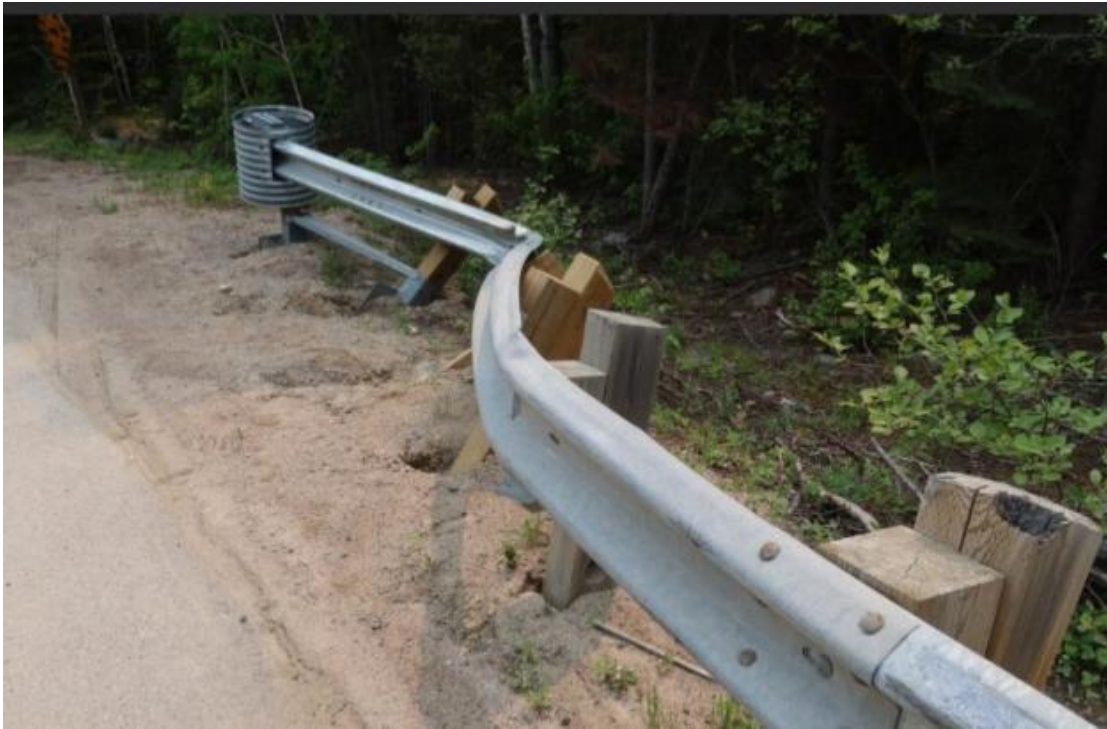
Figure A.3 (h) Steel Flex Beams

Condition State: Poor	Performance Deficiency: Load Carrying Capacity
Permanent deformation of flex beam and posts	
Maintenance Need: Railing System Repair

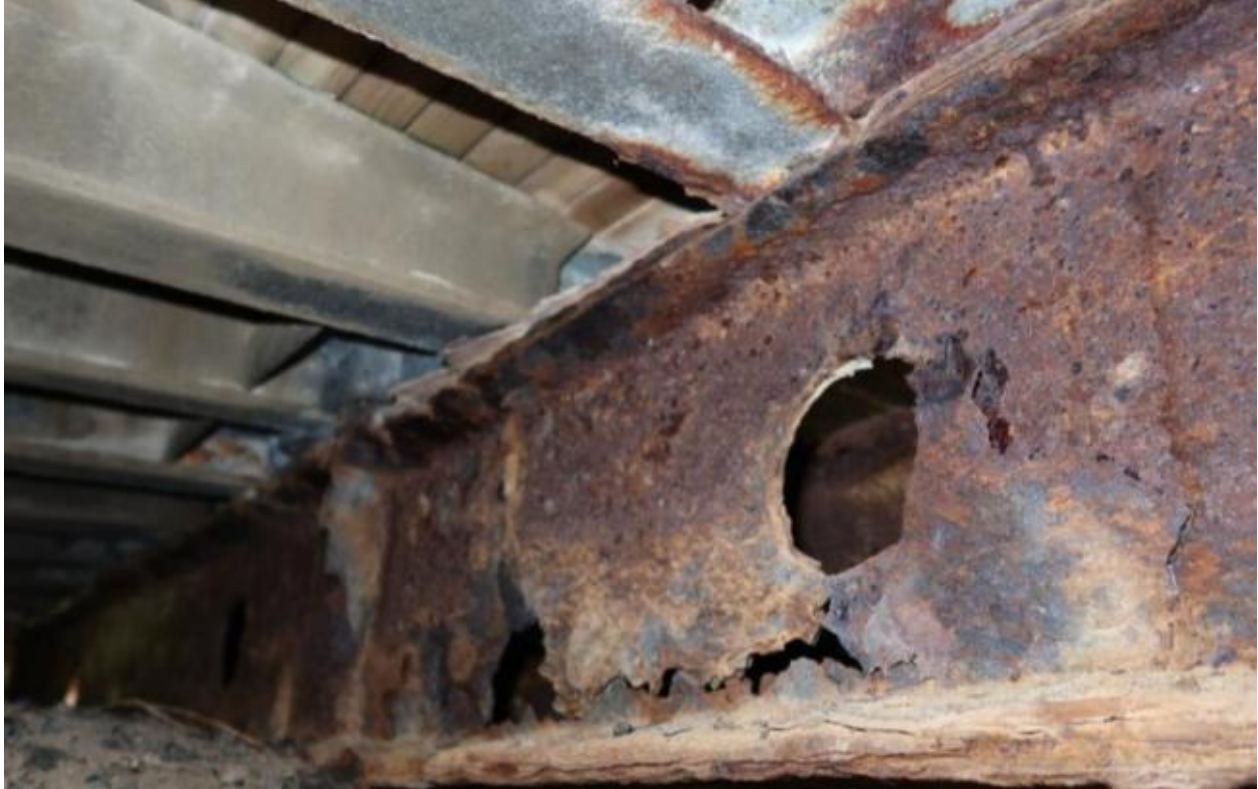
Figure A.4 (a) Beam Girder/MLE - Stringer

Condition State: Poor	Performance Deficiency: Load Carrying capacity
Very severe corrosion with perforation of stringer web	More than 20% loss of cross-section of Stringer. An evaluation is required to determine the extent of strength reduction

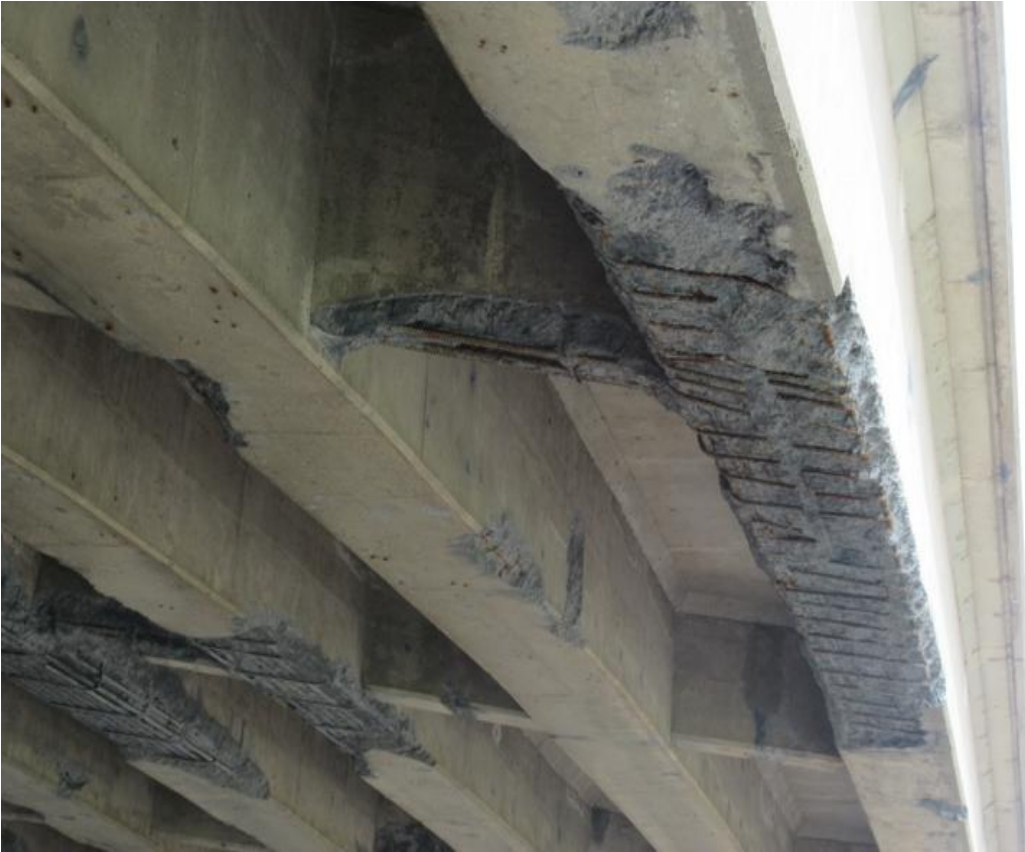
Figure A.4 (b) Reinforced Concrete Girders

Condition State: Poor	Performance Deficiency: Load Carrying Capacity
Severe spalling on the girder with exposed rebar.	The inspector should consider a structural evaluation.

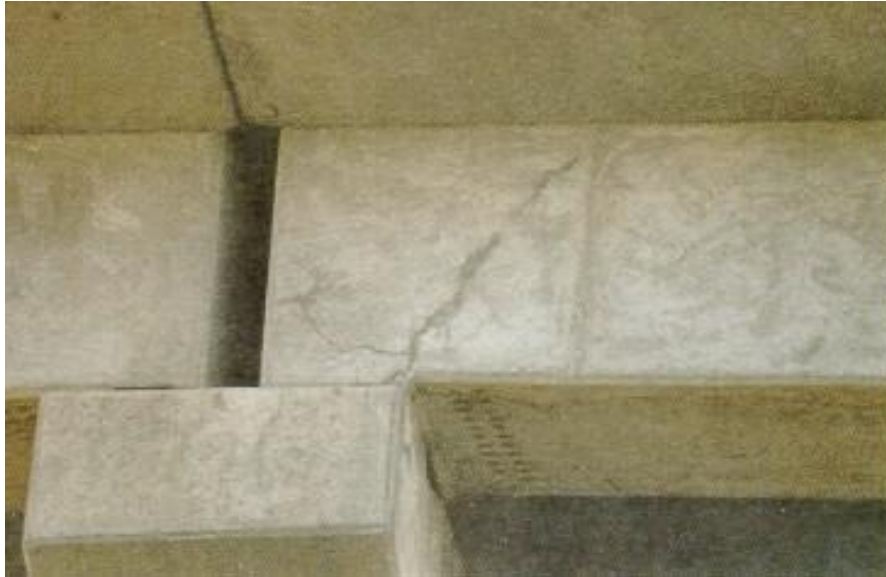
Figure A.4 (c) Concrete T-Beam

Condition State: Fair	Performance Deficiency: Load Carrying Capacity
Full height, medium shear crack	Potentially inadequate beam capacity. An evaluation is required to determine the extent of strength reduction

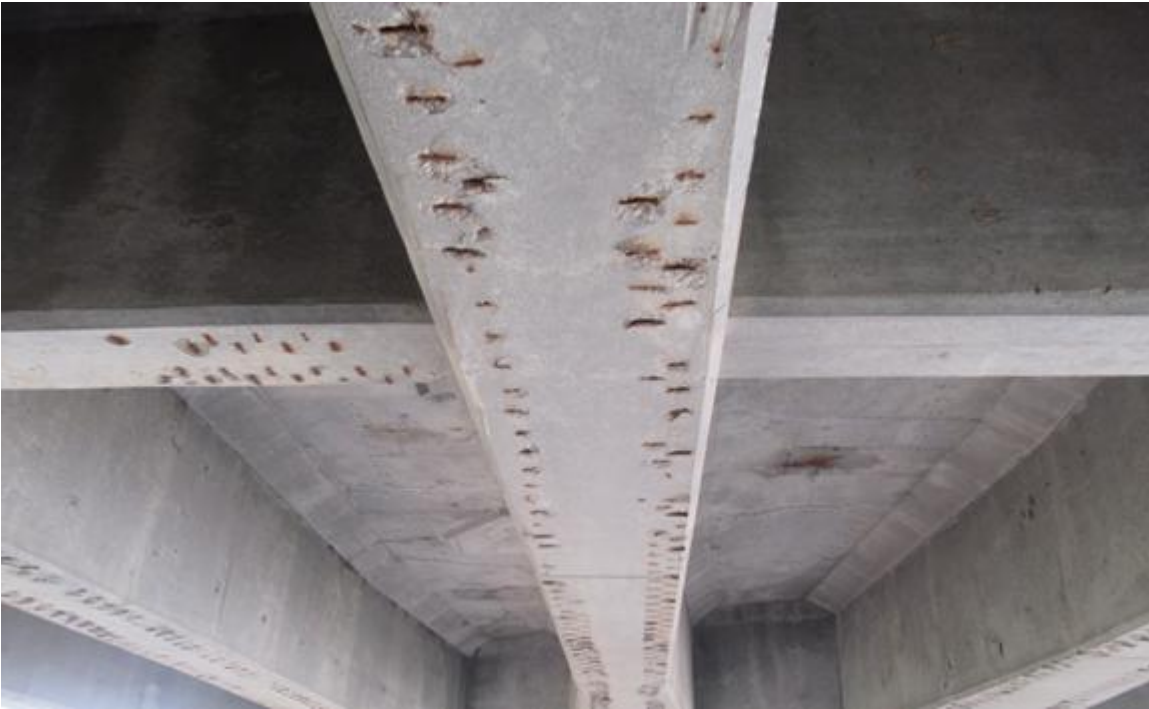
Figure A.4 (d - New) Concrete Girder

Condition State: Good	Performance Deficiency: None
Concrete is in good condition. Rusting rebar chairs are not an indication of rebar corrosion and are considered to be in good condition.

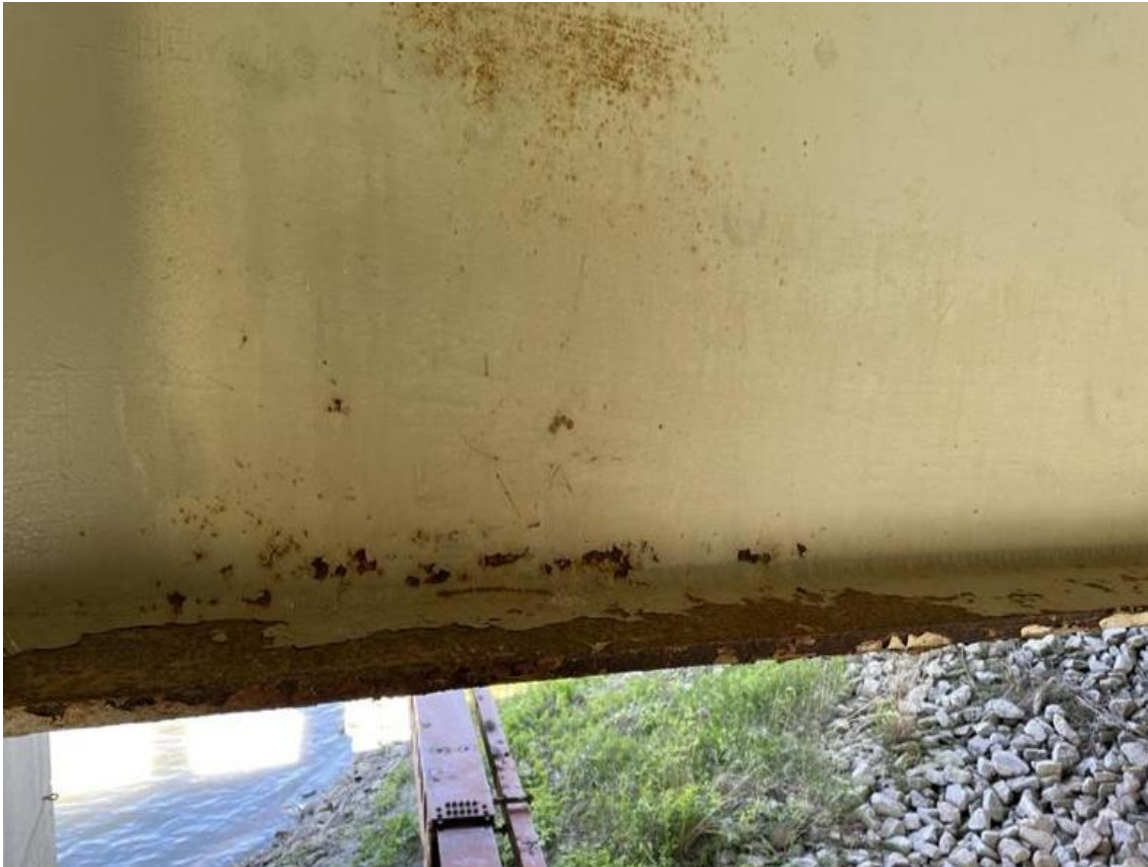
**Figure A.4 (d) Steel Girder**

Condition State: Good	Performance Deficiency: None
Coating has broken down at bottom flange and some light corrosion at the bottom flange has developed with some loose rust but no section loss.

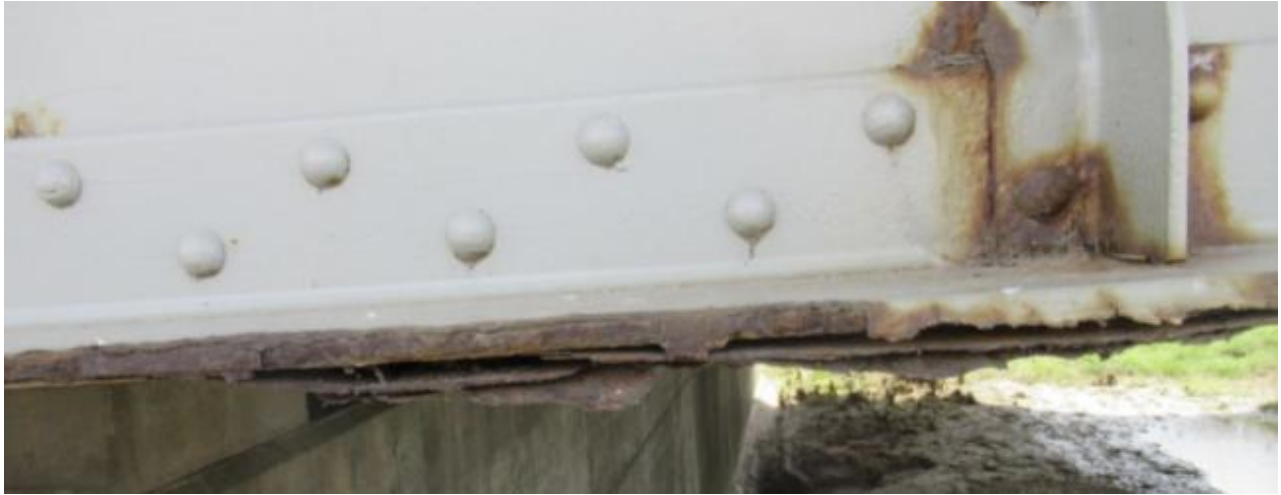
Figure A.4(e) – Steel Girder

Condition State: Fair/Poor	Performance Deficiency: None
Coating has broken down at bottom flange and medium to severe corrosion has taken place. The section loss appears to potentially be more than 10%. The inspector should remove the flaking and measure the section loss to confirm the condition.

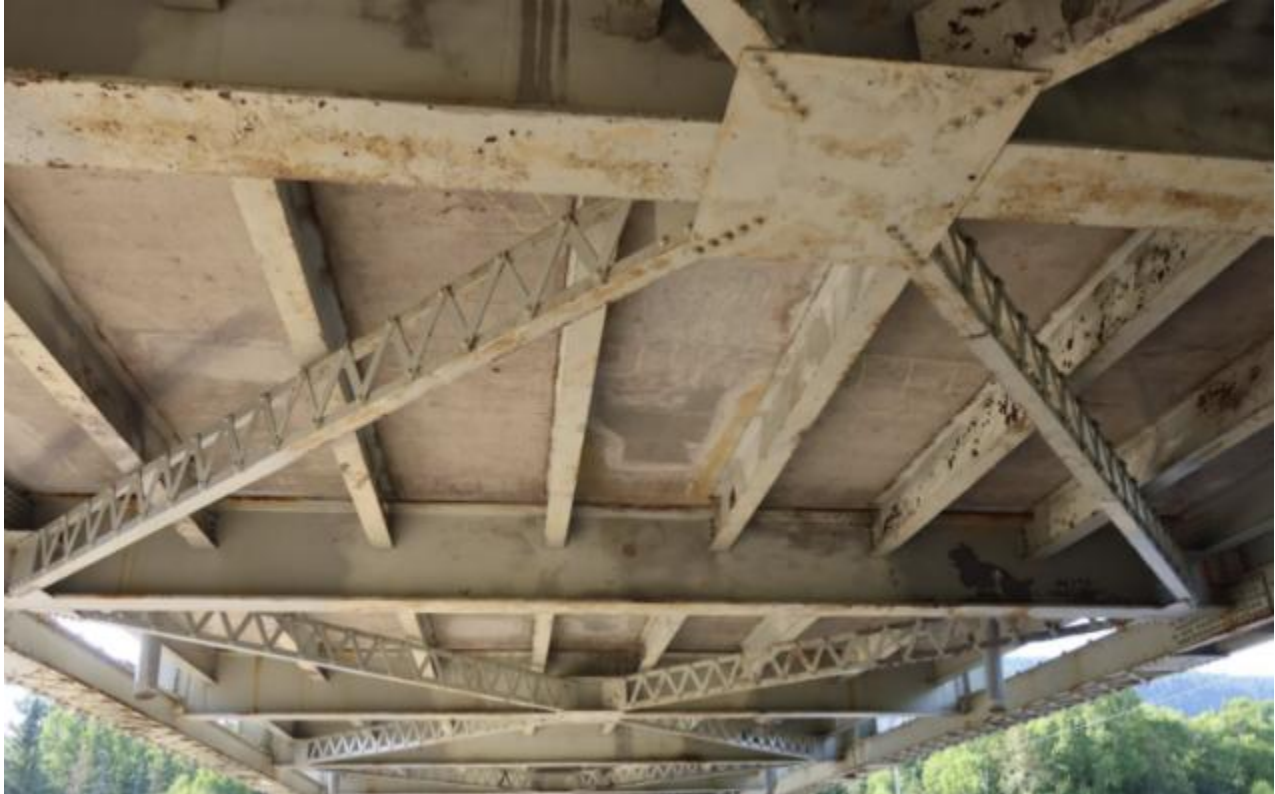
Figure A.5 (a) Steel Beam Bracing

Condition State: Good	Performance Deficiency: None
Light corrosion of bracing systems

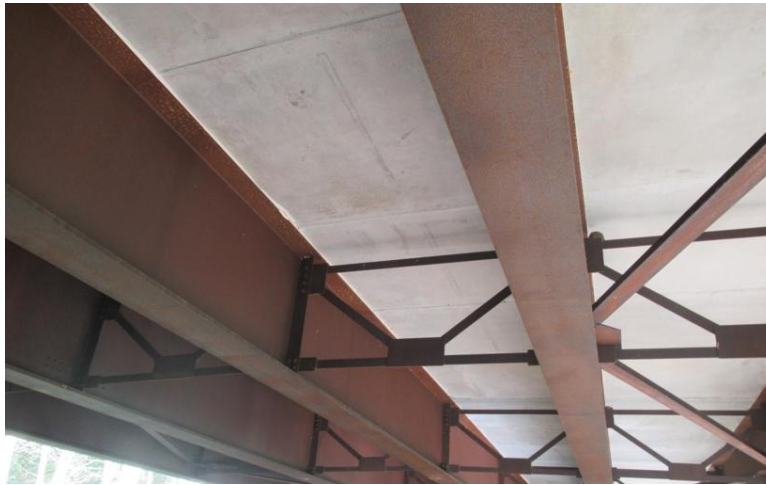
Figure A.5 (b) Intermediate Diaphragms

Condition State: Good	Performance Deficiency: None
Light patina has formed over the surfaces of bracing angles

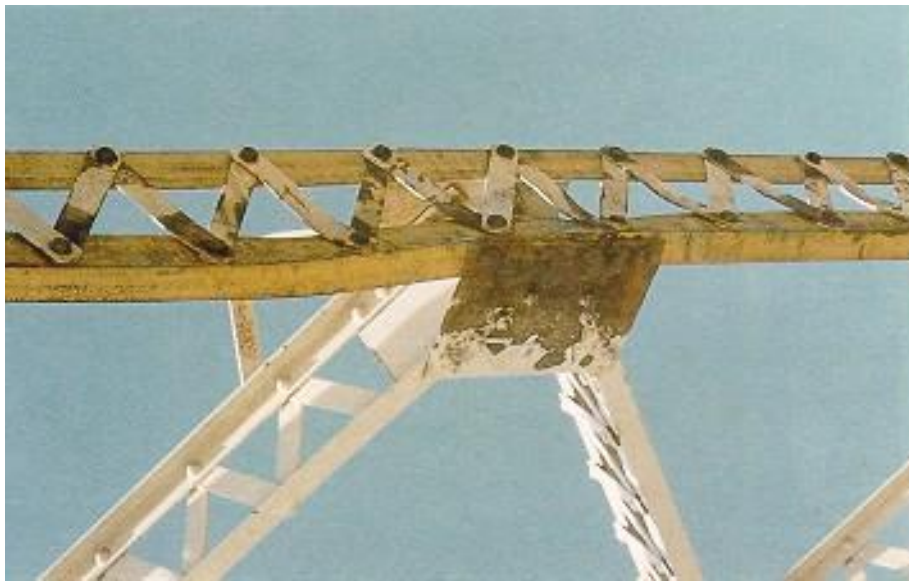
Figure A.5 (c) Top Lateral Bracing In Steel Through Truss

Condition State: Poor	Performance Deficiency: Load Carrying Capacity
Permanent deformation of member	Possible loss of strength and ability to provide lateral support, due to deformation. An evaluation is required to determine the extent of strength reduction

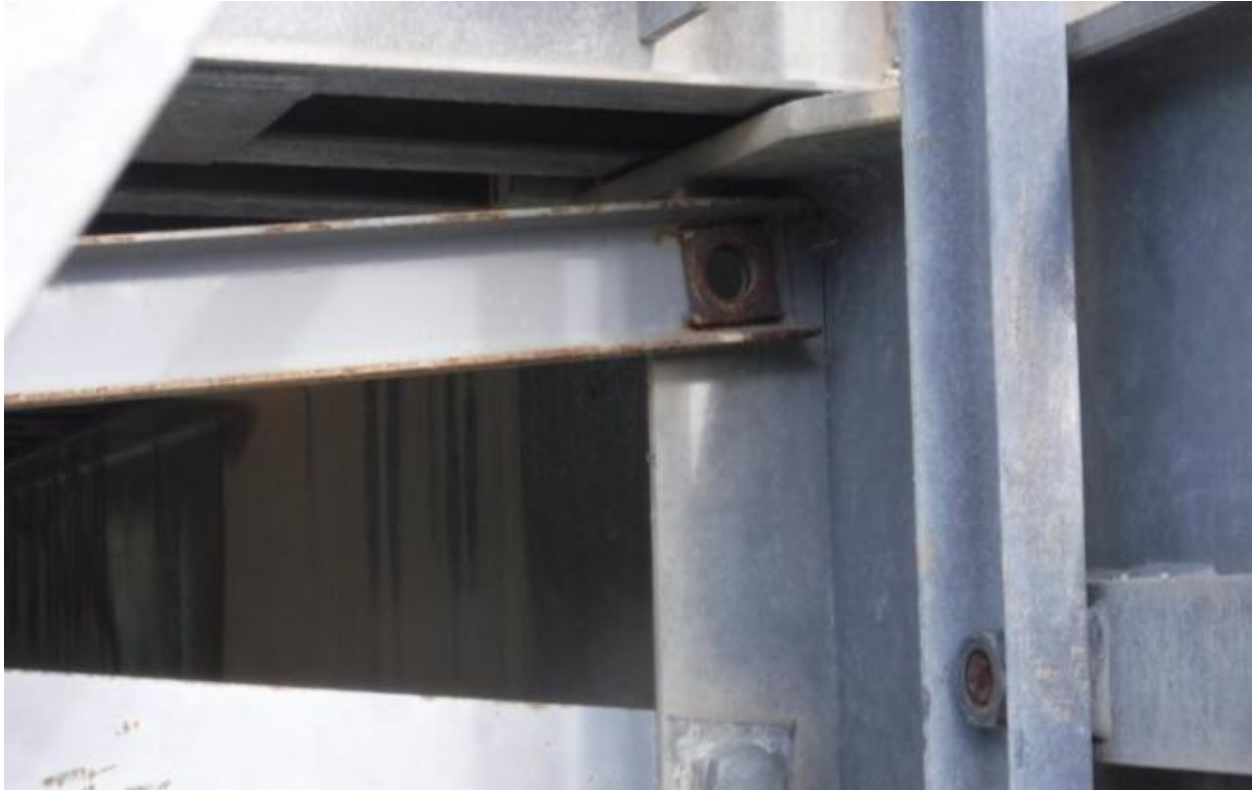
Condition State: Poor	Performance Deficiency: Load Carrying Capacity
Missing only bolt to connection plate.	Load from diaphragm can not be properly transferred to connecting member.
Maintenance Repair: Structural Steel Repair

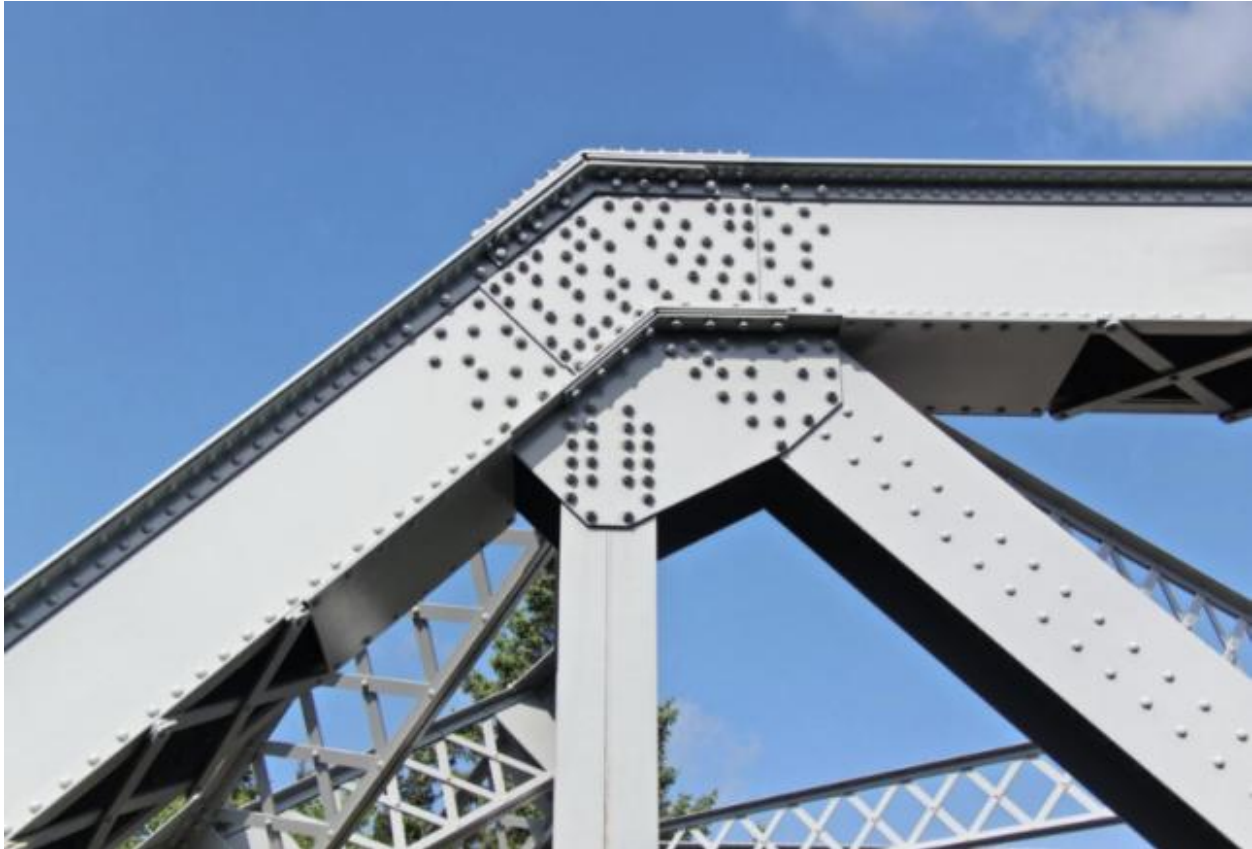
Figure A.6 (a) Coating of Through Truss

Condition State: Excellent	Performance Deficiency: Not Applicable
No defects in coating material

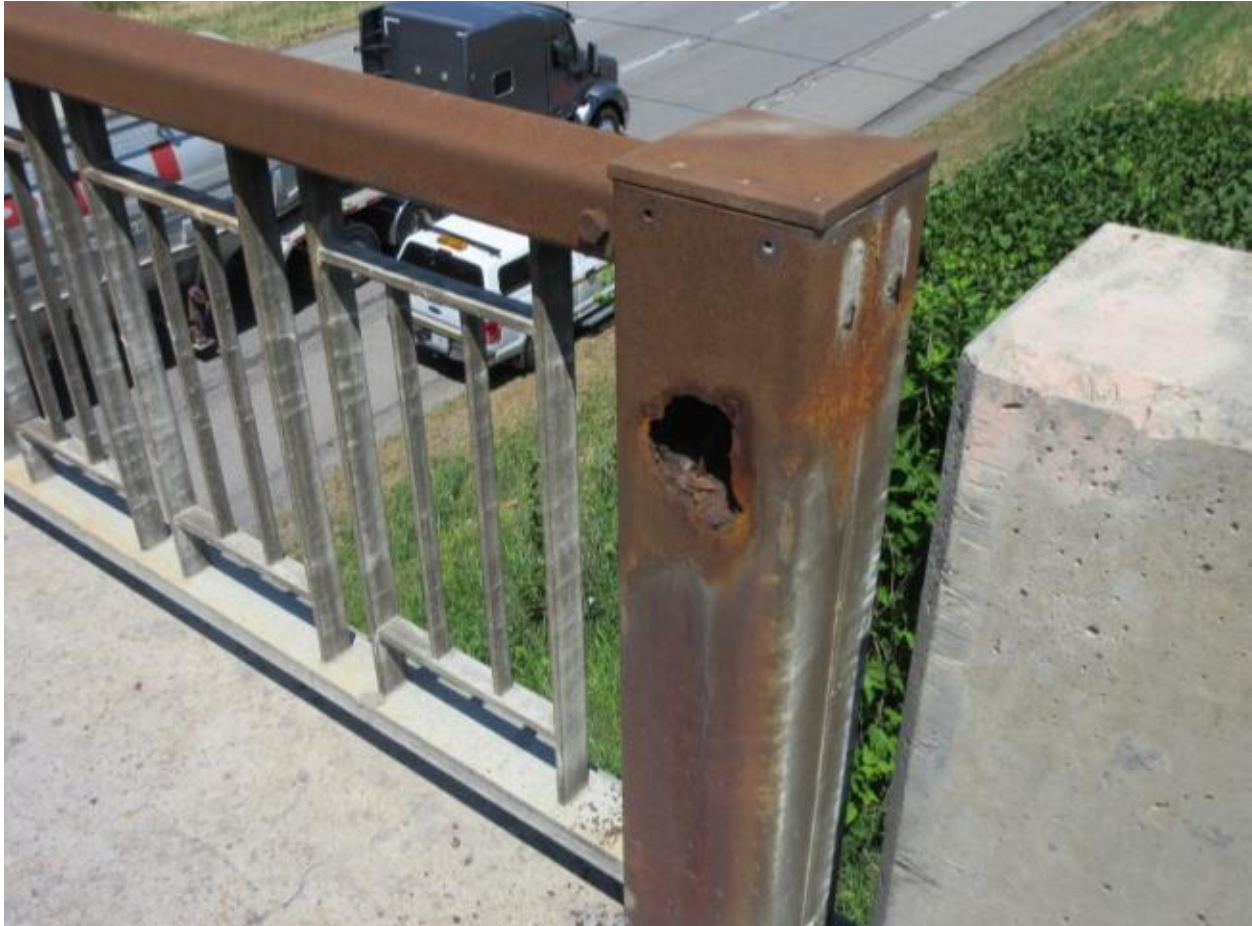
Figure A.6 (b) Railing

Condition State: Poor	Performance Deficiency: Not Applicable
Coating has completely broken down on the post and top rail. This entire area would be poor. Rust Condition Rating – Category 4

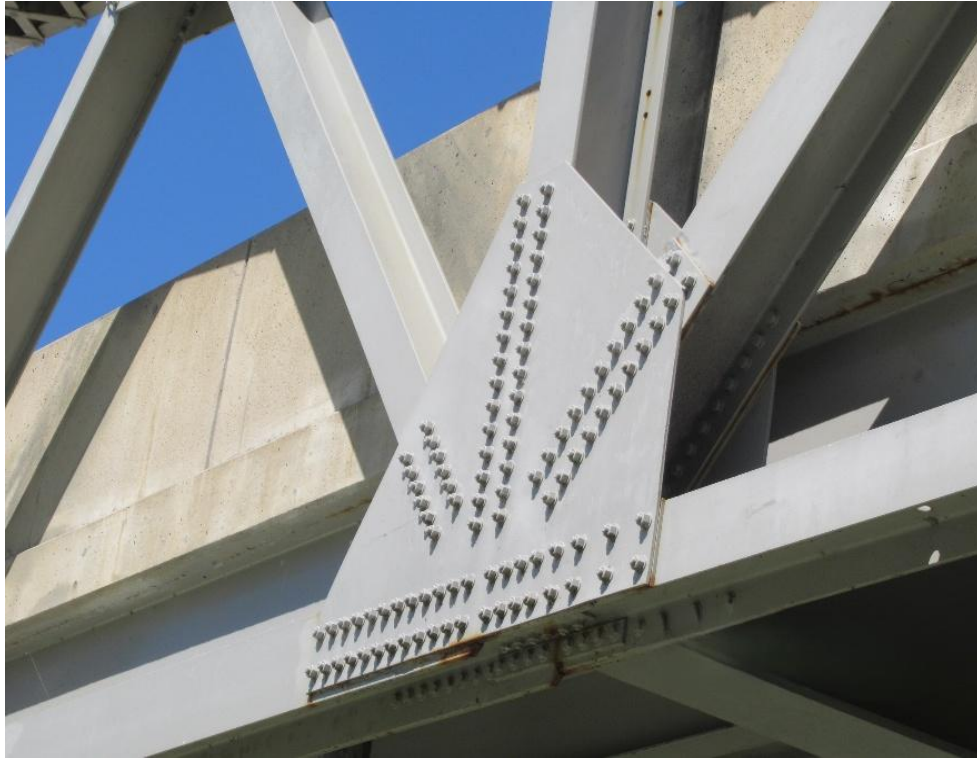
Figure A.6 (c) Coating of Connection - Bottom Chord

Condition State: Good/Fair/Poor	Performance Deficiency: Not Applicable
Connection coating is largely in good with a small amount in poor where the coating has broken down and stained by rusting at the very bottom. An equal amount of fair should be included in the condition state quantities.

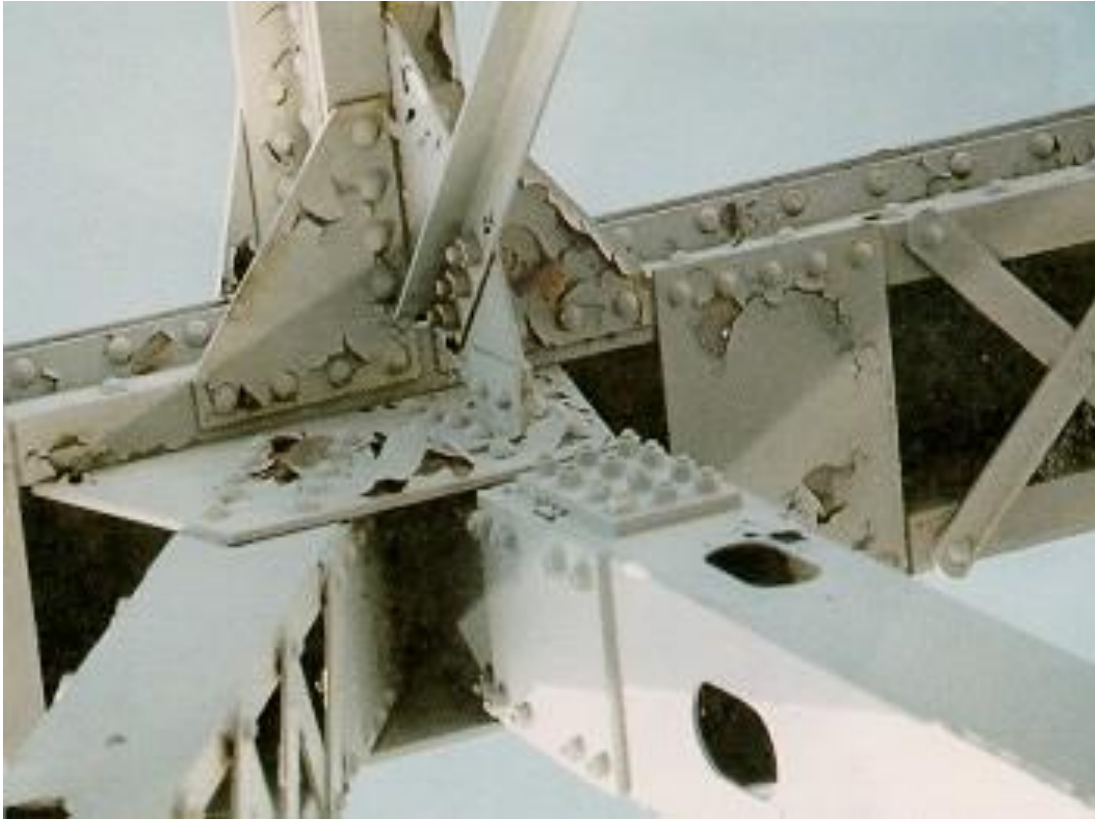
Figure A.6 (d) Through Truss – Connection of Primary Components

Condition State: Poor	Performance Deficiency: Not Applicable
Coating is peeling in various locations

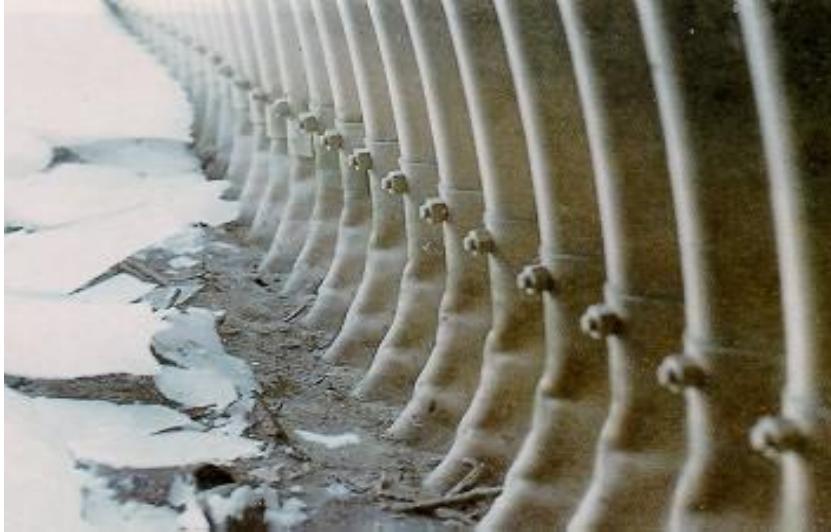
Figure A.7 (a) Multi-Plate Pipe Arch

Condition State: Poor	Performance Deficiency: Load Carrying Capacity
Medium crimping of corrugations. Quantity is measured as the area of the crimping zone only	Possible inadequate capacity to support applied loading

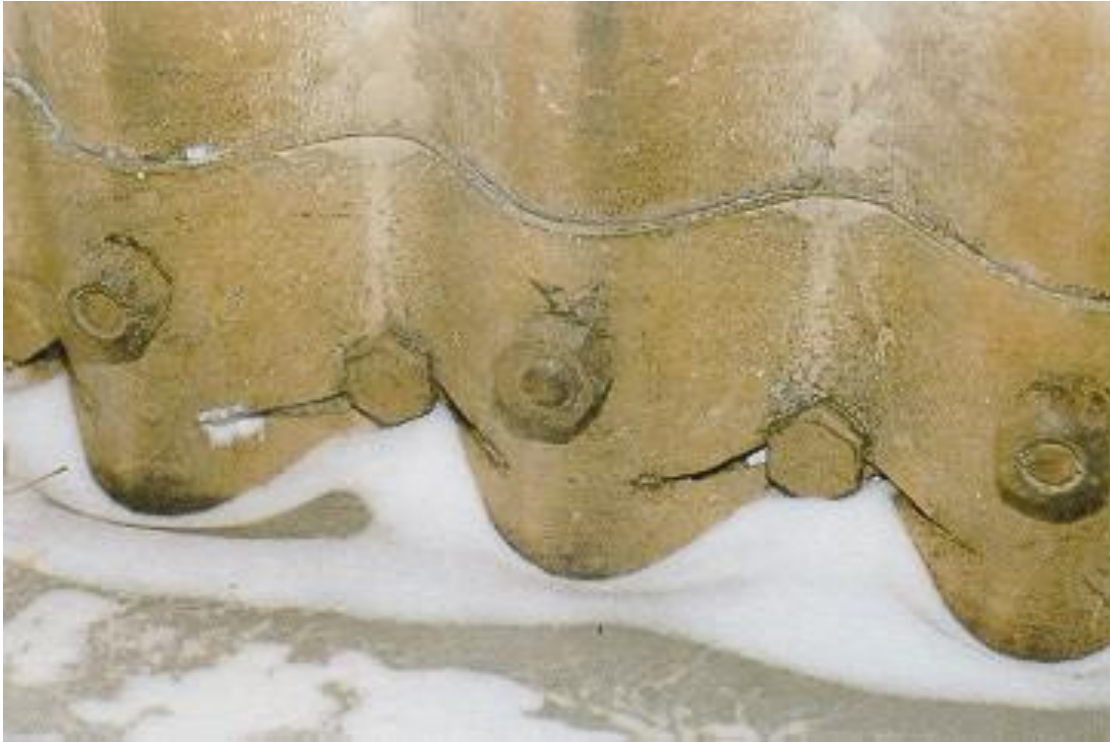
Figure A.7 (b) Multi-Plate Pipe Arch

Condition State: Poor	Performance Deficiency: Excessive Deformations
Severe cracks along bolt line in the valley corrugations of the haunch lap joint. Quantity is measured as the area of the circumferential band where cracks exist (i.e., there is a small band (under the ridge bolt) that is not cracked and is not Poor	Severe local deformation has occurred. Present strength is just adequate, but local or general collapse of the pipe may occur suddenly

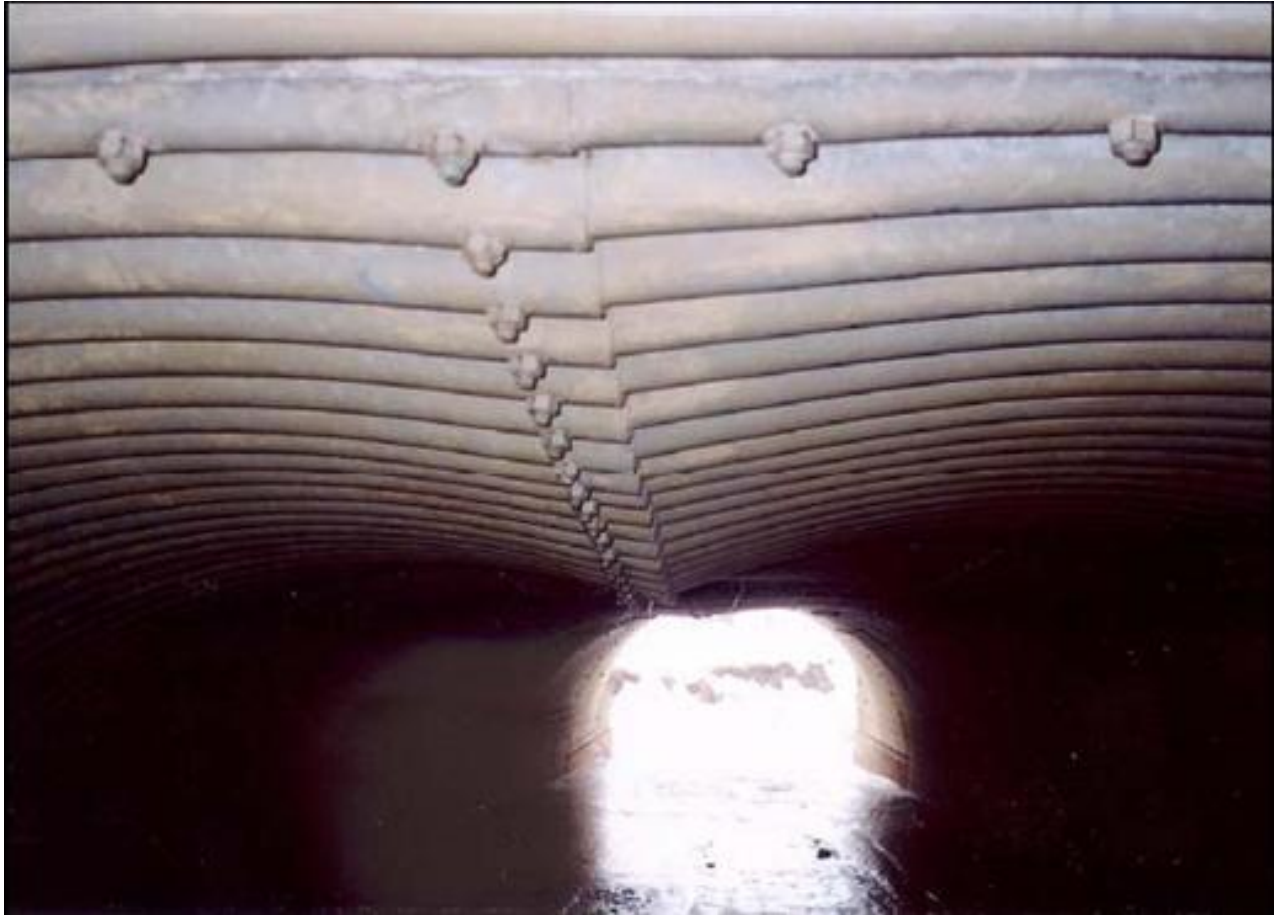
Figure A.7 (b) Multi-Plate Pipe Arch

Condition State: Poor	Performance Deficiency: Excessive Deformations, Load Carrying Capacity
Deformation and reverse curvature of culvert roof, plus cusping (separation of plates at joint <10mm. Quantity is measured as the area of the circumferential band for the length that reverse curvature extends	Possible inadequate capacity to support applied loading and local or general collapse may occur suddenly

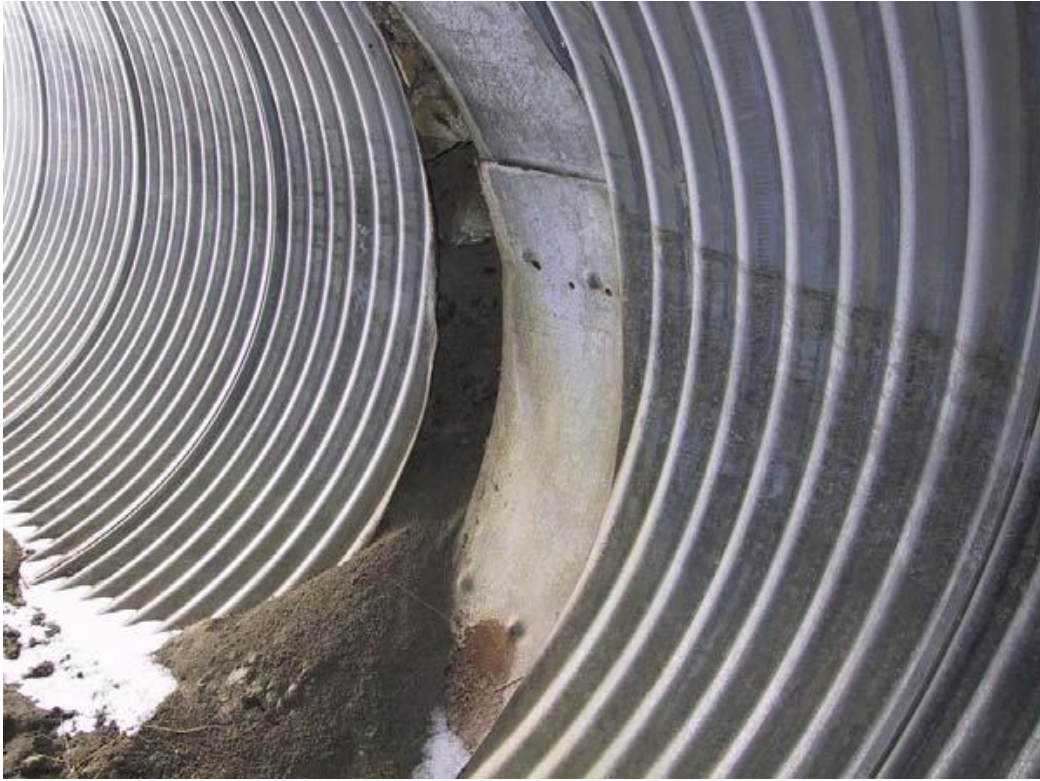
Figure A.7 (bc) Multi-Plate Pipe Arch

Condition State: Poor	Performance Deficiency: Load Carrying Capacity
Separation of culvert units. Quantity is measured as the band area where the separation occurs	Present strength appears adequate, but local continued loss of support material for soil-steel culvert may lead to general collapse of the pipe

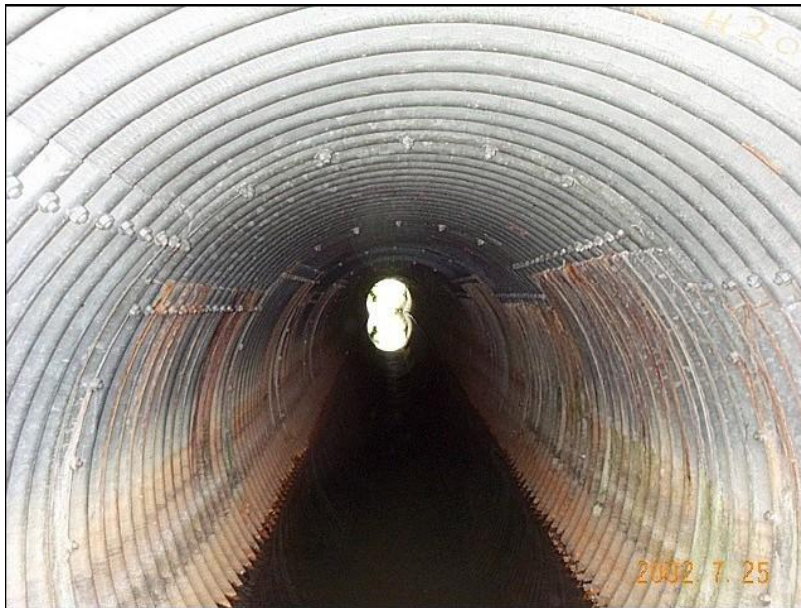
Figure A.7 (d) Multi-Plate Pipe Arch

Condition State: Good/Fair	Performance Deficiency: None
Moderate rust along waterline with section loss < 10%, light rust elsewhere

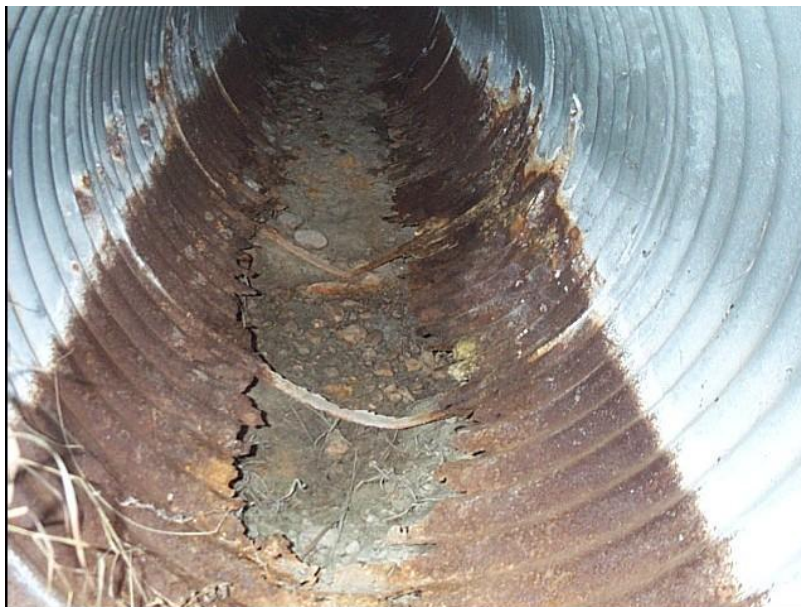
Figure A.7 (e) Multi-Plate Pipe Arch

Condition State: Poor	Performance Deficiency: Load Carrying Capacity
Severe rusting along floor of culvert with perforations. Quantity is measured as the circumferential band area where there are perforations and the actual area of corrosion where the section loss is >10%, but no perforations exist	Severe rusting has occurred. Present strength is just adequate, but local or general collapse of the pipe may occur suddenly. Inspector should look closely at the asphalt above for any sink holes.

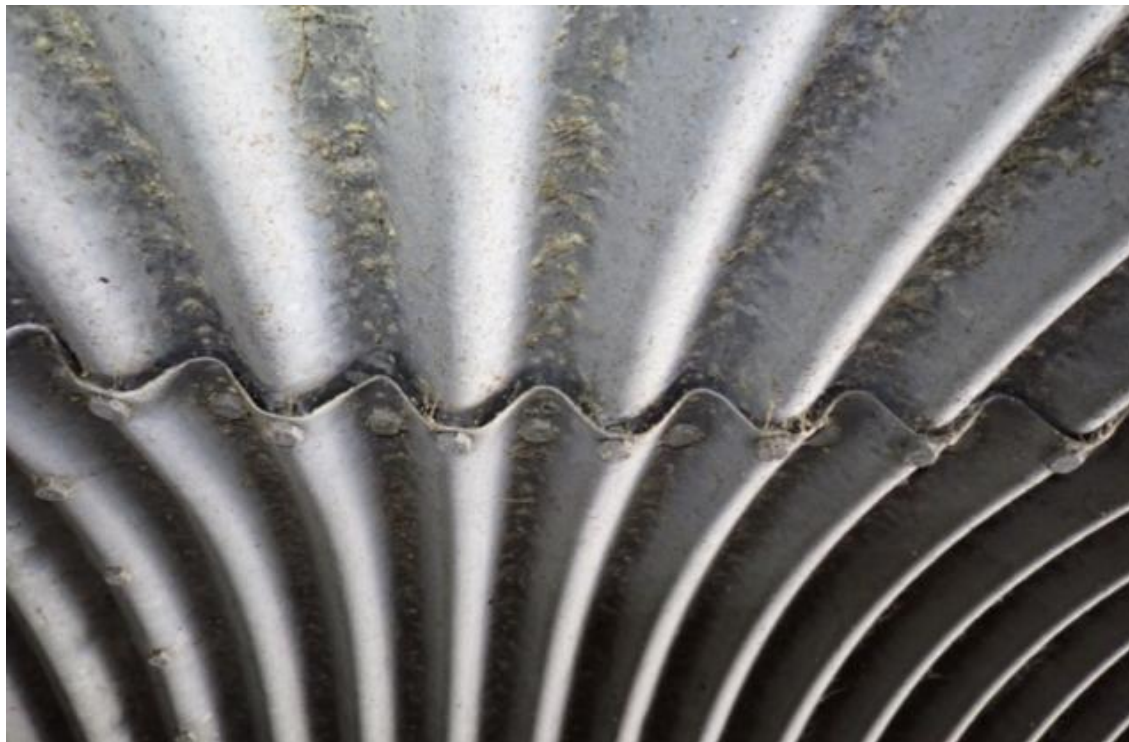
Figure A.7 (f) Multi-plate Pipe Arch

Condition State: Good	Performance Deficiency: None
Steel joint looks like it is trying to separate in this area. No deformations have been observed. Inspector should monitor the area for any deformations.

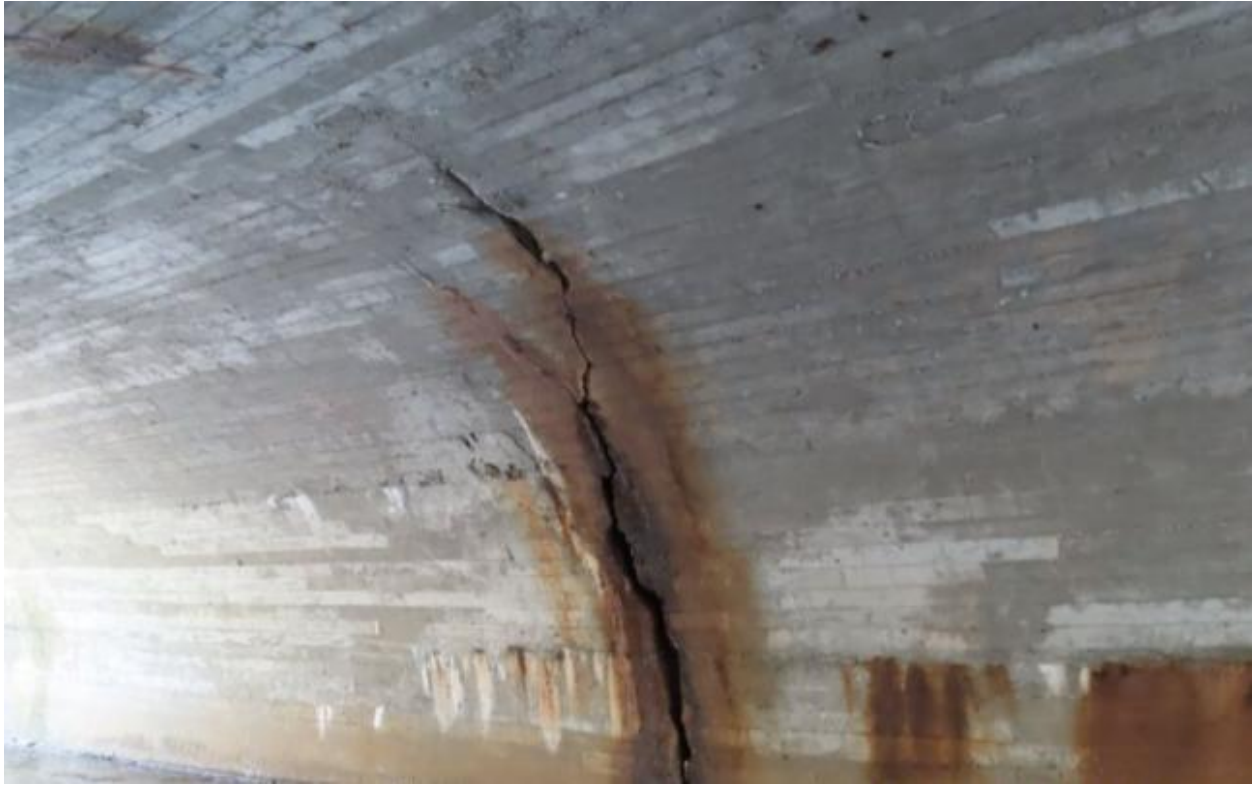
Figure A.7 (g) Concrete Arch Culvert

Condition State: Poor	Performance Deficiency: None
Very wide crack with rust staining	There is a potential for load carrying capacity if the inspector can confirm that there is also deformations near the crack area.
