PART 2 – DETAILED VISUAL INSPECTION

A.4 BEAMS / MAIN LONGITUDINAL ELEMENTS

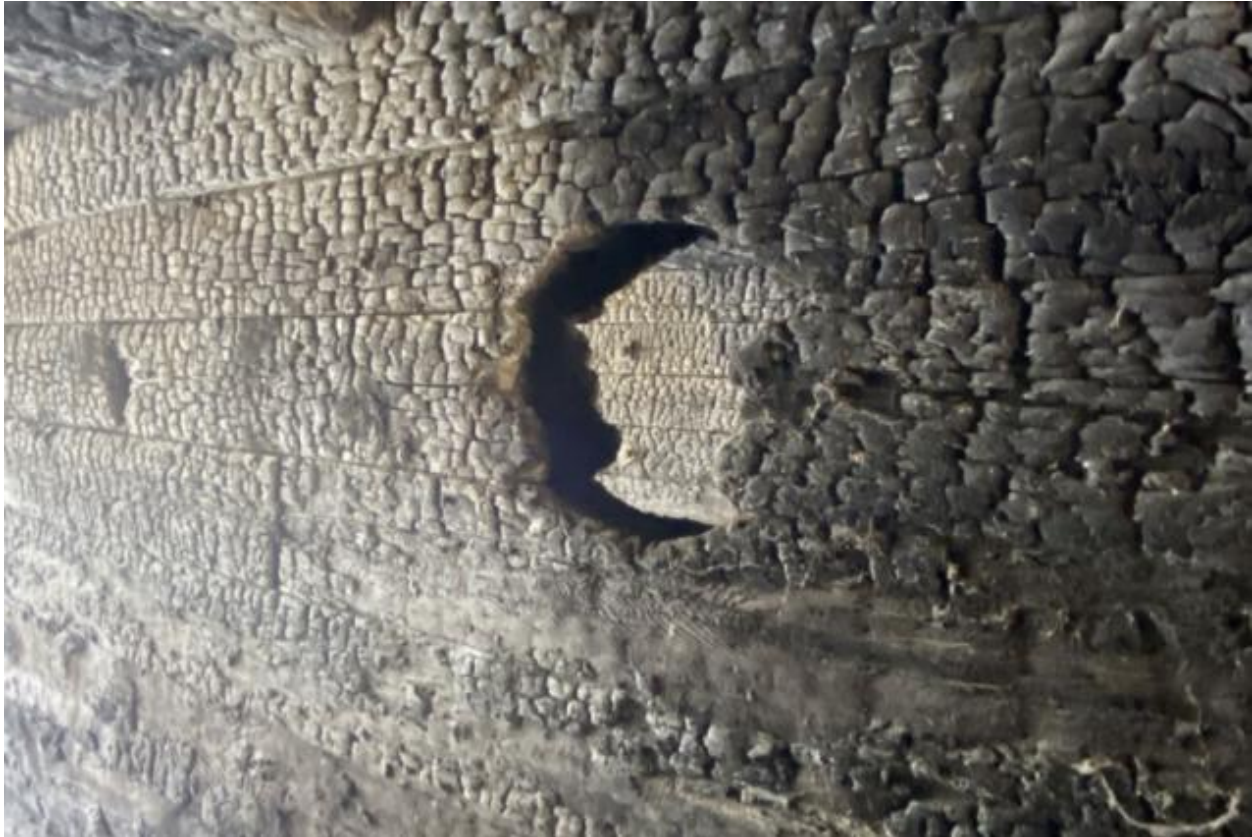
Figure A.7 (h) Wood Culvert Barrel

Condition State: Fair/Poor	Performance Deficiency: None
Fair: Fire Damage to barrel is in the 5-10% section loss due to charring.	
Poor: Hole in centre wall (2 cell structure)

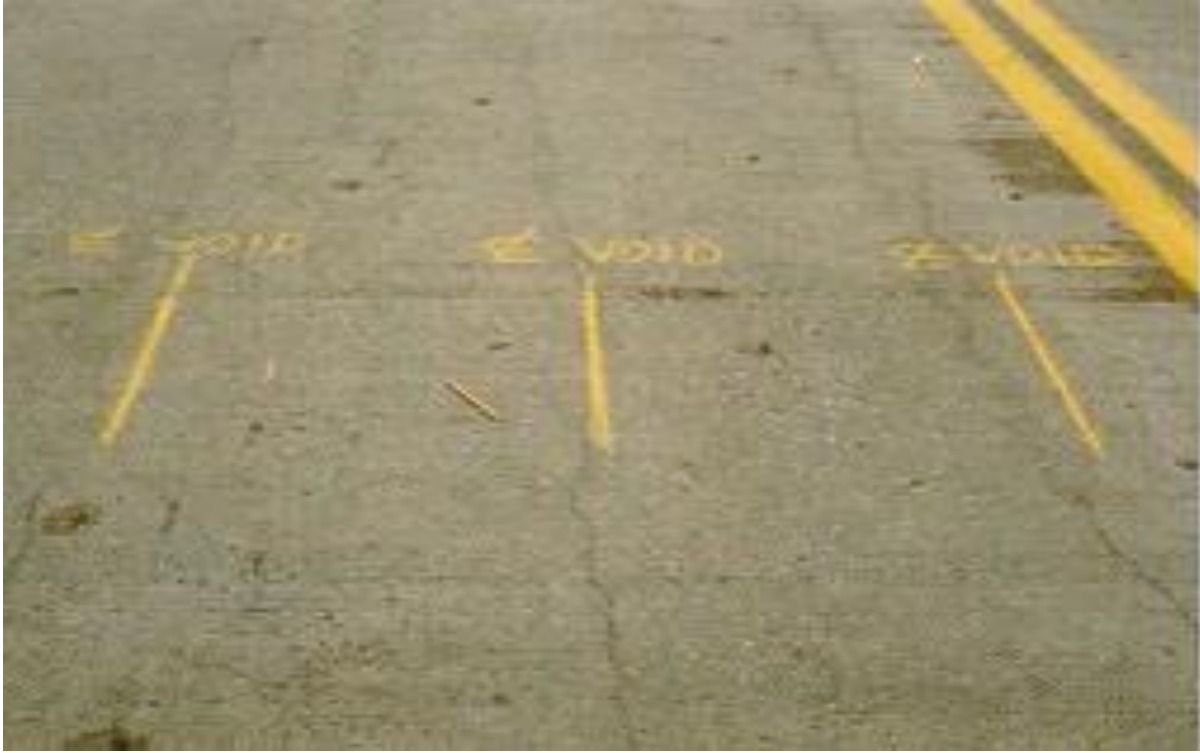
Figure A.8 (a) Exposed Concrete Deck of a Voided Slab

Condition State: Fair	Performance Deficiency: None
Medium longitudinal cracks in deck top surface at the void locations	Material defects unlikely to cause reduction in load carrying capacity

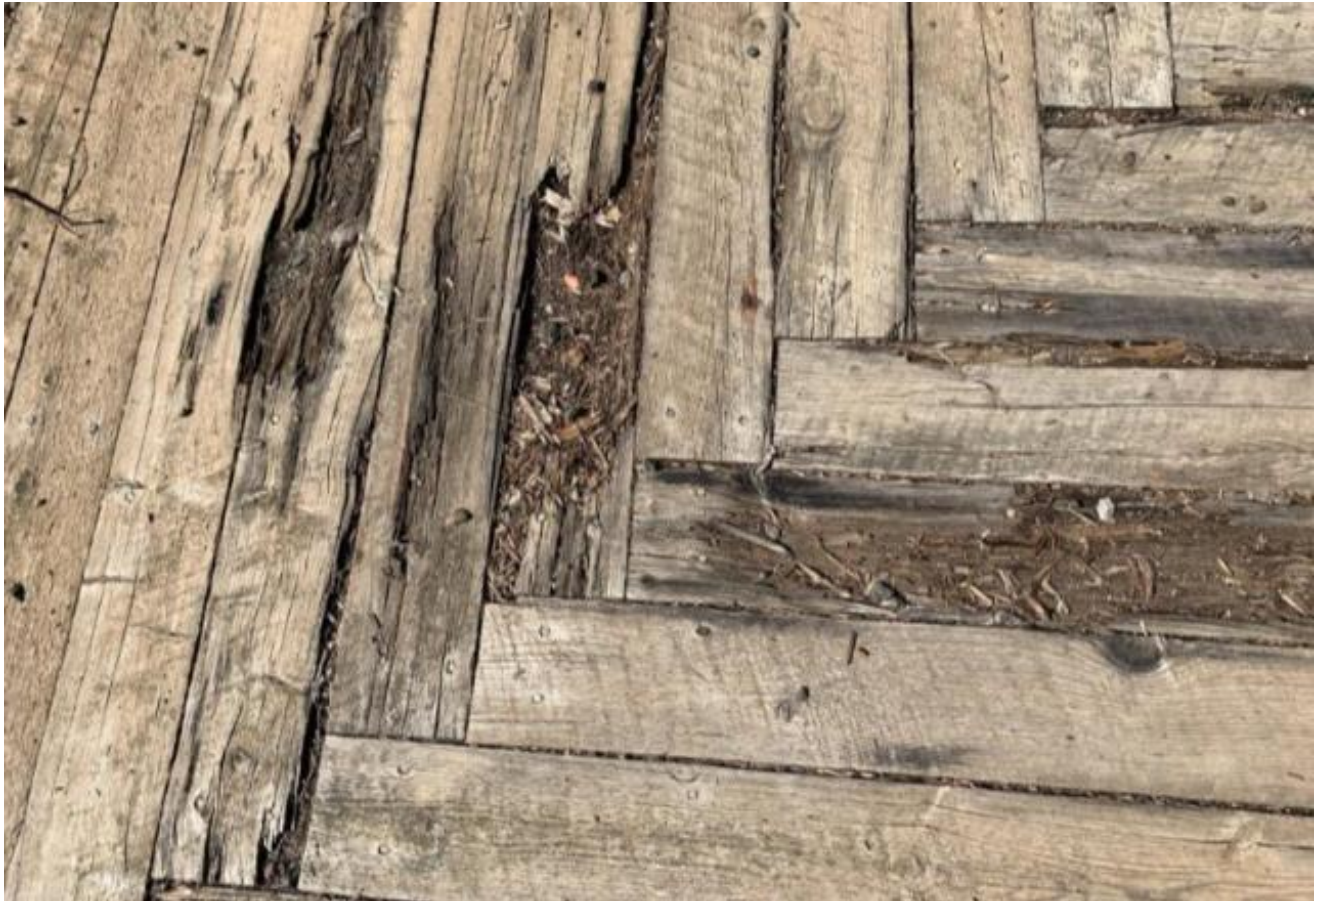
Figure A.8 (b) Wooden Deck

Condition State: Fair/Poor	Performance Deficiency: Rough Riding Surface
Wooden wearing surface has areas of 5-10% section loss and >10% section loss of the wood boards due to weathering and rot.

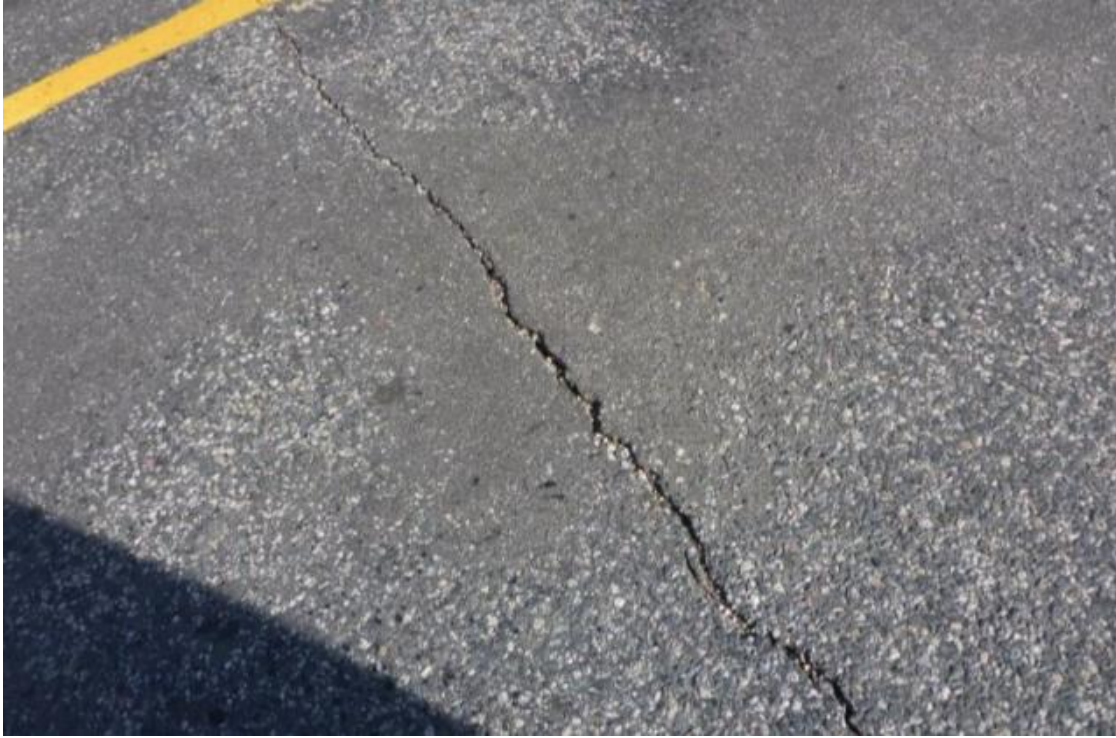
Figure A.8 (c) Deck Top

Condition State: Good	Performance Deficiency: RNone
All medium cracks in asphalt are considered to reflect a good condition of the underlying concrete deck.

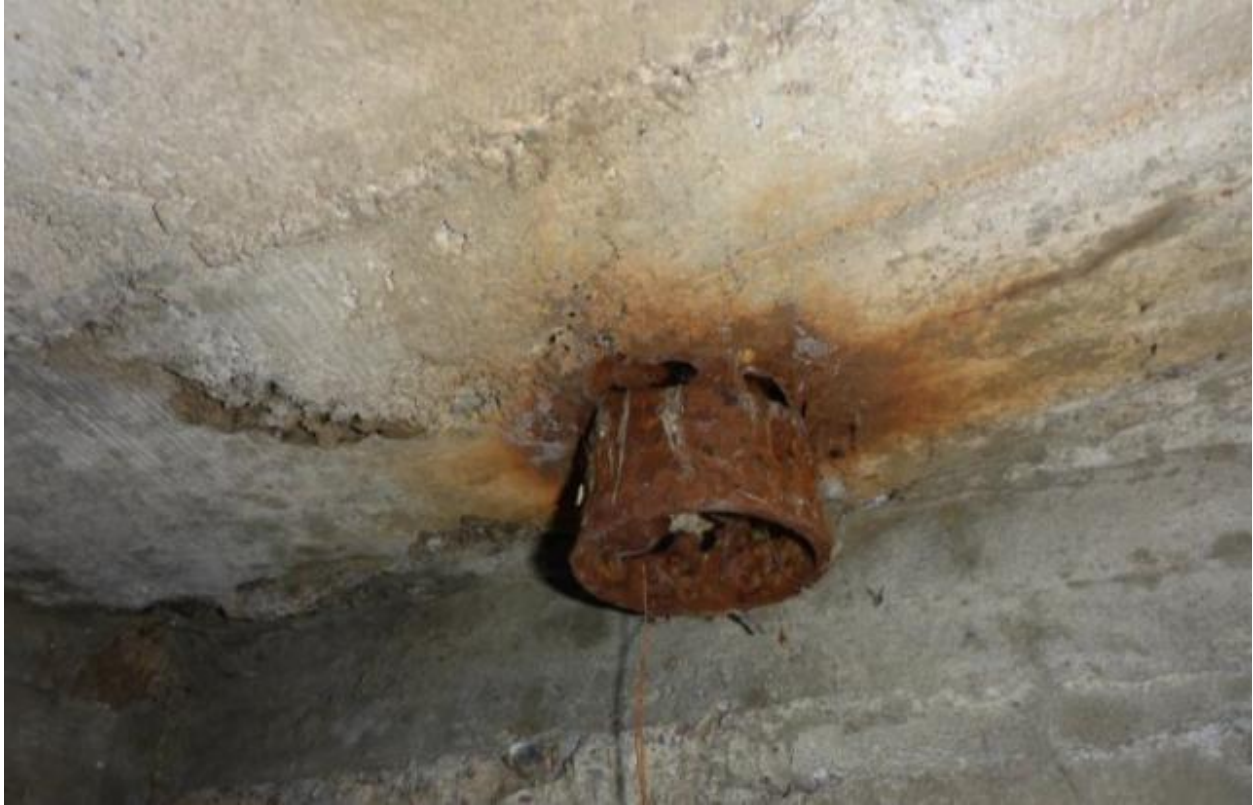
**Figure A.8 (d) Deck Drain**

Condition State: Poor	Performance Deficiency: None
Severe corrosion of deck drain with perforations.

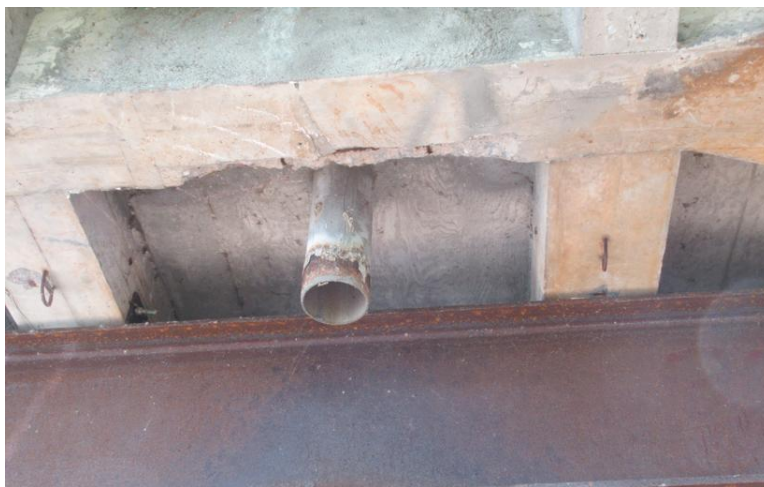
**Figure A.8 (e) Steel Deck Drain**

Condition State: Good	Performance Deficiency: Deck Drainage
Light corrosion with no section loss or flaking.	Deck drain should be extended below the steel member to avoid salt spray.

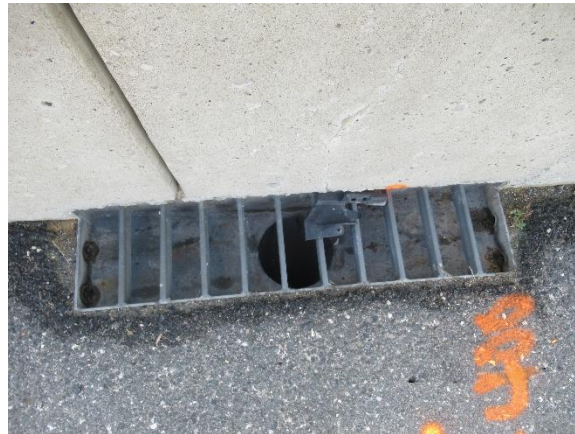
Figure A.8 (g) Deck Drain with Basin

Condition State: Fair	Performance Deficiency: None
Light corrosion of basin

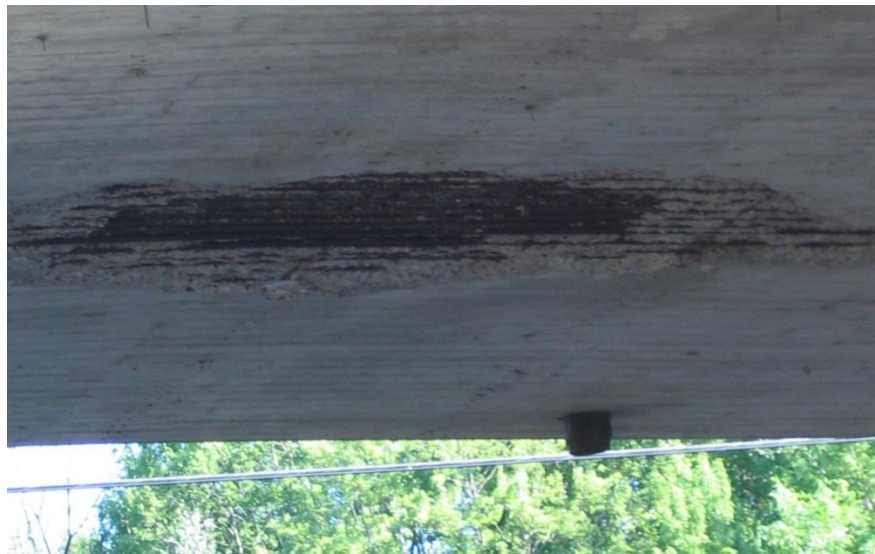
Figure A.8 (g) Rigid Frame, Thick Slab Soffit

Condition State: Poor	Performance Deficiency: Load carrying capacity
Large area of soffit spalled, exposing many lines of reinforcing steel, all at mid-span of a rigid frame.	Enhanced inspection should be scheduled to determine extent of the lost bond of reinforcing steel to concrete over such a large area of the mid-span soffit.

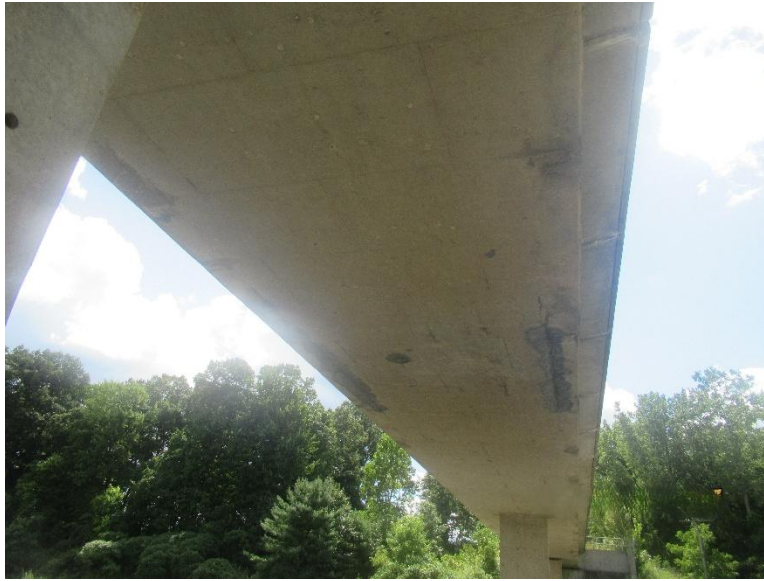
Figure A.8 (h) Thick Slab Soffit

Condition State: Fair and Poor	Performance Deficiency: None
Fair: Medium longitudinal cracks. Poor: Some spalling with exposed corroded reinforcement

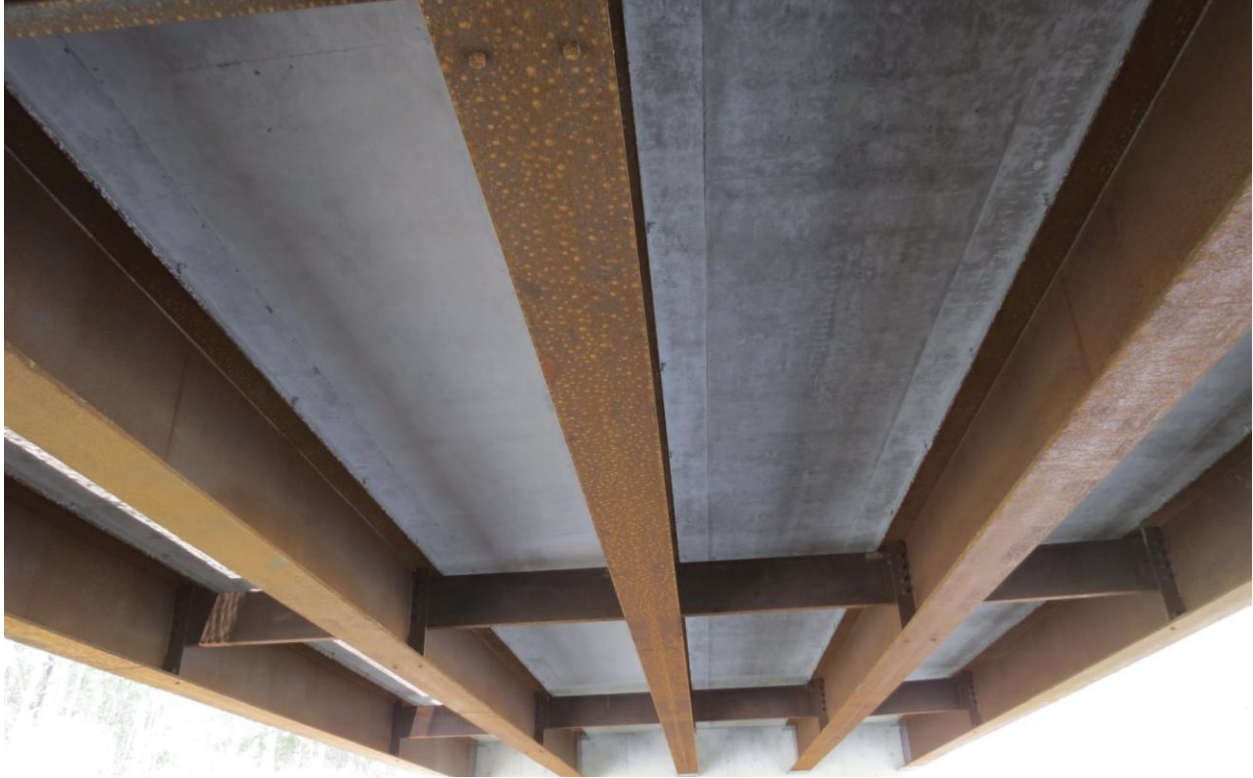
Figure A.8 (i) Soffit of a Thin Slab

Condition State: Excellent	Performance Deficiency: None

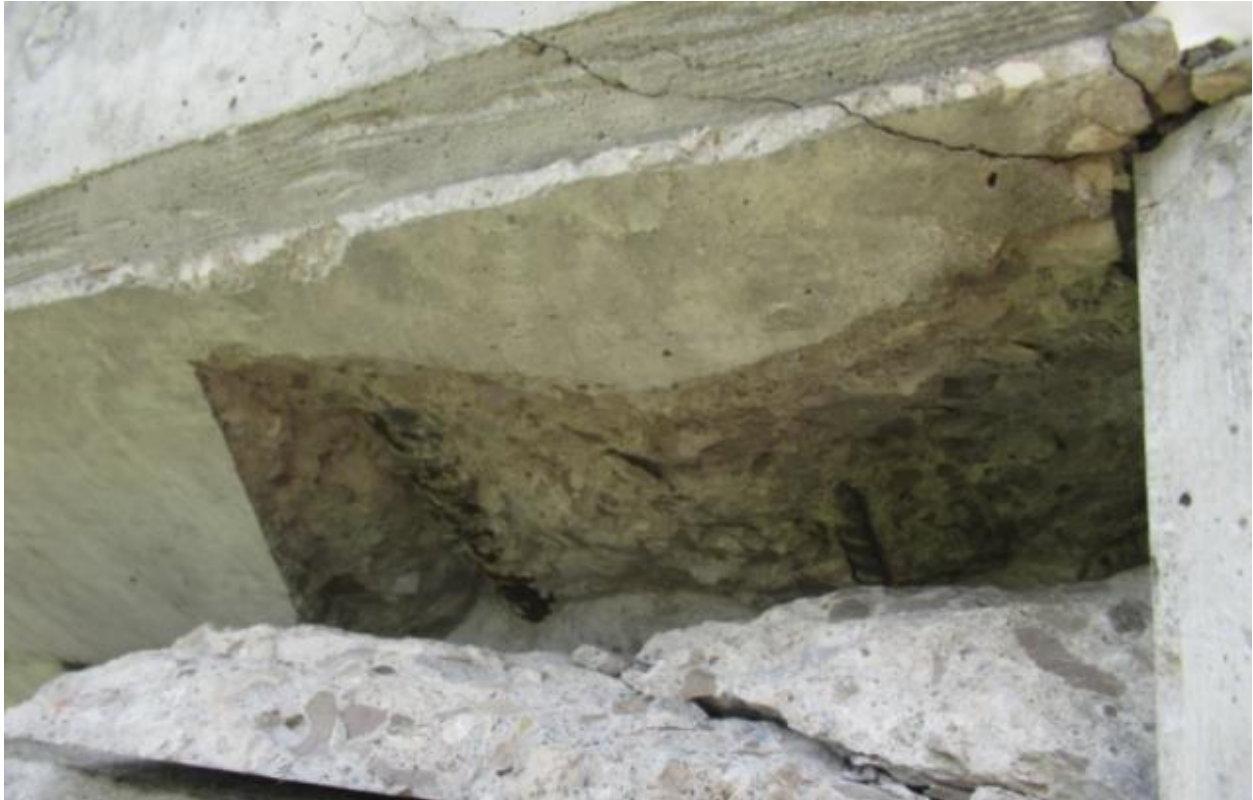
Figure A.8 (n) Deck Soffit End – Thick Slab

Condition State: Poor	Performance Deficiency: None
Large spall at deck end with exposed rebar and wide diagonal crack in corner caused by expansion movement of the bridge deck against the ballast wall.

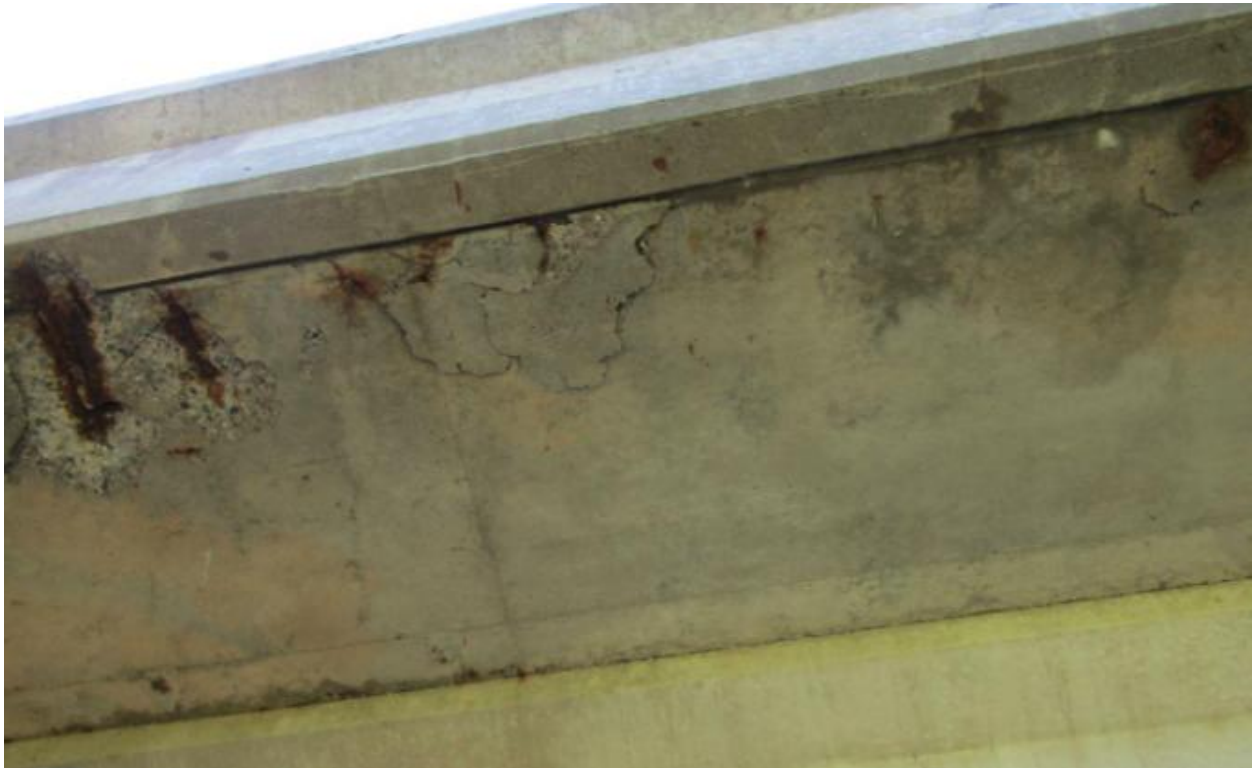
Figure A.8 (o) Deck Soffit Exterior – Thin Slab

Condition State: Poor	Performance Deficiency: None
Spalls with exposed corroded rebar and delaminations at deck exterior underneath construction joint of the barrier wall.
