PART 2 – DETAILED VISUAL INSPECTION

A.9 EMBANKMENTS & STREAMS

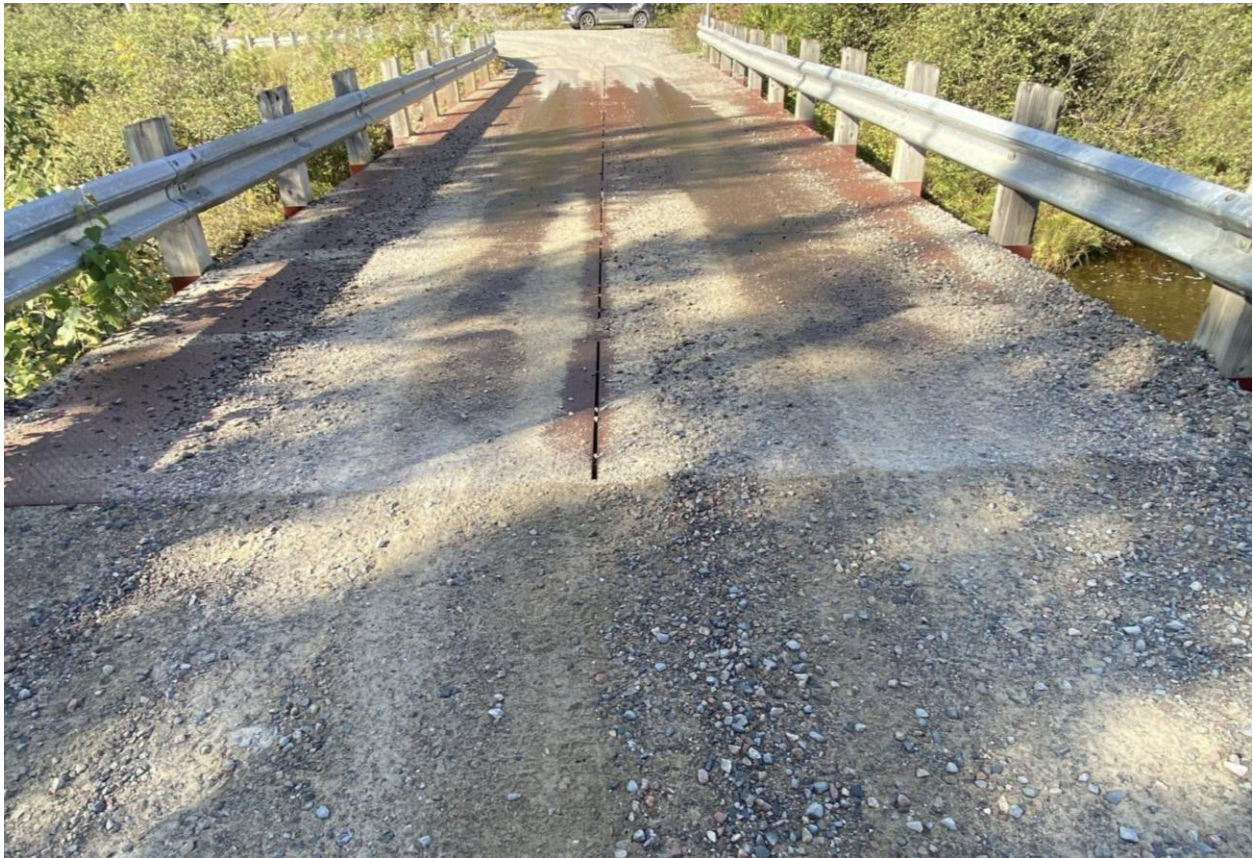
Figure A.8 (s): Steel Deck

Maintenance Need: Bridge Surface Repair
Gravel should be removed from the deck surface

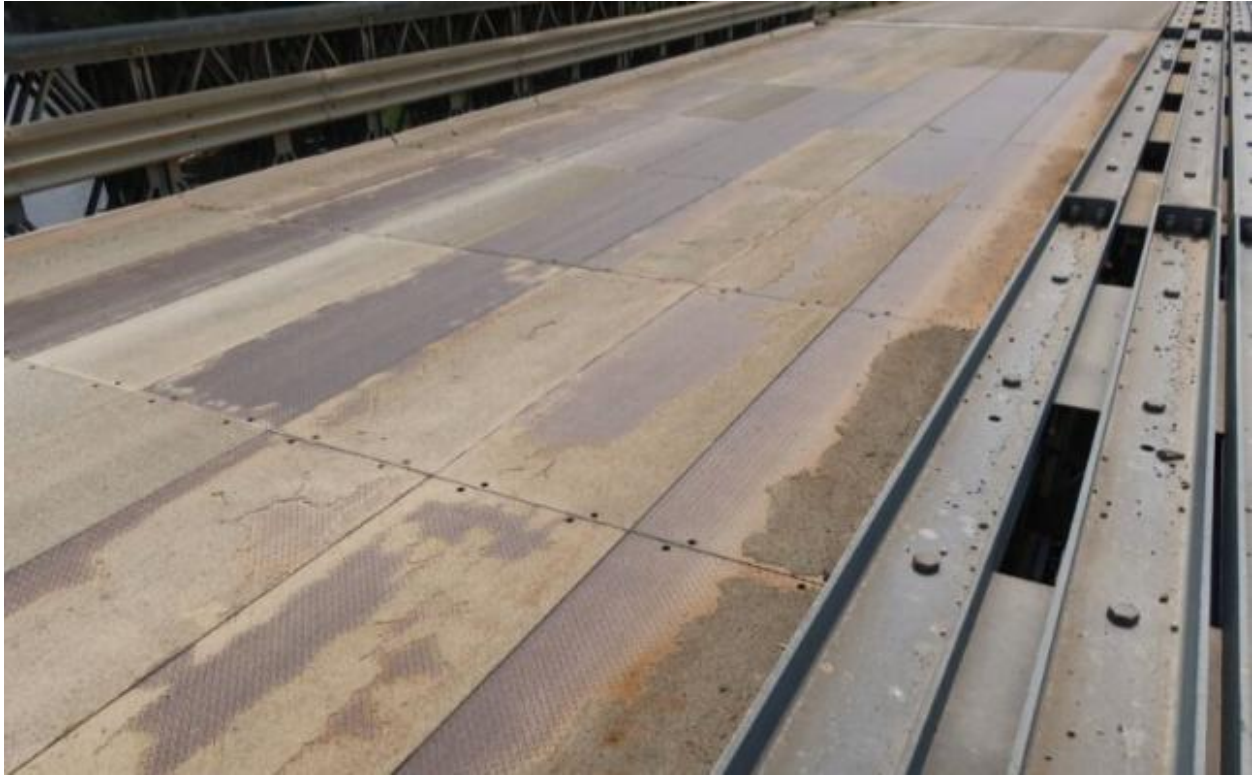
Figure A.8 (t) Steel Deck – Friction Coat Break Down

Condition State: Good	Performance Deficiency: Slippery Surface
	Friction Coating has severely worn off bridge deck
Maintenance Need: Bridge Surface Repair

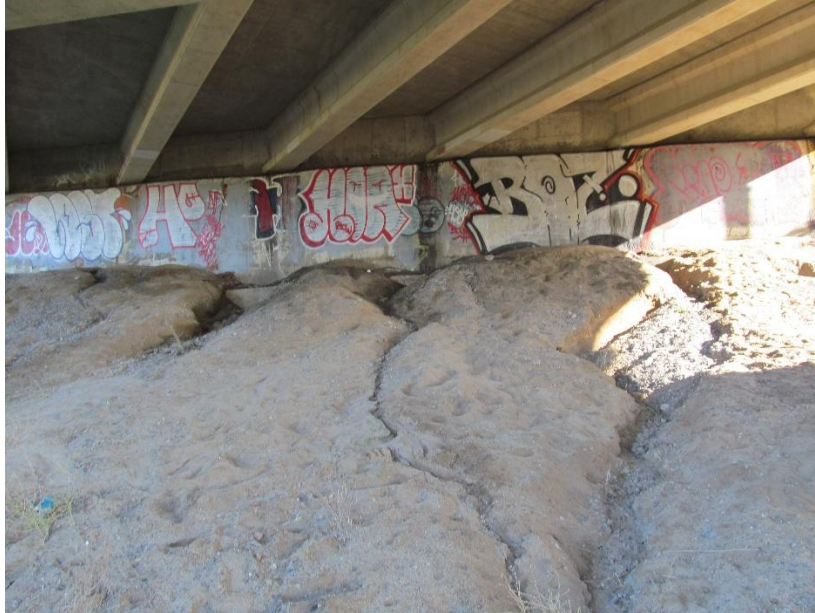
Figure A.9 (a) Embankment

Condition State: Poor	Performance Deficiency: Continuing Movement
Erosion causing many very deep, closely spaced gullies. Loss of embankment material to top of footing	<ul style="list-style-type: none"> Erosion has removed fill to below top of footing, removing frost protection, creating potential for frost heaving

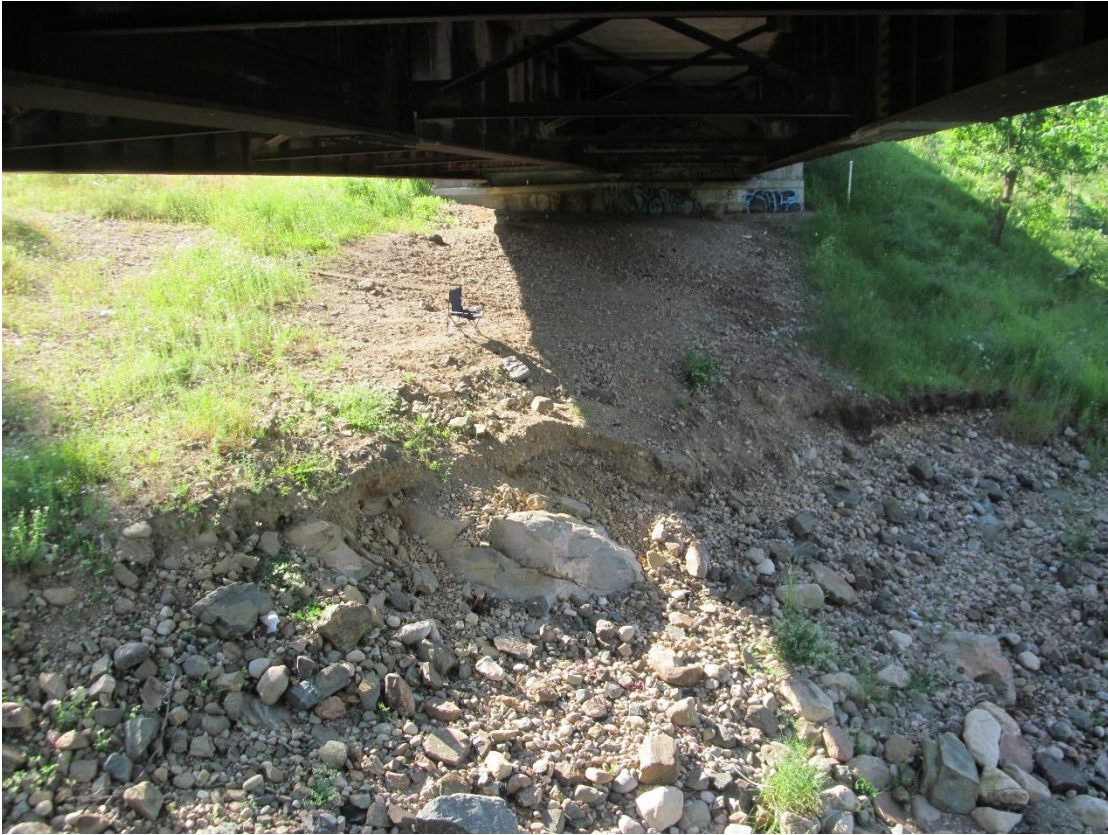
Figure A.9 (b) Embankment

Condition State: Poor	Performance Deficiency: Unstable Embankments
Loss of slope protection materials during flooding event. Water velocities were estimated to be over 3-4 m/s.	Embankment is unstable. Bank will continue to erode after loss of scour resistant materials. Site should have banks restored with slope protection materials sized for expected water velocities.

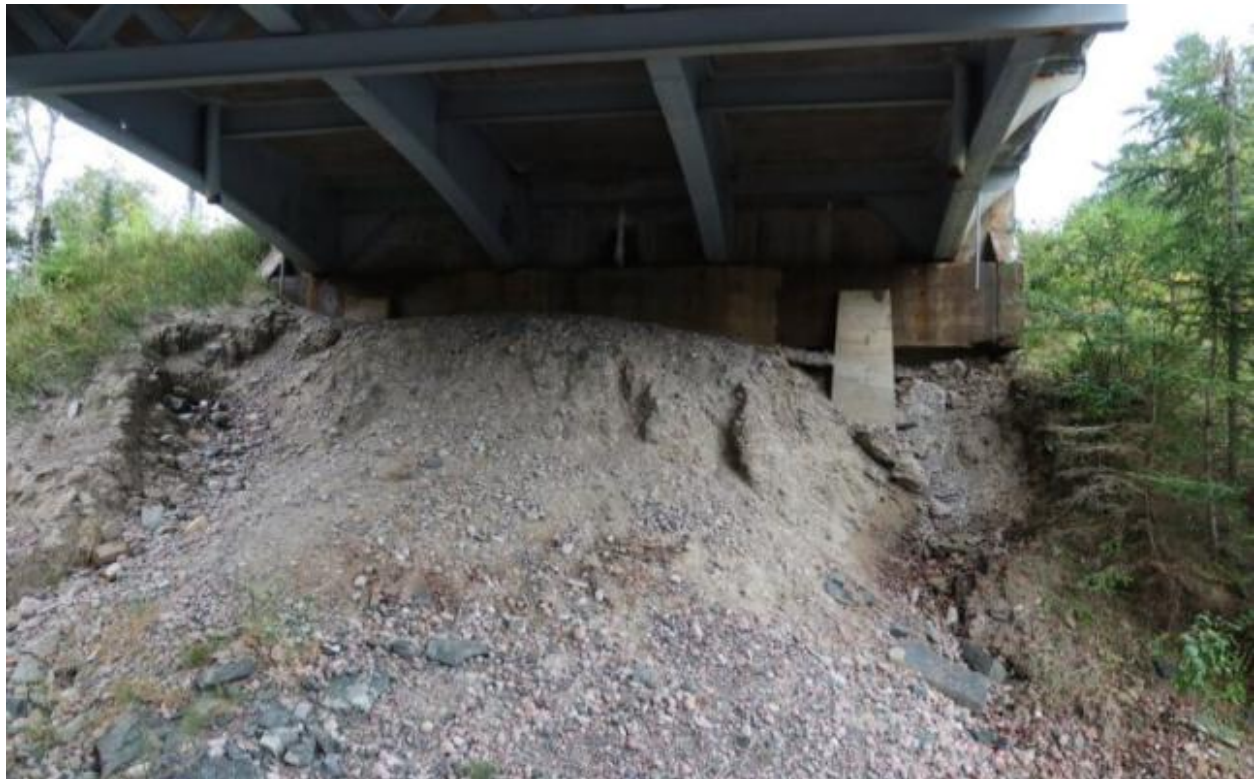
Figure A.9 (c) Embankments

<p>Condition State: Poor</p>	<p>Performance Deficiency: Unstable Embankment</p>
<p>Erosion of 30% to 40% of embankment</p>	<p>Erosion will continue without replacement of slope protection materials.</p>

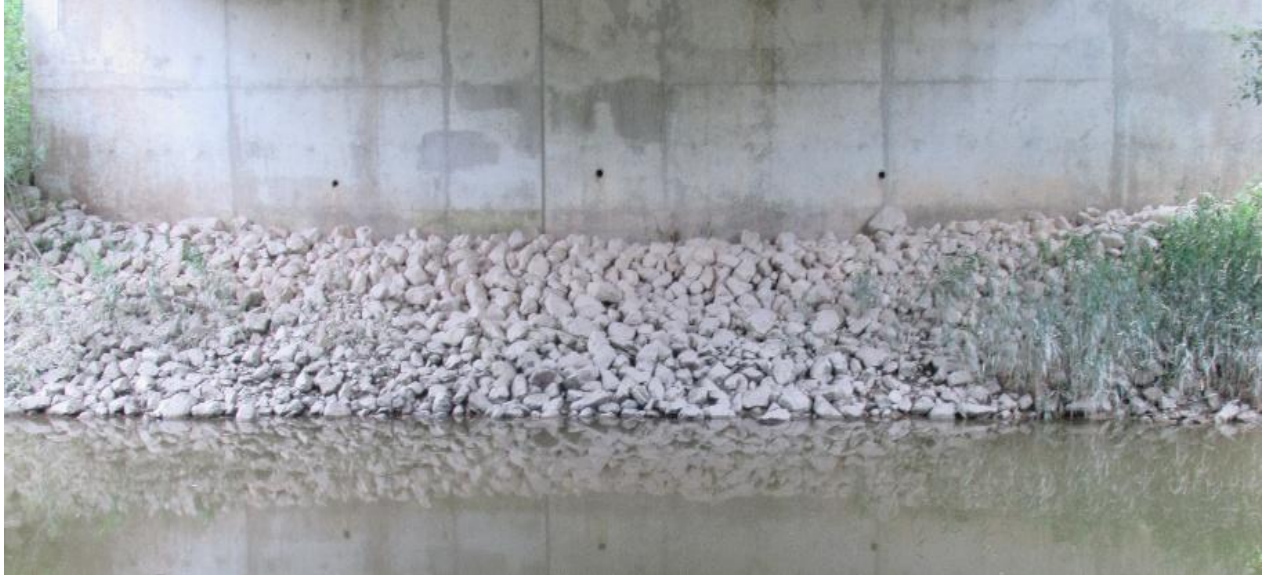
Figure A.9 (d) Random Rip-Rap Slope Protection

Condition State: Excellent	Performance Deficiency: None
No evidence of material deterioration

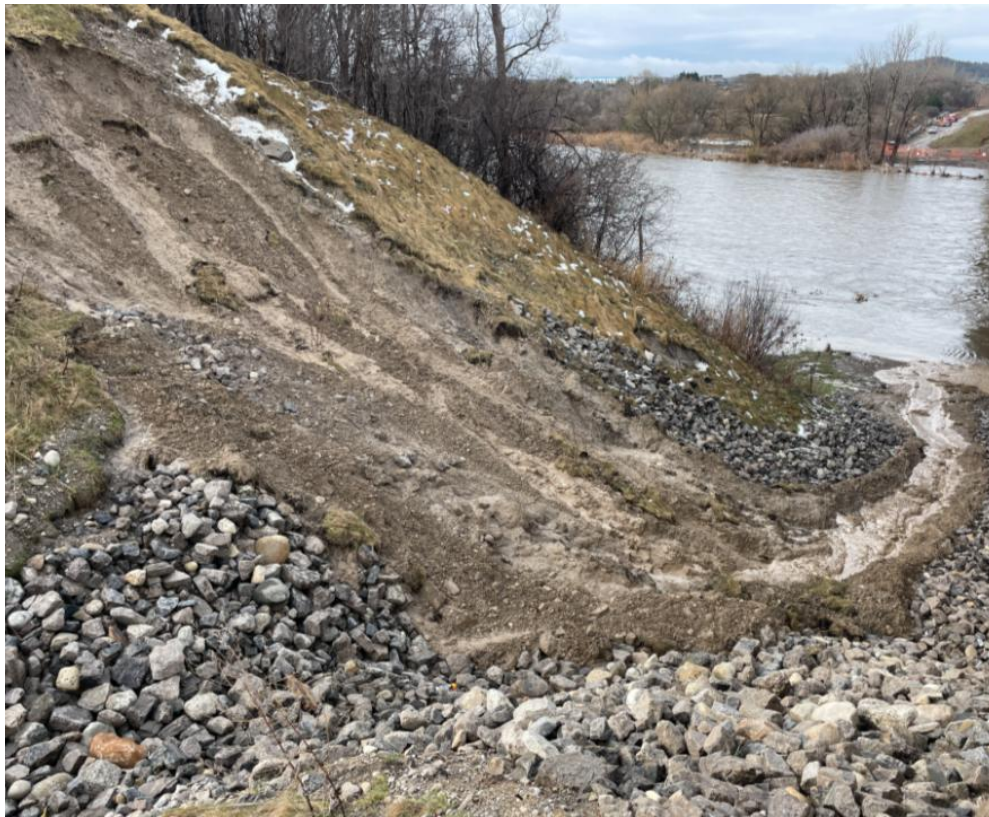
Figure A.9 (e) Slope Protection

<p>Condition State: Poor</p>	<p>Performance Deficiency: Unstable Embankment</p>
<p>Erosion over 20% of embankment</p>	<p>Loss of erosion protection to the embankment. Continued uncontrolled release of soil to the waterway is unacceptable and reinstatement of erosion protection materials should occur as soon as is practicable.</p>

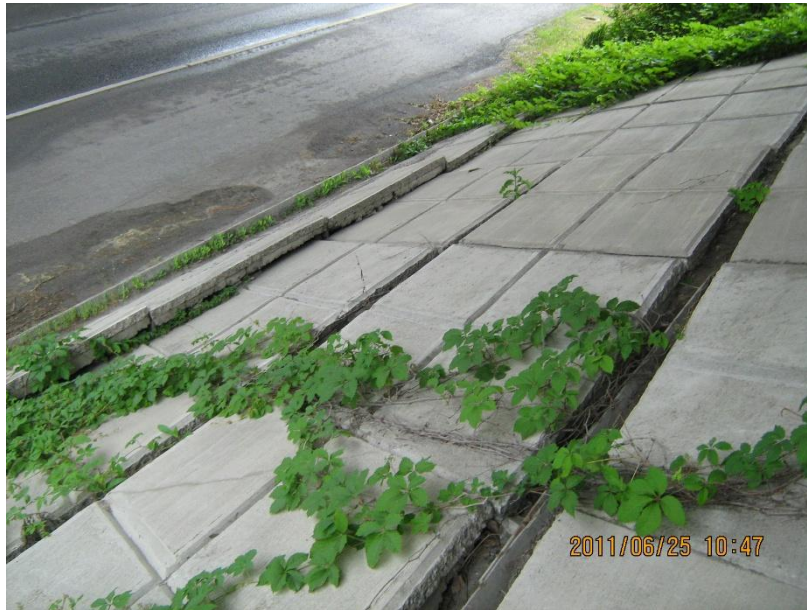
Figure A.9 (f) Precast Concrete Slope Protection

<p>Condition State: Poor</p>	<p>Performance Deficiency: Continuing Settlement; Continuing Movement</p>
<p>Slope paving panels broken, settling and overlapping.</p>	<ul style="list-style-type: none"> • Slope paving no longer in position and functioning. Embankment slope protection should be replaced.

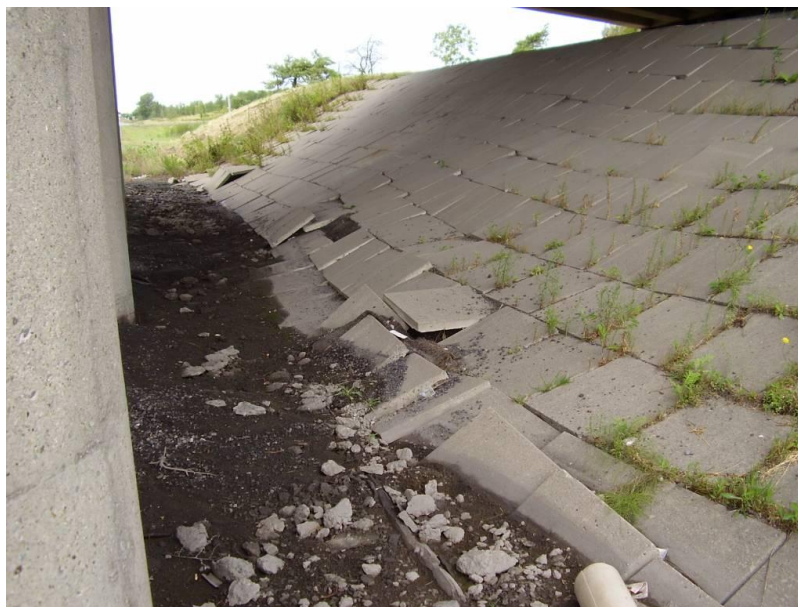
Figure A.9 (g) Precast Concrete Slope Protection

Condition State: Poor	Performance Deficiency: Continuing Settlement; Continuing Movements
Slab continuity compromised, with panels breaking up and sliding towards toe of slope.	Severe settlement and movement of the slope protection, with slabs telescoping underneath one another.

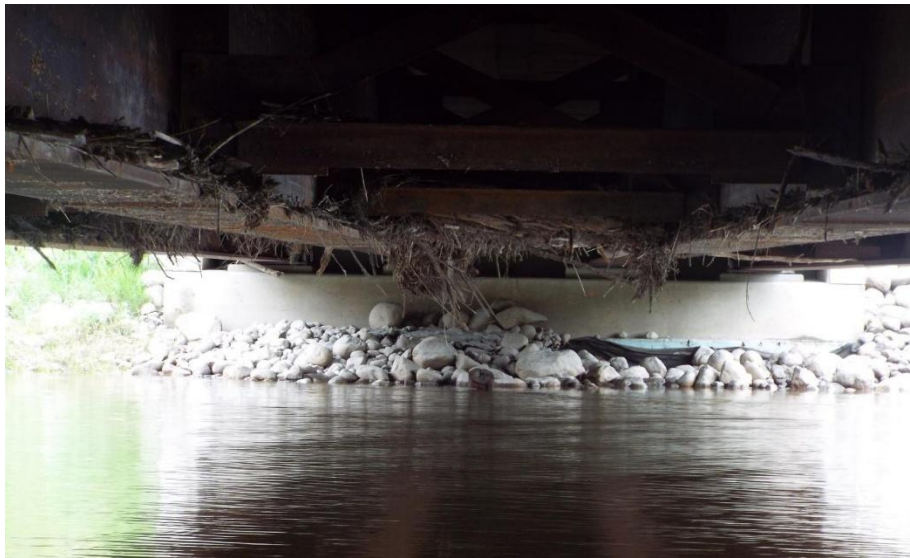
Figure A.9 (h) Streams

Condition State: Good	Performance Deficiency: Flooding/Channel Blockage
No material defects.	Maximum high-water marks above soffit of beams

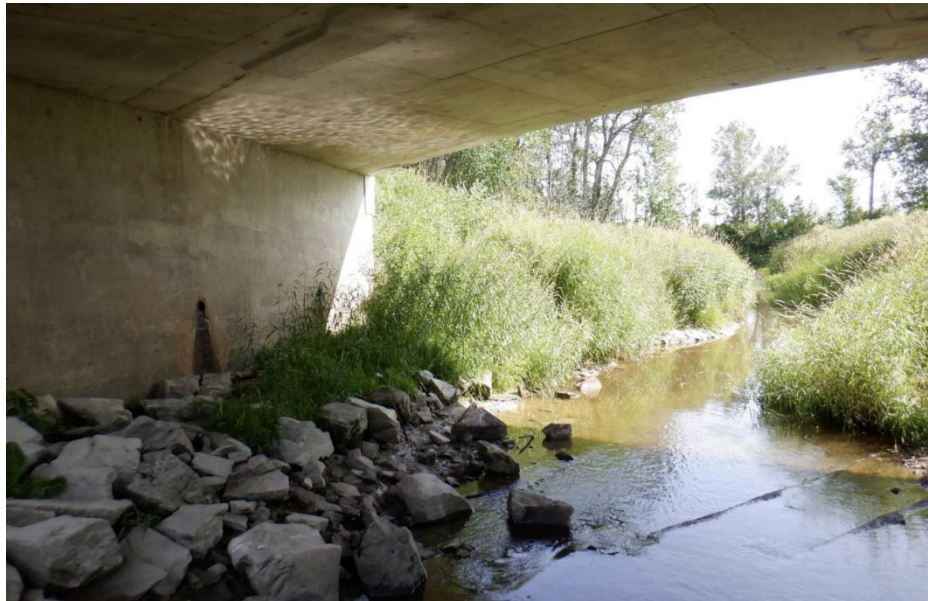
Figure A.9 (i) Meandering Stream

<p>Condition State: Poor</p>	<p>Performance Deficiency: Undermining of Foundation</p>
<p>Lack of erosion resistant materials adjacent to wingwall, upstream of structure.</p>	<p>Meandering stream is encroaching against wingwall and substructure with high potential for erosion of the embankment and scour beneath the foundation. Erosion resistant materials should be reinstated to protect the foundation.</p>

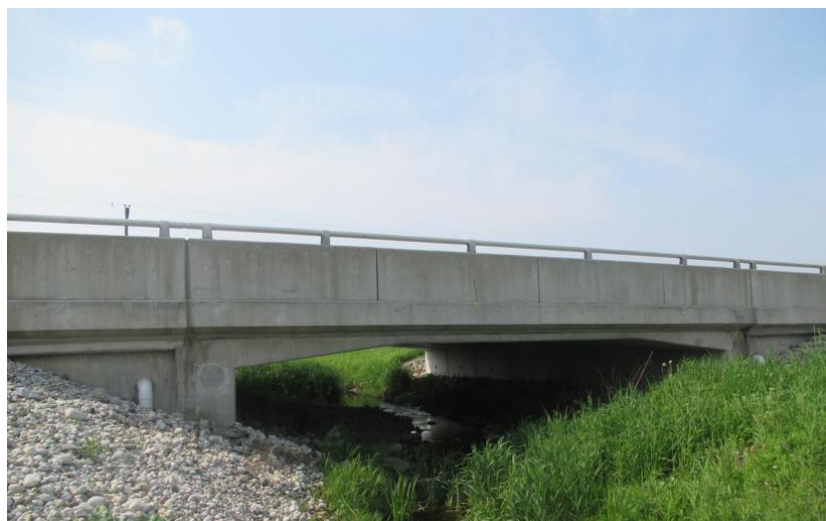
Figure A.9 (j) Streams

Condition State: Poor	Performance Deficiency: Flooding/Channel Blockage
Aggradation of stream bed is extensive with considerable portion of the channel blocked	Channel blockage reduces flow capacity of the channel, increases flooding potential.

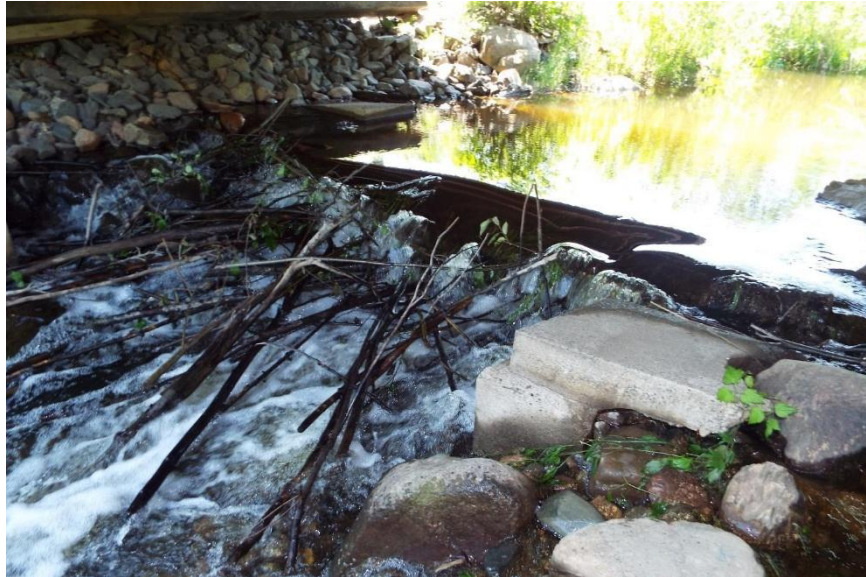
Figure A.9 (k) Streams

Condition State: Poor	Performance Deficiency: Flooding/Channel Blockage
Aggradation of the streambed upstream and degradation downstream due to debris buildup under structure	Partial blockage of the opening at the structure, causing high potential for flooding upstream and possible undermining due to scour with increased water velocities.

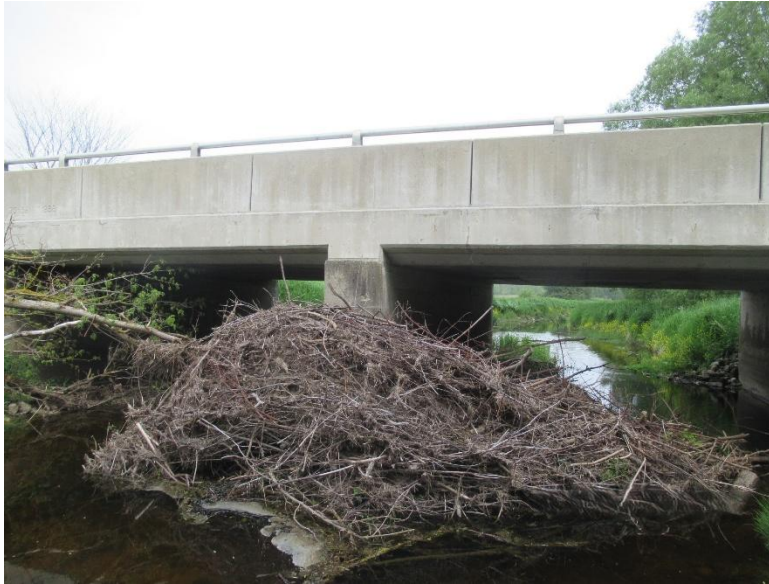
Figure A.9 (I) Streams

Condition State: Undetermined	Performance Deficiency: Flooding/Channel Blockage
Debris blocking majority of channel will induce scour around the pier. Condition state will need to be determined through examination of the location and extent of the scour.	Debris carried and deposited against a structure during a flooding event can cause damage to the streambed after the event, by altering the water flow patterns and velocities.

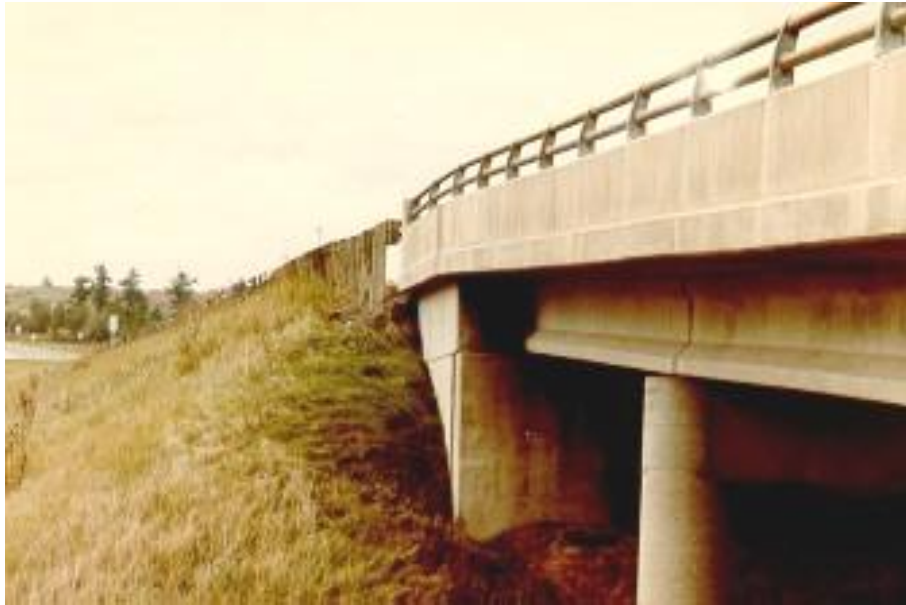
Figure A.10 (b) Foundation

Condition State: Not Applicable	Performance Deficiency: None
	Previous settlement of wingwall has stabilized

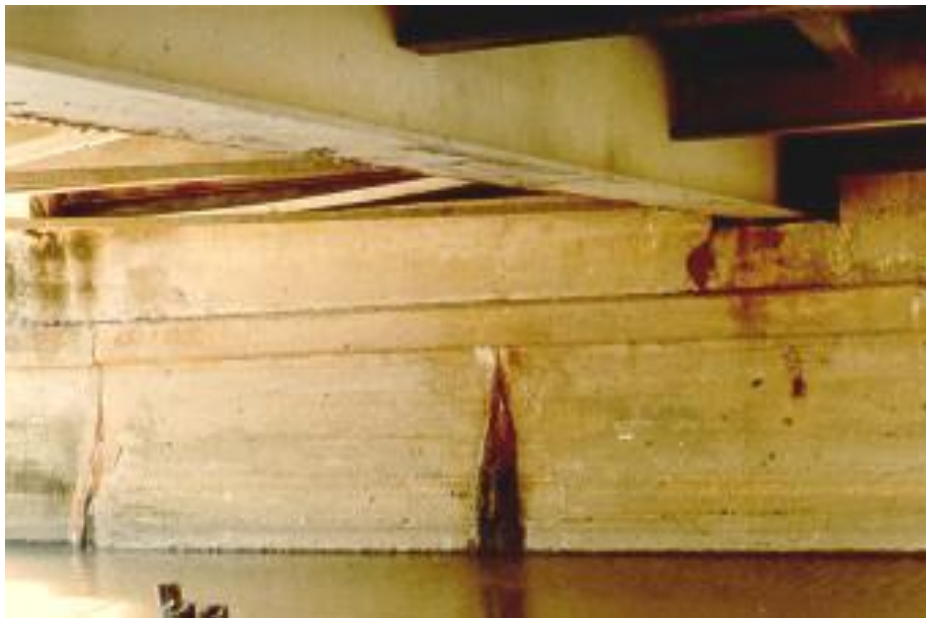
Figure A.10 (c) Foundation

Condition State: Not Applicable	Performance Deficiency: None
	Movement of foundation has stabilized. It has produced wide cracks in abutment but has not affected the stability of the abutment

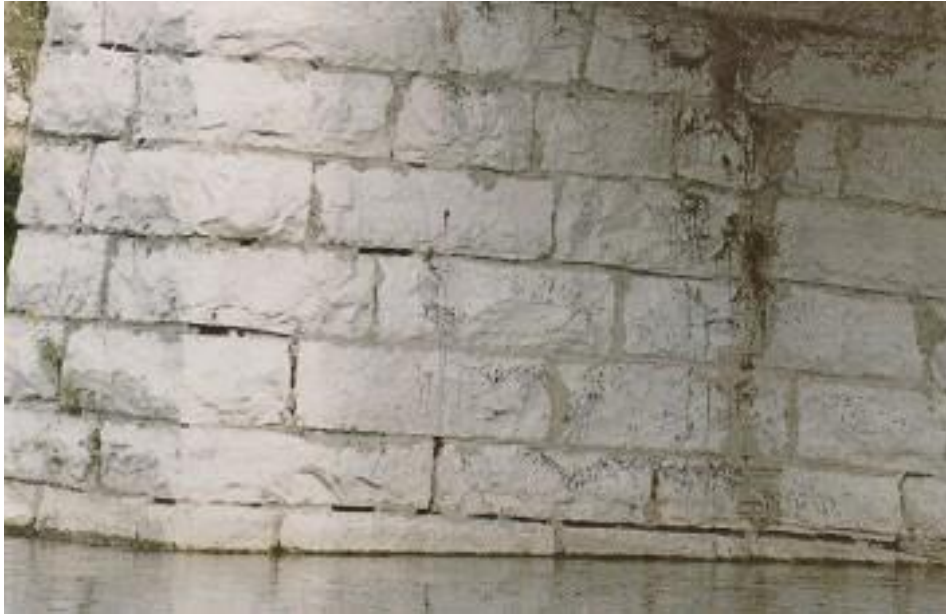
Figure A.10 (d) Foundation

Condition State: Not Applicable	Performance Deficiency: Continuing Movements
	Continuing increasing movement of foundation has affected stability of the pier and the superstructure

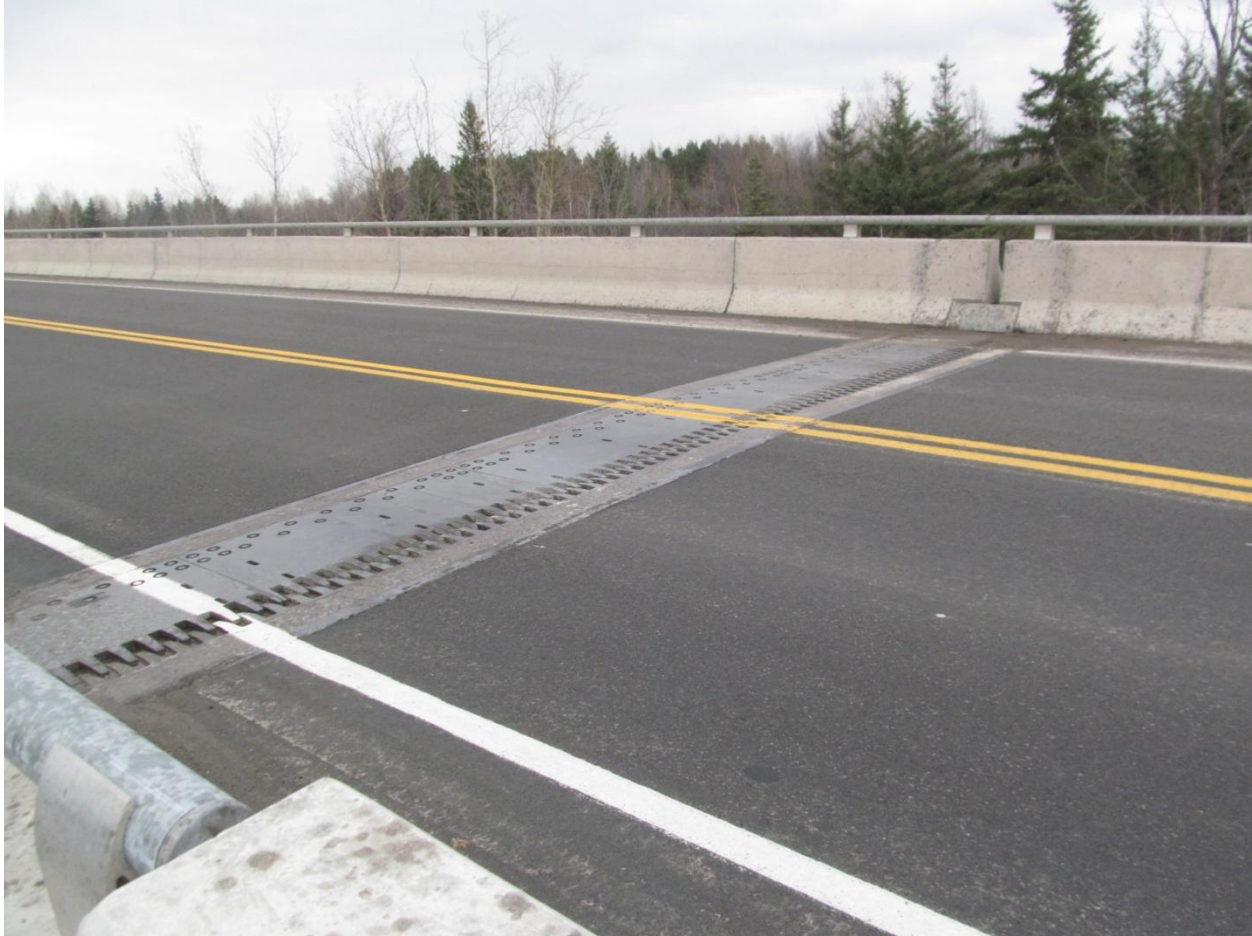
Figure A.11 (a) Finger Plate Expansion Joint

Condition State: Good	Performance Deficiency: No performance deficiency.
Light rust	. Joint operating well
