PART 2 – DETAILED VISUAL INSPECTION

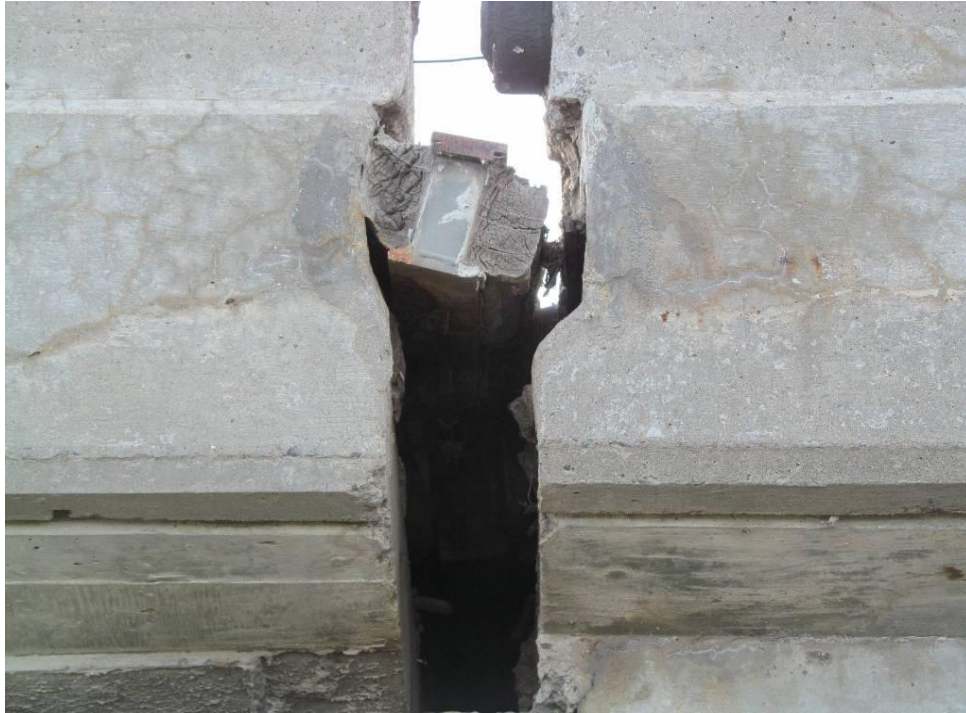
Figure A.11 (b) Compression Seal Joint

Condition State: Poor	Performance Deficiency: Continuity of roadway surface and leakage.
Seal is leaking	Seal has insufficient pre-compression to fill gap and separation beam twisted in joint.

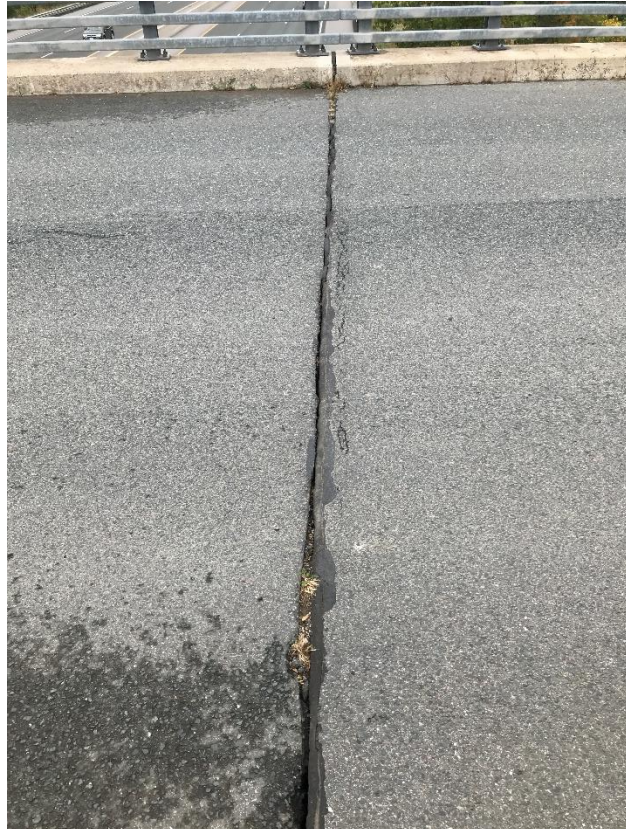
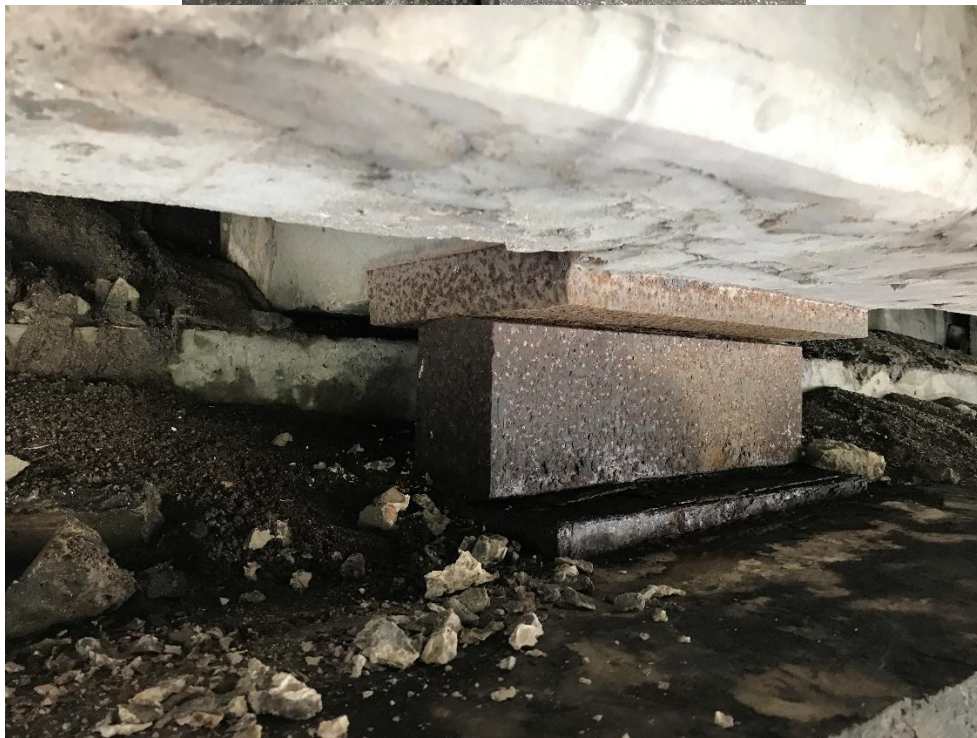
Figure A.11 (c) Paved-Over Joint and Leakage Effects

Condition State: Poor	Performance Deficiency: Leaking, with
Significant cracking of asphalt. Joint leaking, providing no protection to elements below.	Top photo showing joint leaking, and bottom photo showing consequences. Debris includes concrete spalled from ballast wall and deck end, as well as sand from roadway.

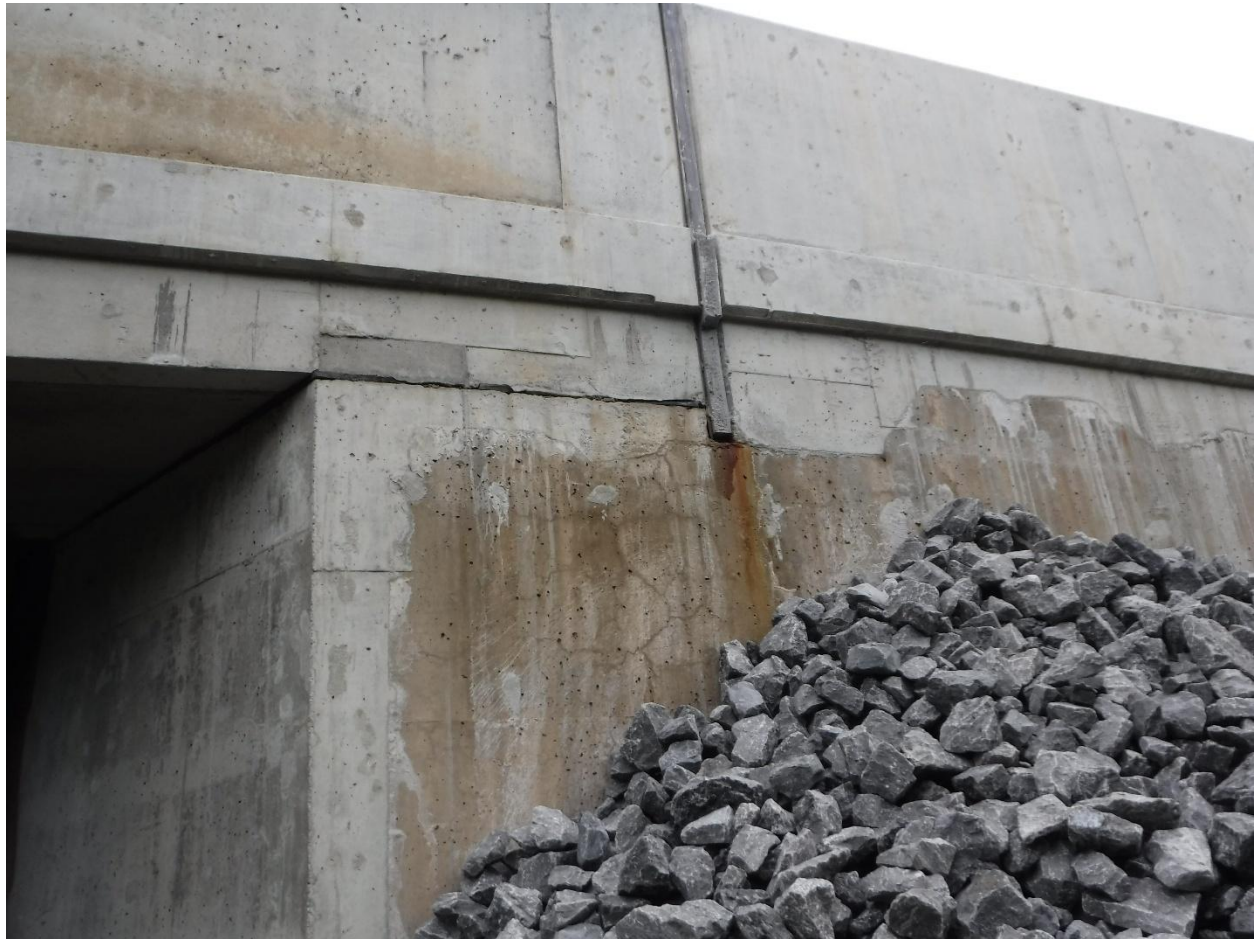
Figure A.11 (d) Ethylene Vinyl Acetate Seal

Condition State: Poor	Performance Deficiency: Leaking
Loss of resiliency of seal	Seal allowing water leakage

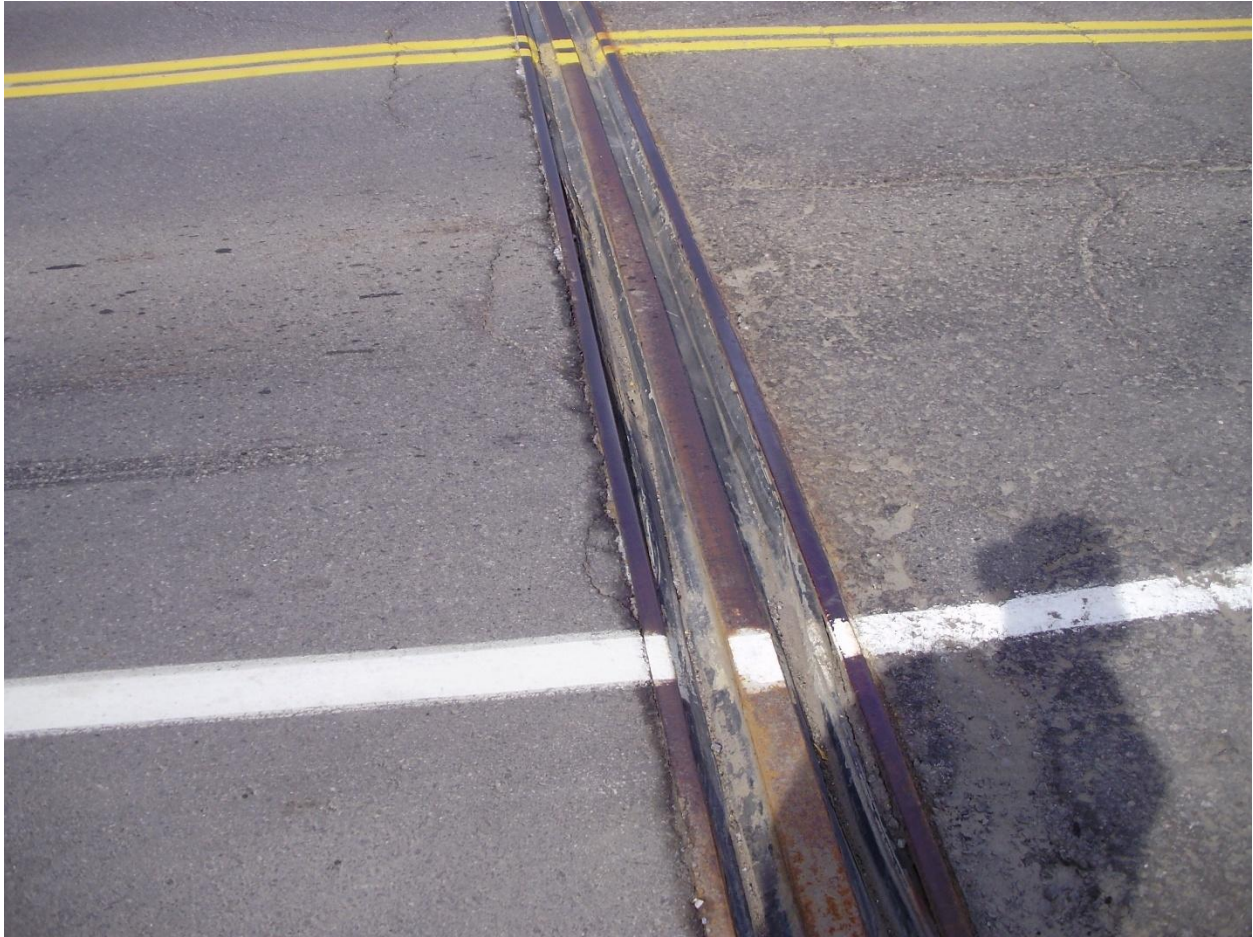
Figure A.11 (e) Multiple Seal Joint

Condition State: Poor	Performance Deficiency: None
Seal torn and joint is leaking

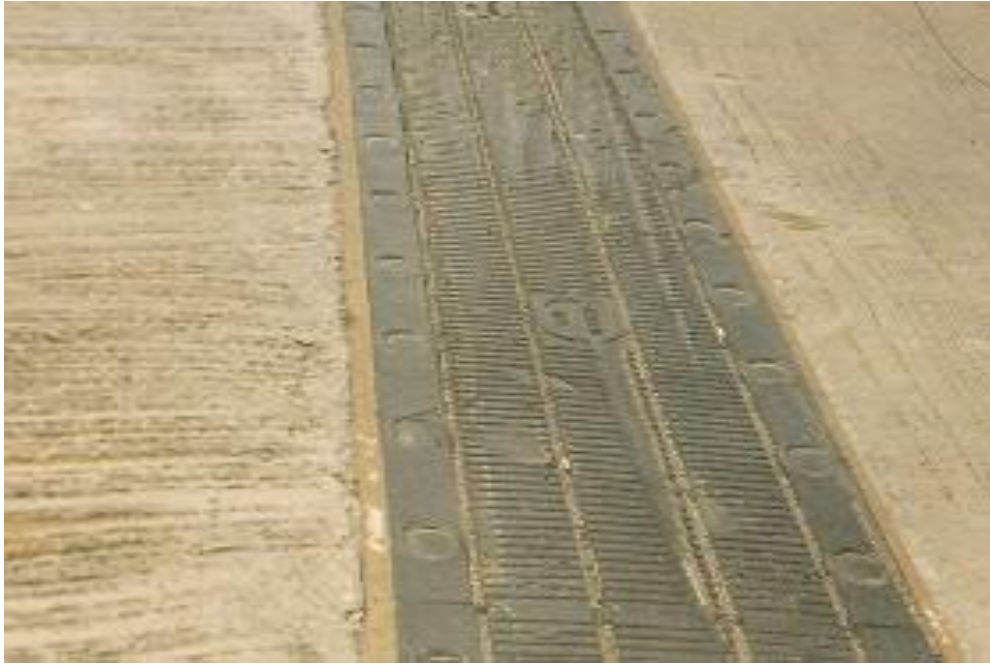
Figure A.11 (f) Rubber Cushion Joint

Condition State: Poor	Performance Deficiency: None
Joint is leaking

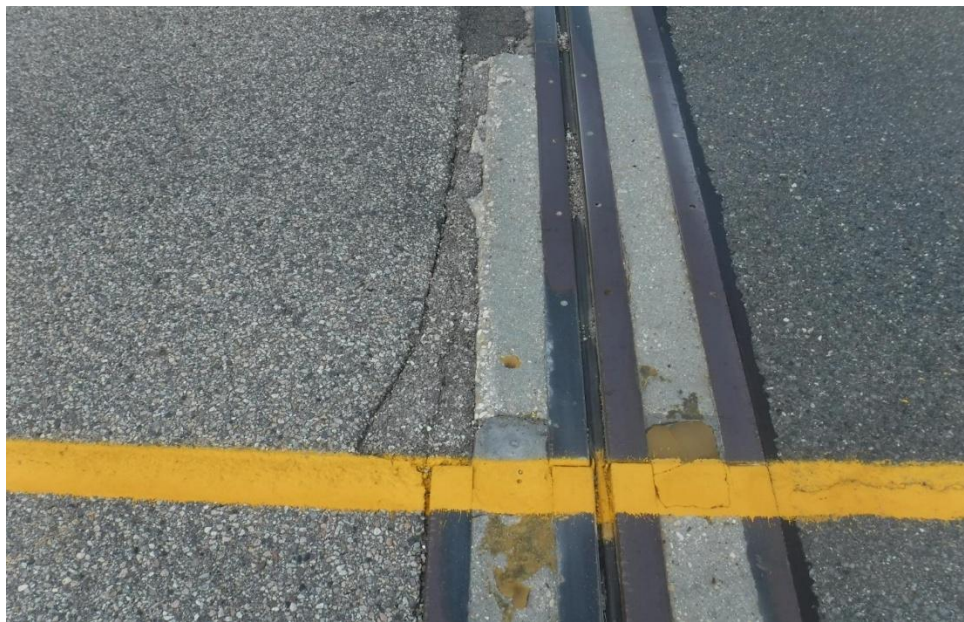
Figure A.11 (g) Expansion Joint Armouring

Condition State: Poor	Performance Deficiency: Rough riding surface.
Armouring missing over considerable length.	Expansion joint end dam will continue to be damaged and adjacent section of armouring may catch on snowplough.

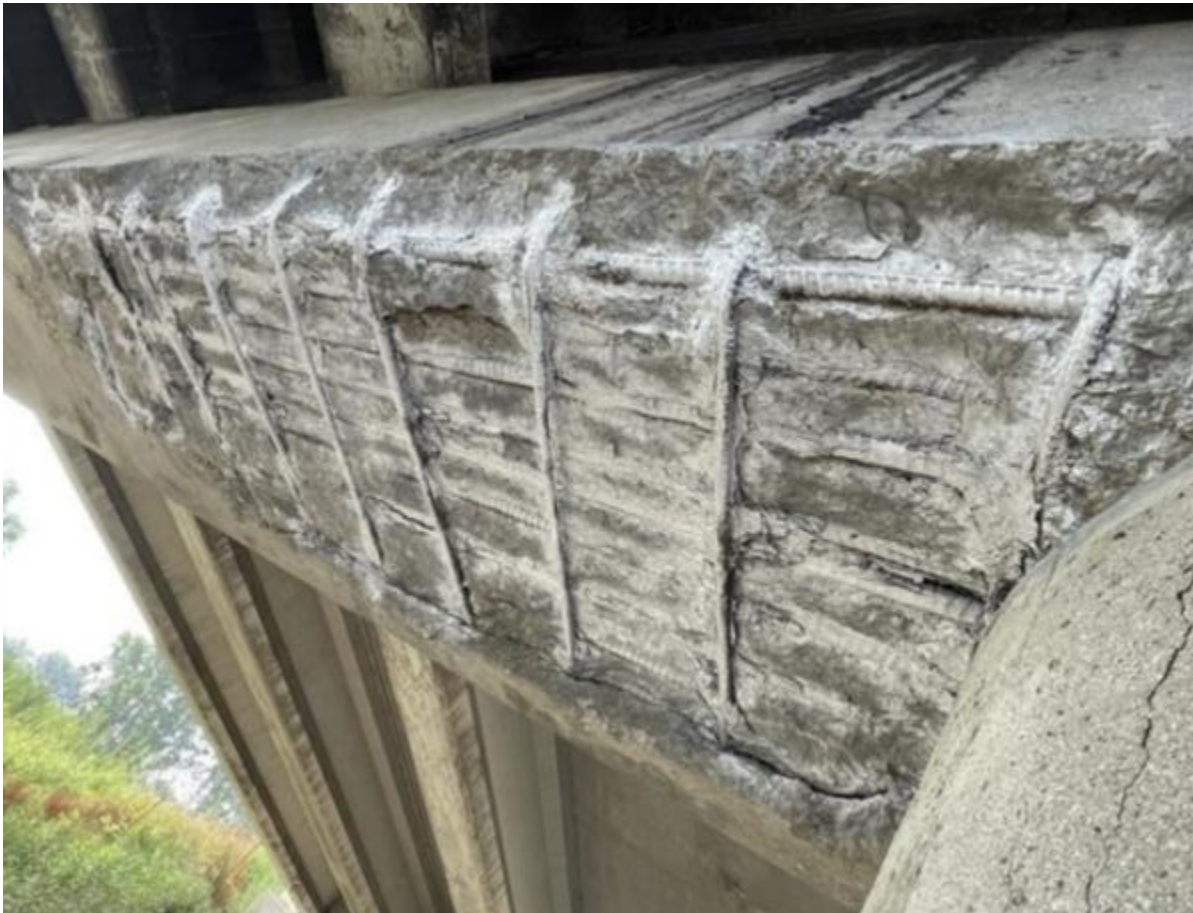
**Figure A.12 (a) Concrete Pier Cap**

Condition State: Poor	Performance Deficiency: None
Very severe spalling and corrosion of exposed reinforcement

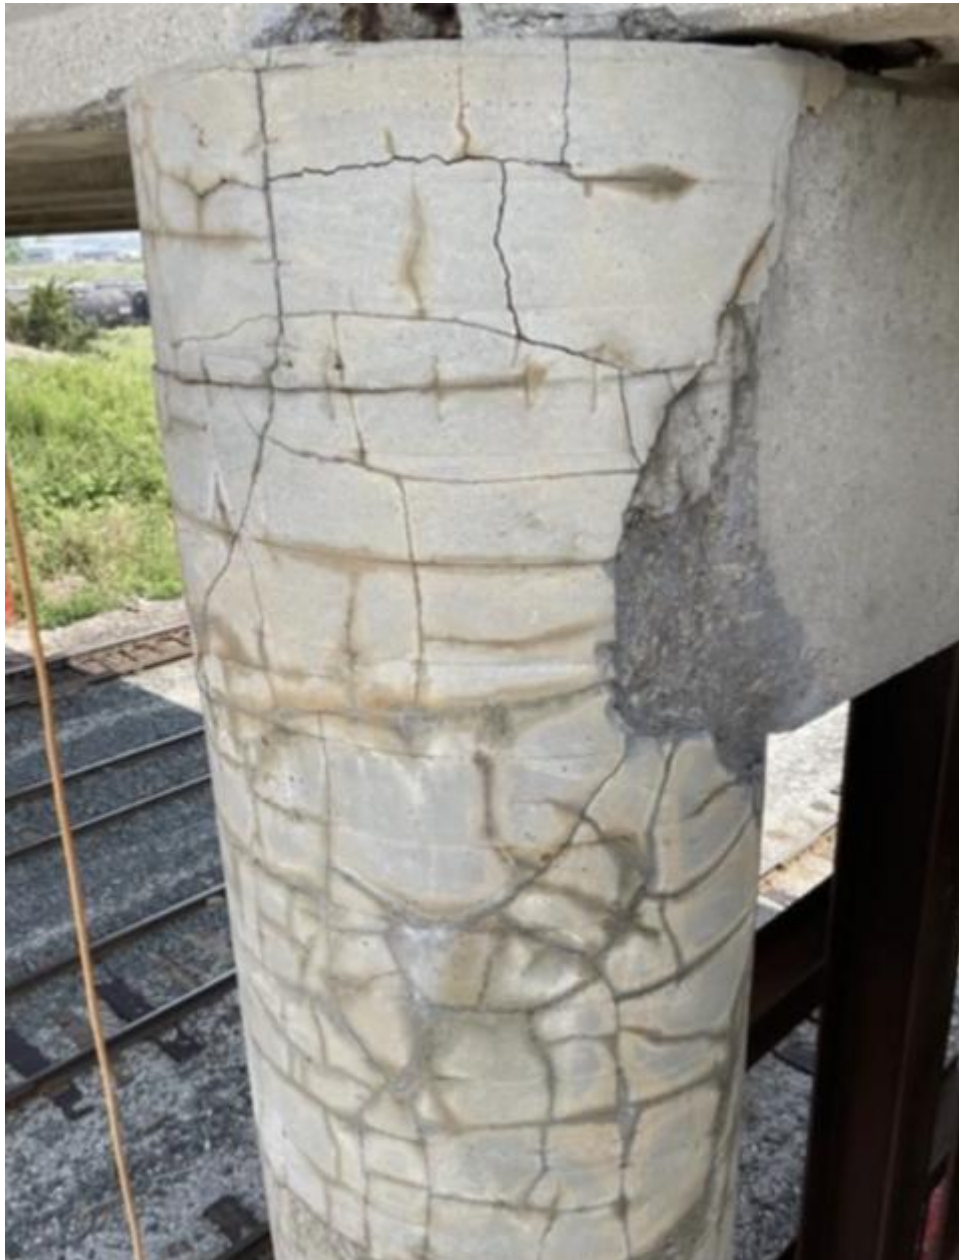
Figure A.12 (b) Concrete Pier Column

Condition State: Poor	Performance Deficiency: None
Very severe spalls and delamination and	Concrete refacing is performing poorly. The

<p>spalling of the column, Medium to wide stained pattern cracking.</p>	<p>condition of the pier prior to refacing should be revisited and whether this refacing has addressed any load capacity issues it was intended to resolve.</p>
---	---

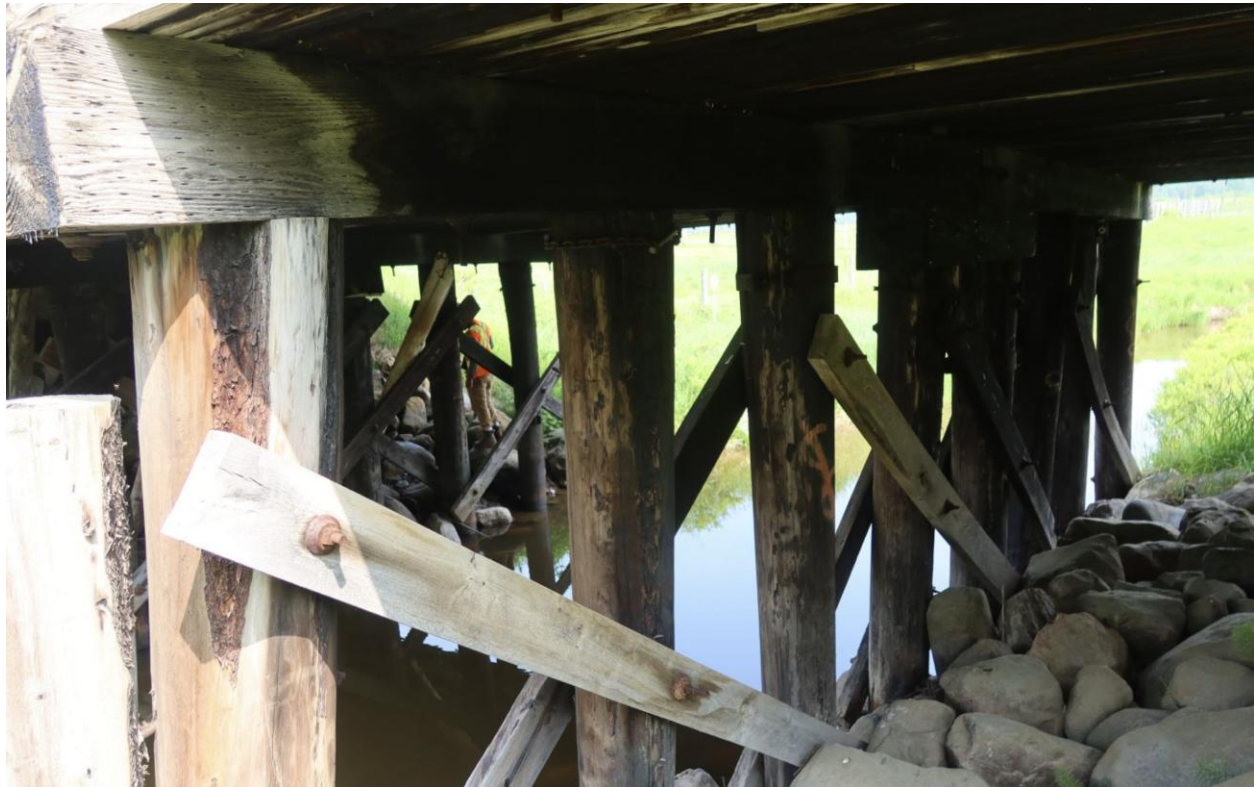
Figure A.12 (c) Wood Pier Columns

<p>Condition State: Good/Poor</p>	<p>Performance Deficiency: None</p>
<p>Good: Light weathering of piles. Overall in good condition.</p>	<p>No evidence of movement. Piles are straight with no major defects or loose components. Pier cap is evenly supported by piles.</p>
<p>Poor: Some severe splits observed at the pier collars</p>

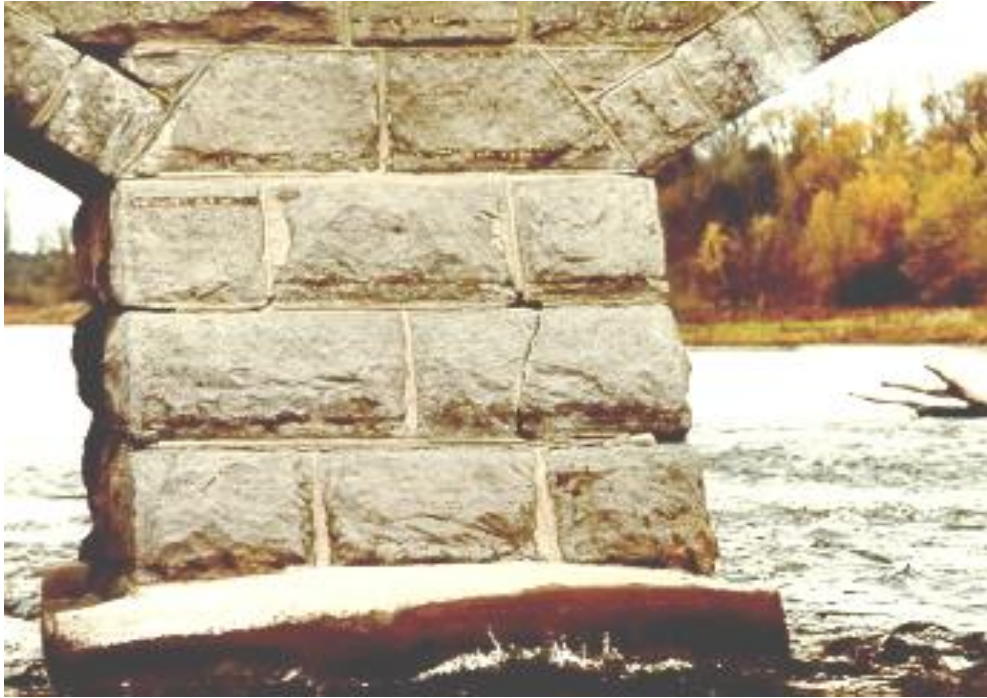
Figure A.12 (d) Masonry Pier

Condition State: Fair	Performance Deficiency: None
Medium crack in stone	Previous movement has stabilized

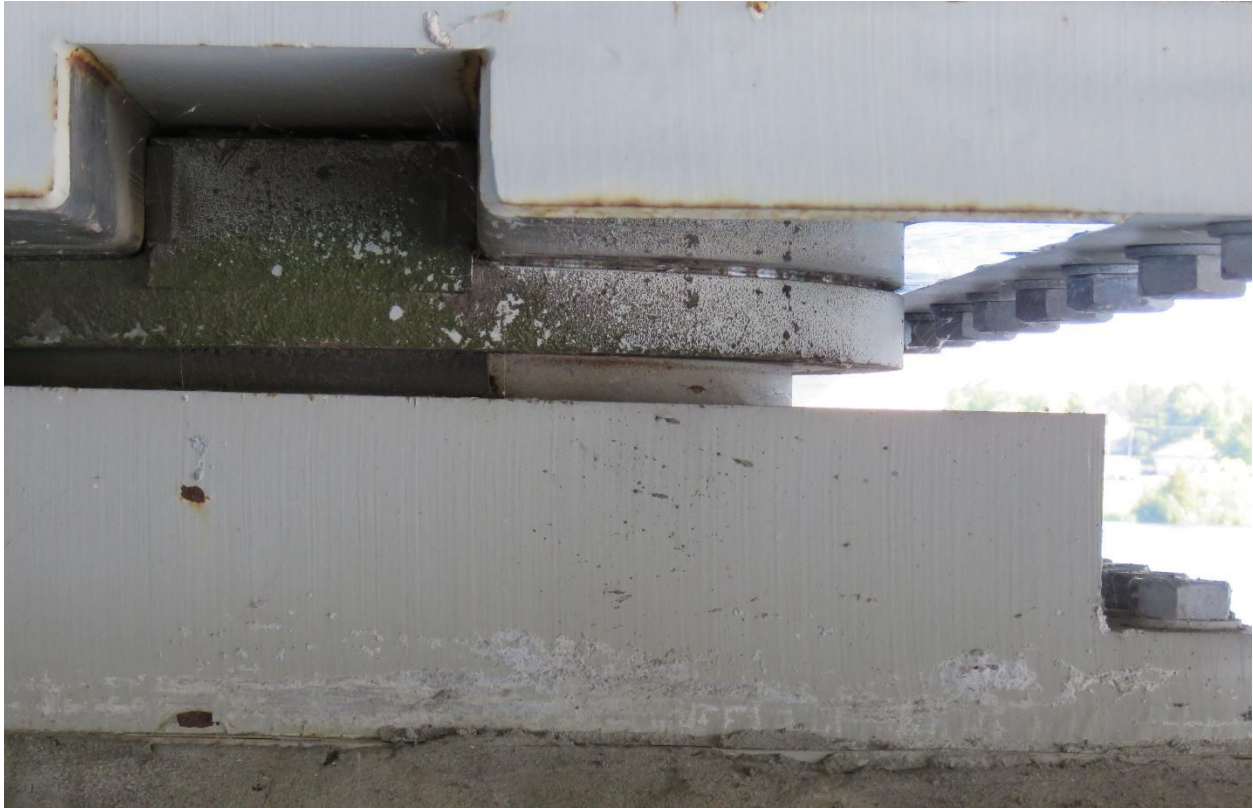
Figure A.12 (e) Disc Bearing

Condition State: Fair	Performance Deficiency: None
Dust seal broken, with half missing

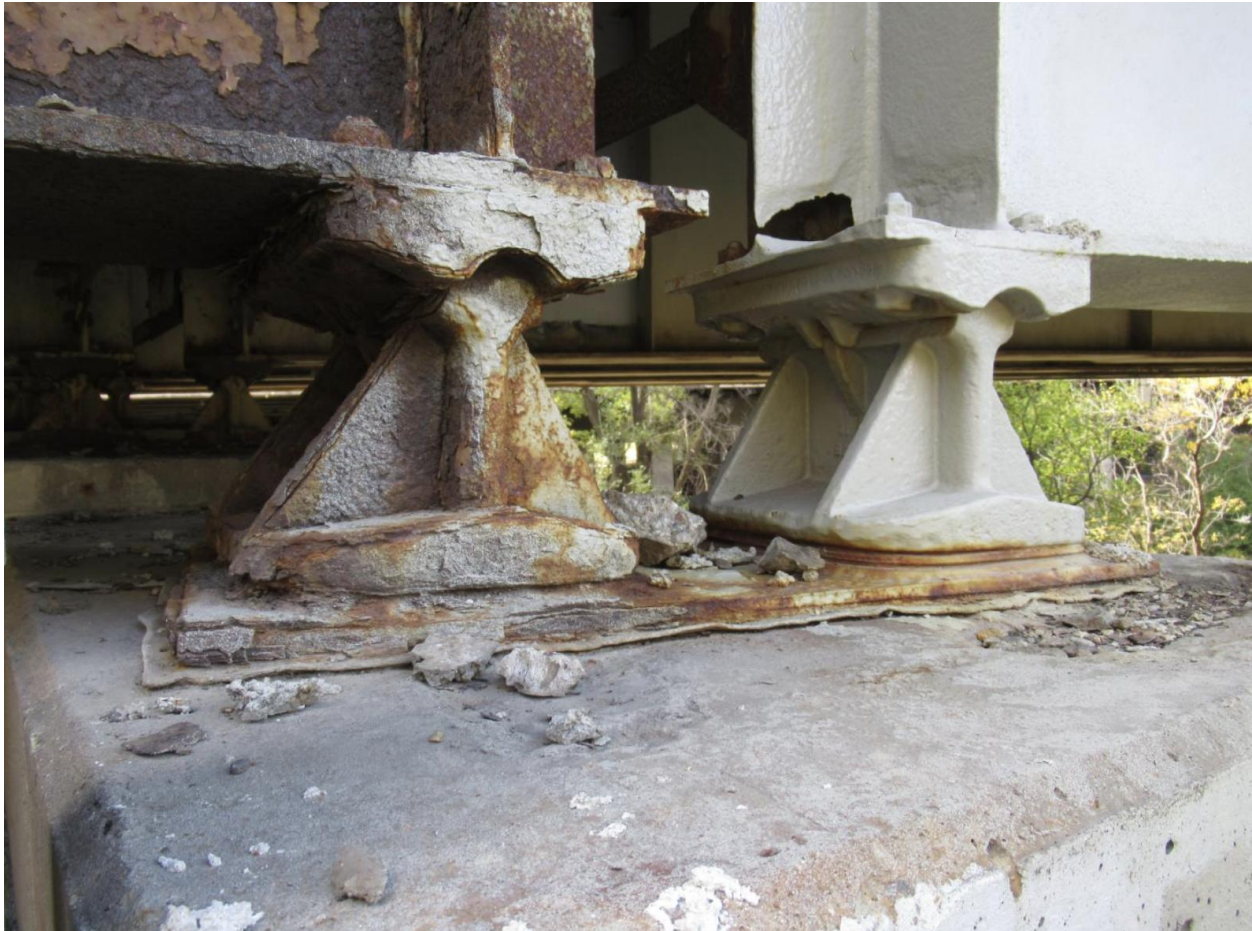
Figure A.12 (f) Rocker Bearings

Condition State: Good and Poor	Performance Deficiency: Seized Bearing
<p>Good: Rocker bearing on right has light corrosion at the base but is otherwise in good condition.</p> <p>Poor: Rocker bearing on left has moderate corrosion and is locked in position as evidenced by the buildup of corrosion products.</p>	<p>Bearing on left is seized.</p>

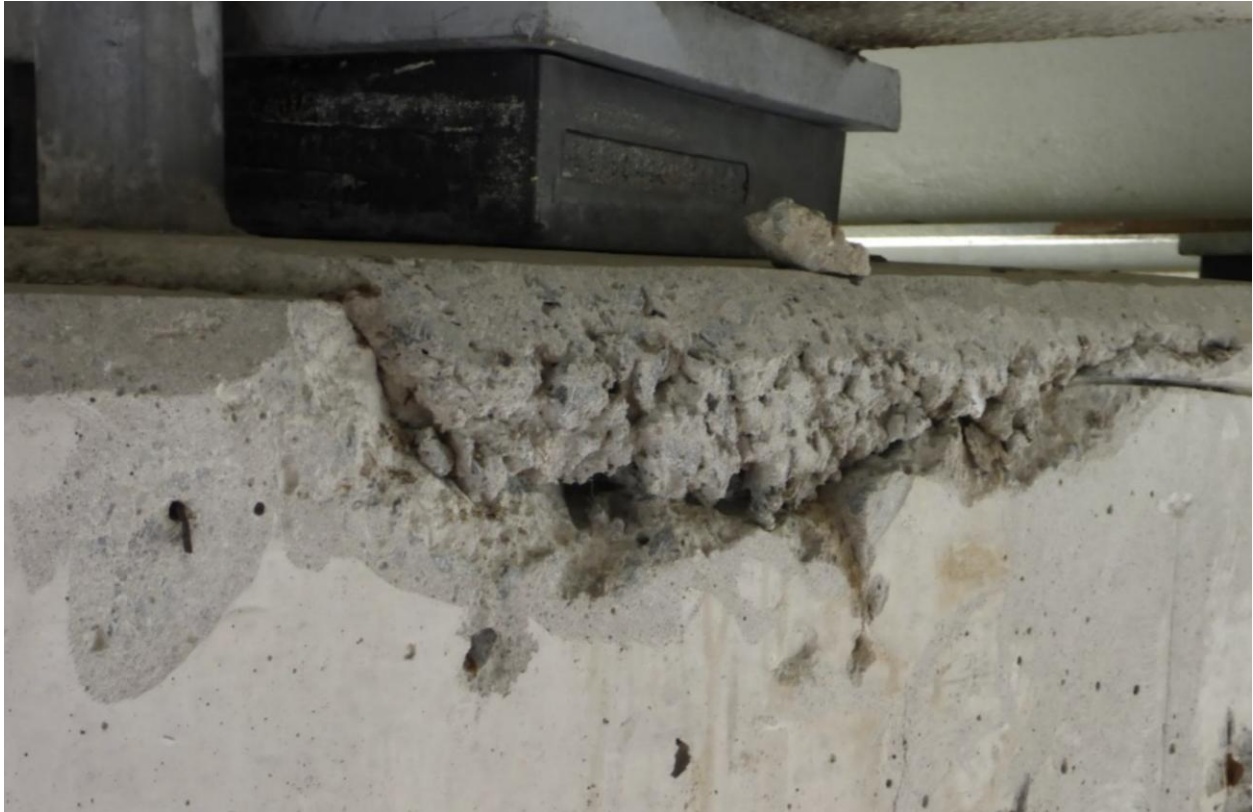
Figure A.12 (f) Concrete Pier Cap

Condition State: Good / Poor	Performance Deficiency: None
Bearing support at pier cap was repaired but resulted in moderate honey combing of the new concrete and did not completely repair the spalled concrete underneath. Unrepaired area should be considered poor while the honeycombing would be considered good because the holes are less than 25 mm deep.
