**REHABILITATION SELECTION**

**P2-3.10 Bearings**

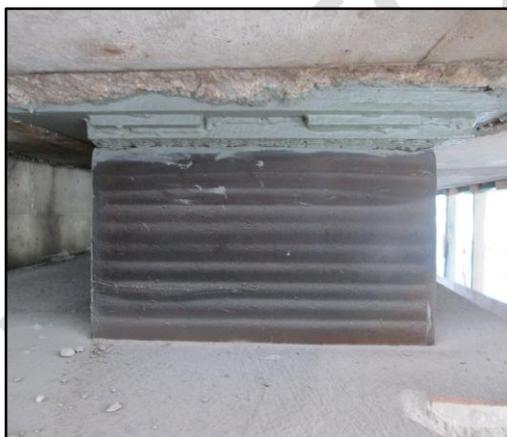
**Picture 16 – A laminated elastomeric bearing in service since 1965.**

In the 1960s, both plain elastomer pads and laminated elastomeric bearings were used. The laminated bearings were supplied by Andre Bearings and were individually moulded using natural rubber, and many remain in service today in good condition ([Picture 16](#) and [Picture 17](#)). Pot bearings were used for large loads, usually with the pot on the top and piston on the bottom. This is opposite to today's practice, with the pot on the bottom.

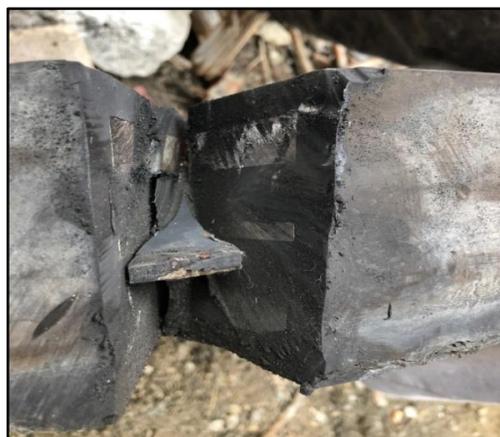
**Picture 17 – Cross-section of a laminated elastomeric bearing from 1962.**

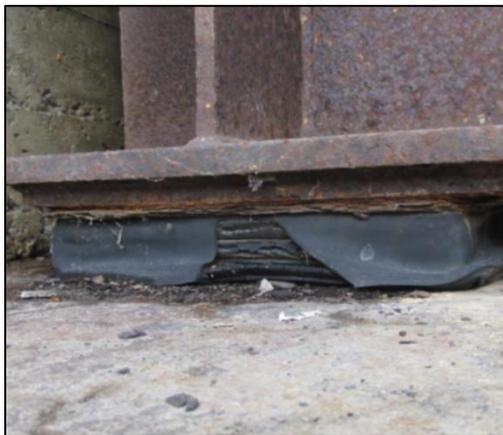
**Picture 18 – Debonded cover of a laminated elastomeric bearing manufactured in the 1970s.**

From 1970s to mid-1980s, laminated elastomeric bearings were cut from large sheets (like cutting a piece of cake in a sheet pan) and the exposed edges were wrapped with a layer of rubber. Over time, the cover layer often cracked or debonded, as illustrated in [Picture 18](#). Many of these

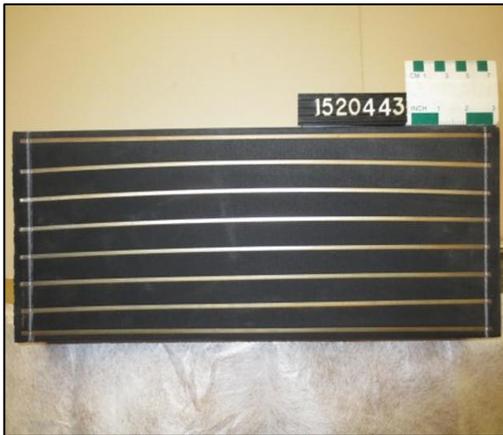
Picture 19 – Cross-section of a laminated elastomeric bearing.

Elastomeric bearings are either plain or laminated. Plain bearings are up to 25 mm in thickness while laminated bearings typically range between 40 to 150 mm. [Picture 19](#) shows the cross-section of a laminated elastomeric bearing. Movements and rotation are accommodated through deformation and compression (refer to [Picture 20](#)) of the rubber. Elastomeric bearings are relatively low cost and are the most common type of bearings used on MTO bridges.

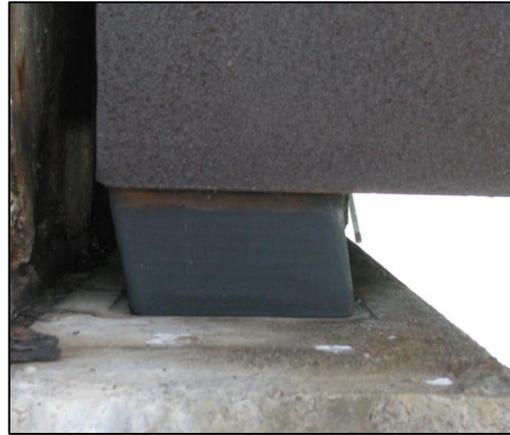
Picture 20 – An elastomeric bearing deforms to accommodate thermal movement.

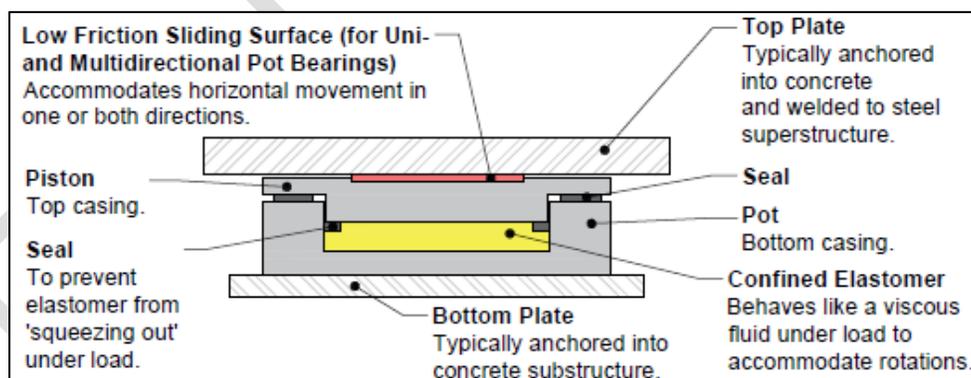
Figure 16 – An idealized cross-section of a pot bearing.

Pot, disc, and spherical bearings accommodate rotations differently. In a pot bearing, an elastomer is confined in a “pot” and behaves like a viscous fluid to accommodate rotation, refer to [Figure 16](#). A disassembled pot bearing is shown in [Picture 21](#).

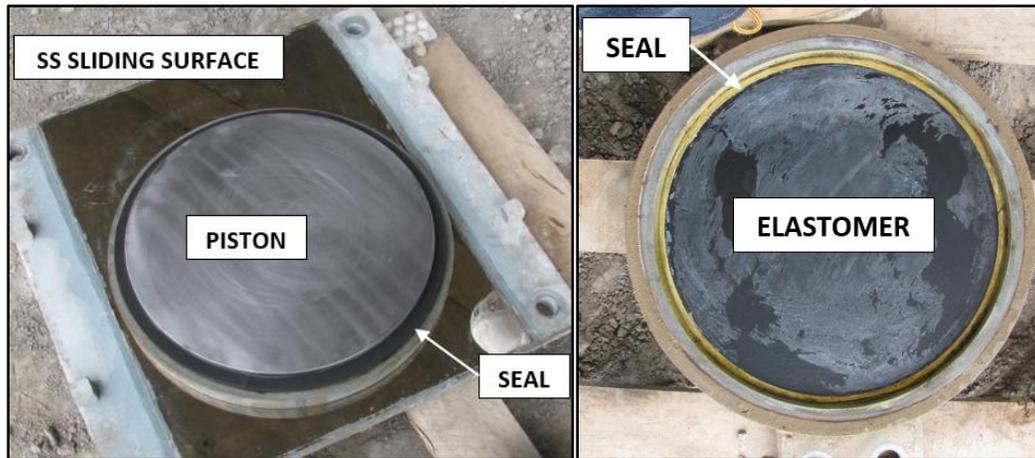
Picture 21 – a disassembled pot bearing.

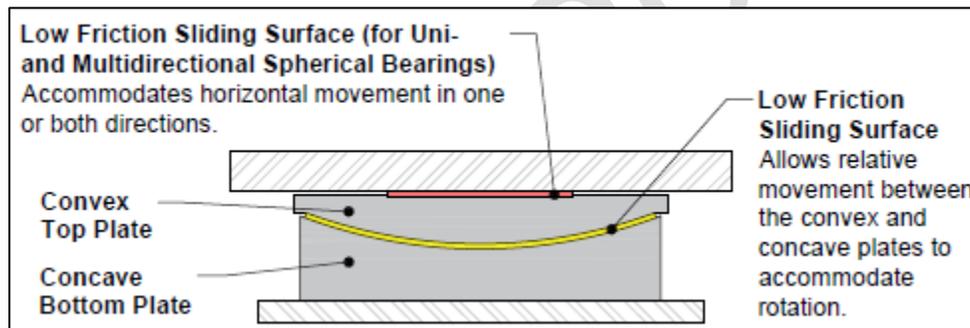
Figure 17 – An idealized cross-section of a spherical bearing.

In a spherical bearing, there is a low friction sliding interface between the top convex and bottom concave plates. The plates move relative to each other to accommodate rotation, refer to [Figure 17](#).

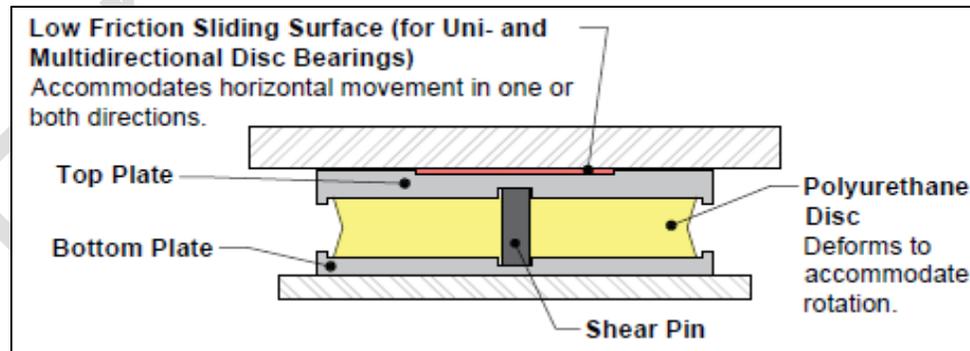
Figure 18 – An idealized cross-section of a disc bearing.

In a disc bearing, a stiff urethane disc is sandwiched between the top and bottom plates, refer to [Figure 18](#), which deforms to accommodate rotation.

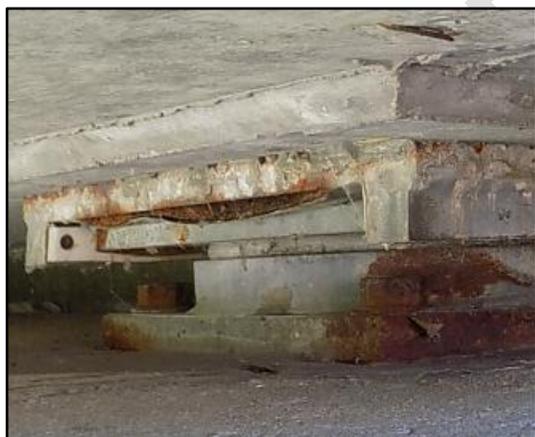
**Picture 22 – Unidirectional pot bearing where the sliding surface has rusted and peeled.**

PTFE sliding surfaces can be replaced when they become scored or damaged (refer to [Picture 22](#)). However, because replacement of the sliding elements requires jacking, seized rotational bearings are more commonly replaced in their entirety.

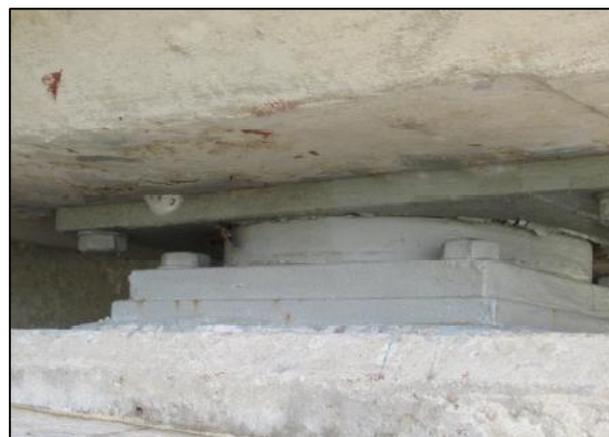
**Picture 23 – Recoated pot bearing.**

Steel bearing assemblies exposed to excessive moisture and deicing runoff may be cleaned and coated (refer to [Picture 23](#)) to remove corrosion and maintain their performance.

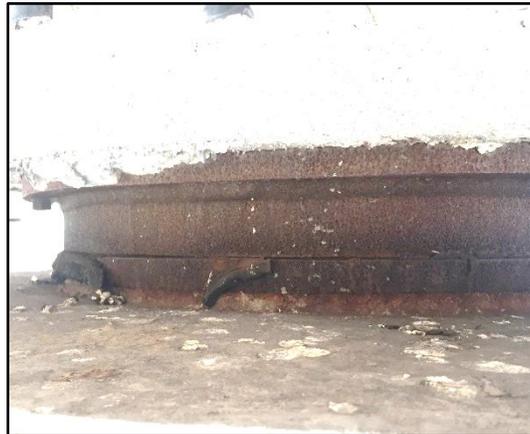
**Picture 24 – Seal between piston and pot is squeezed out.  
(Note: The pot for this bearing is at the top).**

In rare instances, the elastomer can squeeze out of a pot bearing (refer to [Picture 28](#)). The seal between the piston and pot should not be mistaken for the elastomer, (refer to [Picture 24](#)). The seal has no structural purpose; it is to prevent dust and water ingress. Broken seals can be removed, and a new backer rod can be installed into the gap for the same purpose.

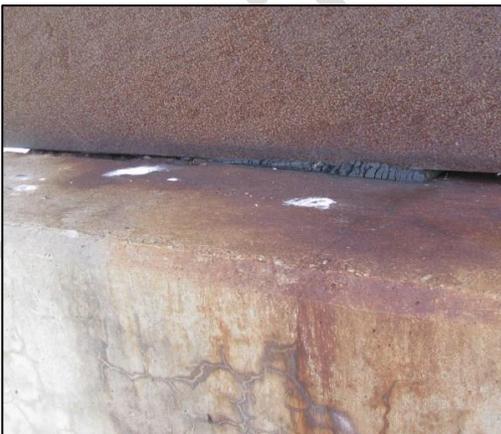
**Picture 25 – A crushed elastomeric bearing.**

- Bearings are in poor material condition.
  - Crushed or cracked elastomer ([Picture 25](#) and [Picture 26](#)), very severely corroded anchor rods, etc.

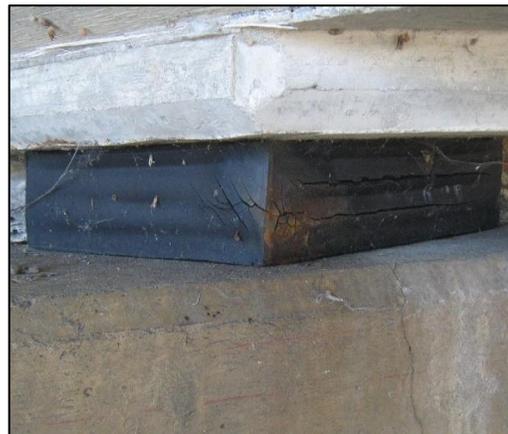
**Picture 26 – Cracked elastomeric bearing with some rust staining.**

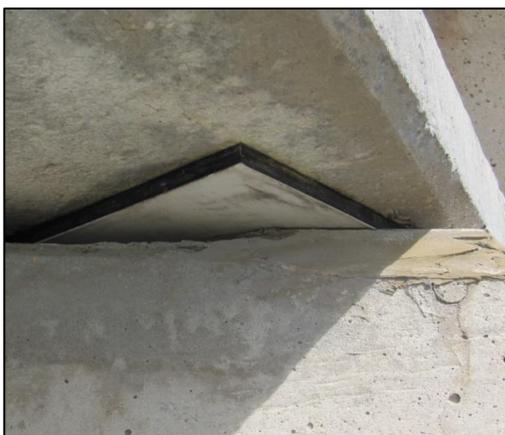
**Picture 27 – An elastomeric bearing that has ‘walked out’.**

- Seized/tilted rocker bearings.
- Walking-out bearings ([Picture 27](#)).
- Elastomer squeezed out in rotational bearings ([Picture 28](#)).

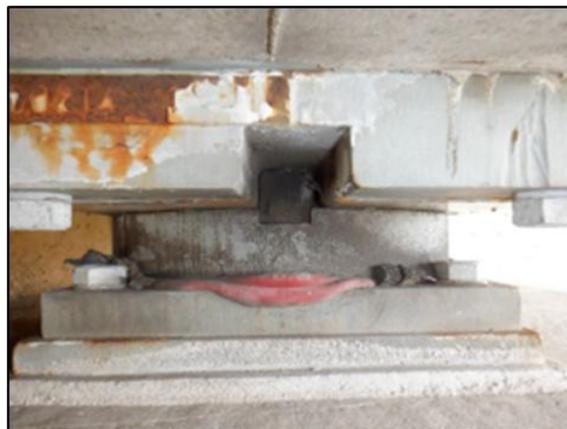
**Picture 28 – Elastomer (red) squeezed out in a disc bearing.**

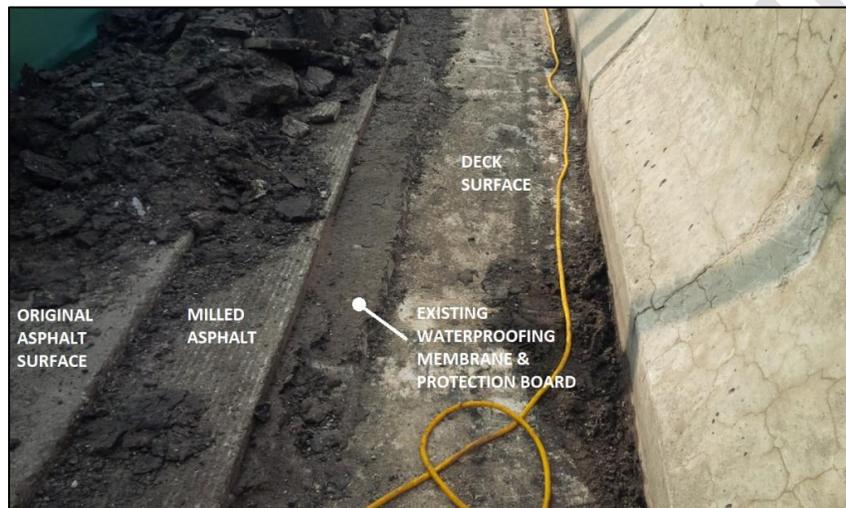
**Picture 29 – Difficulty lapping new waterproofing with existing.**

Waterproofing shall be removed and replaced as part of a bridge rehabilitation. It is recommended to avoid partially removing and replacing waterproofing, as it is very difficult to achieve a clean and proper lap between existing and new membranes, refer to [Picture 29](#).

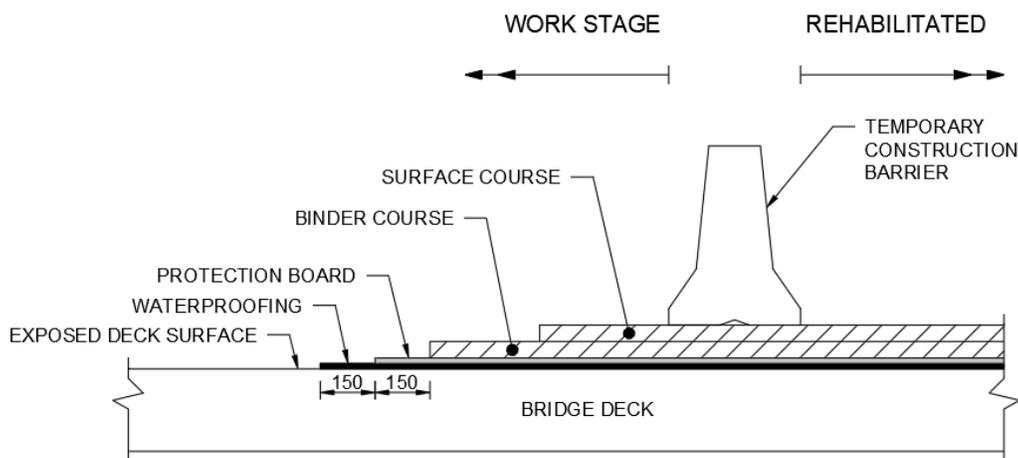
Figure 19 – Typical waterproofing longitudinal joint detail for staged construction.

Where the work is staged, the waterproofing membrane, protection boards and asphalt must be staggered between stages to offset their construction joints, refer to [Figure 19](#). *OPSS.PROV 914* specifies a minimum 150 mm lap. Achieving the minimum lap width is not always feasible due to bridge geometry and staging requirements. Nevertheless, it should be maximized and ensure membrane, protection board and asphalt joints do not stack on top of each other.

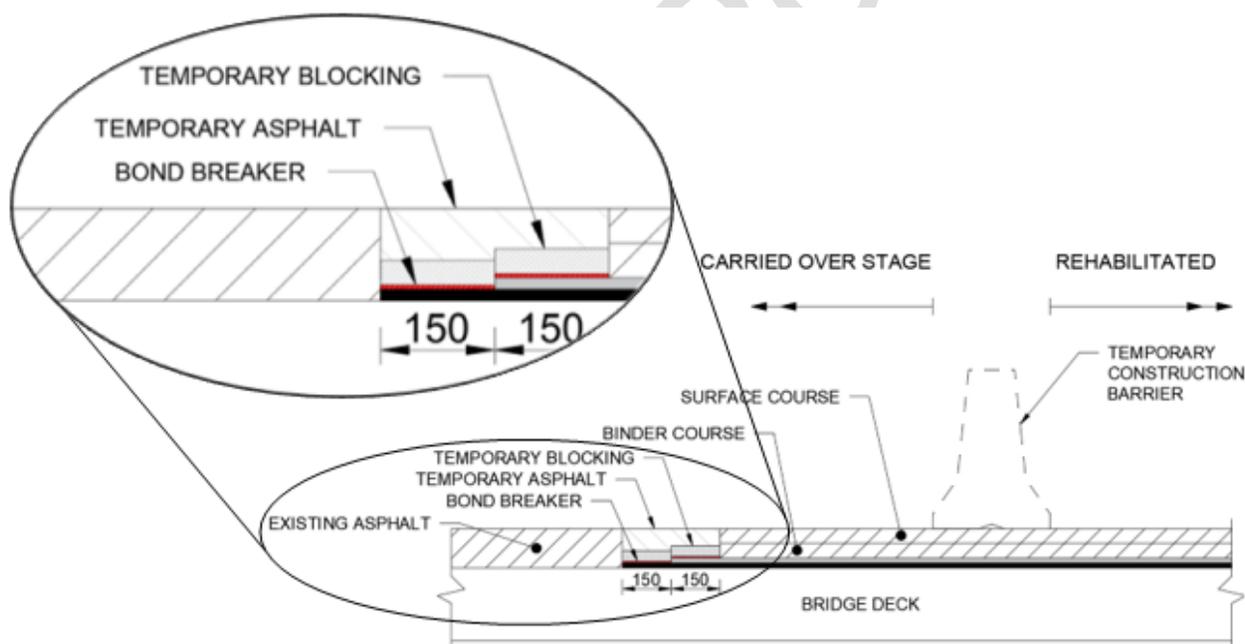
Figure 20 – Typical waterproofing longitudinal joint detail for carryover construction.

For carryover construction, the waterproofing membrane and protection board laps are typically protected by a layer of bond breaker with blocking and are temporarily paved over during winter shutdown (refer to [Figure 20](#)).

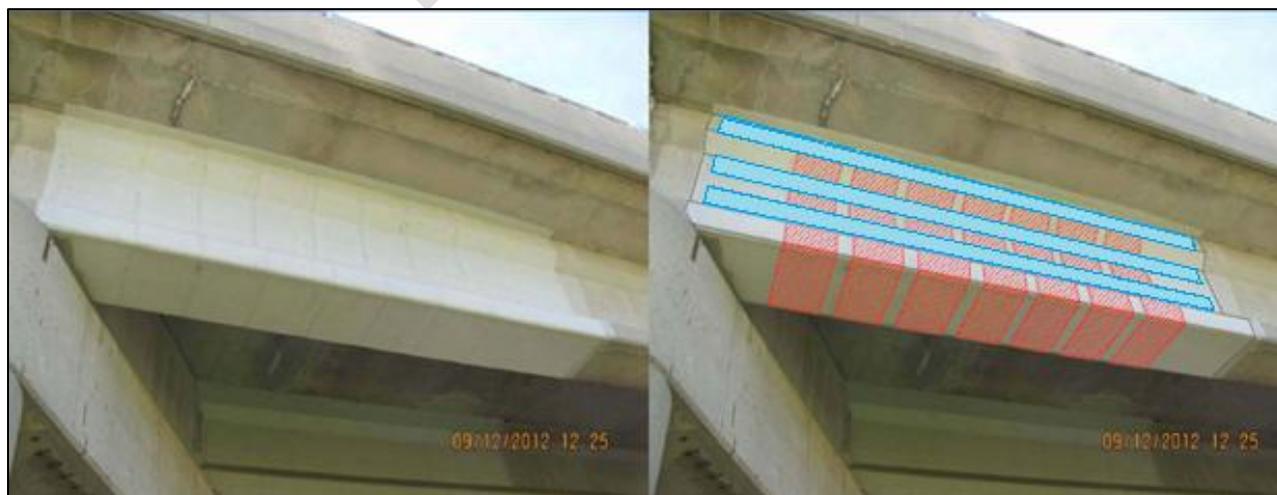
**Picture 30 – Shear strengthening using FRP.**

Shear strengthening using FRP typically involves externally bonding FRP strips to the deficient member. This method has been used to strengthen shear-deficient girders on Ministry projects. The FRP strips act as additional external stirrups. While it is most desirable to fully wrap around an entire cross-section (like a closed stirrup), it is not practical where the deck is integral with the girders. Instead, the FRP strips are generally U-shaped, and anchored in the compression zone with additional horizontal strips, refer to [Picture 30](#). *CSA S6 CHBDC* provisions for calculating FRP shear resistance are developed for beams with rectangular or T-sections. For components with other cross-sections, a more rigorous analysis is required. Fibre direction and installation sequence of FRP layers shall be clearly indicated on the drawings.

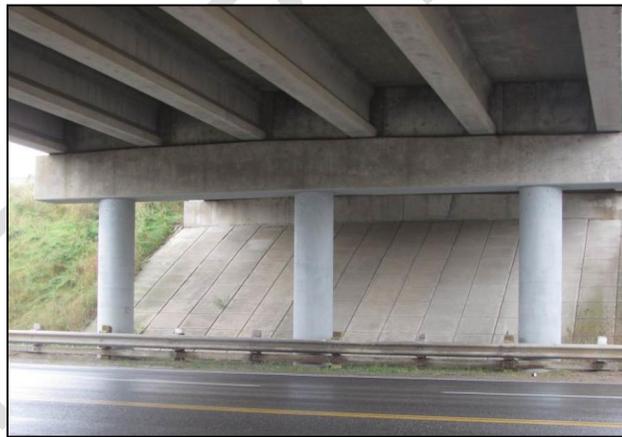
**Picture 31 – Columns wrapped with FRP.**

Wrapped pier columns are shown in [Picture 31](#). Wraps should extend the full height of the columns. For durability improvements it is not necessary to wrap a column whenever it is patched but it can be considered for columns at risk of macro cell corrosion with extensive patching, and where aesthetics is more critical. All columns within a support group should be wrapped together for consistent appearance and protection.

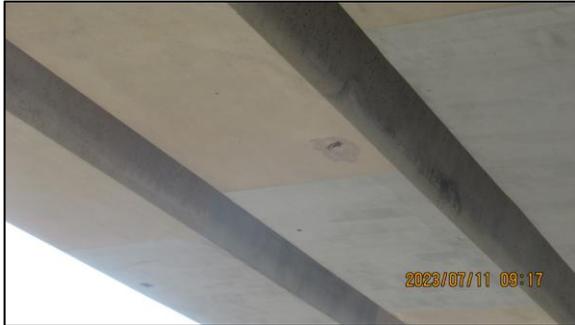
**Picture 32 – Patches on bottom flanges of concrete trapezoidal box girders wrapped with FRP.**

shallow patches while achieving a uniform surface that blends with the existing soffit. [Picture 32](#) shows patches on the bottom flanges of concrete trapezoidal box girders that are wrapped with FRP. Similarly, FRP used to wrap girder end patches is shown in [Picture 33](#).

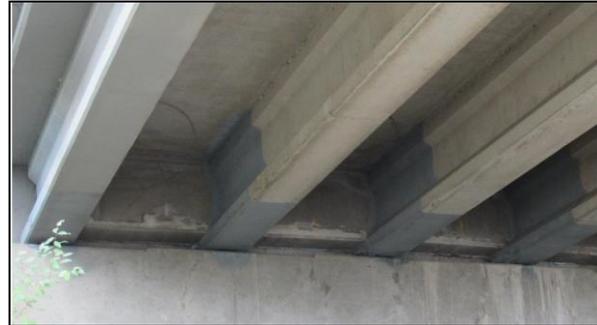
**Picture 33 – Girder ends wrapped with FRP.**

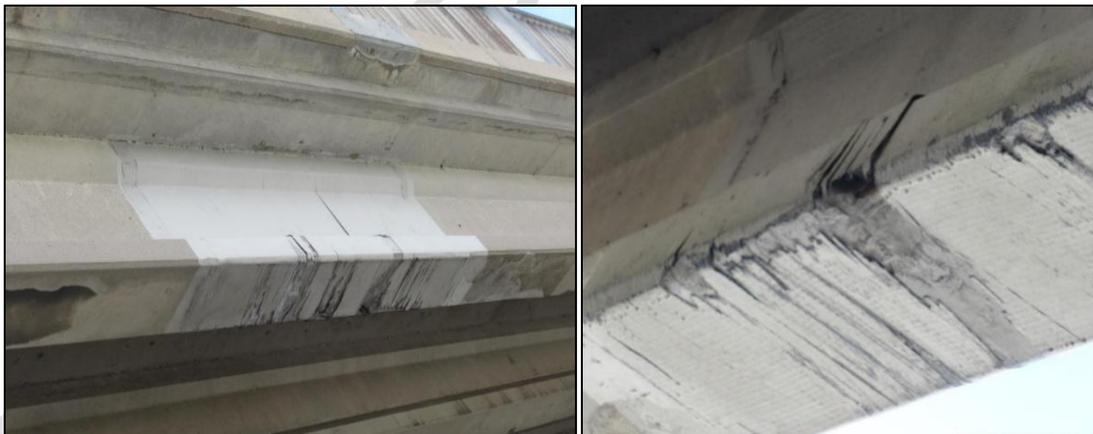
**Picture 34 – Damaged FRP wrap from subsequent load strike.**

In some cases, FRP has been used to wrap patches that were initially damaged by an over height vehicle/load strike. If a structure has low clearance and a history of load strikes, wrapping the impacted areas with FRP should be avoided. The wrap is likely to be damaged again, as illustrated in [Picture 34](#), and there are limited options to repairing them.

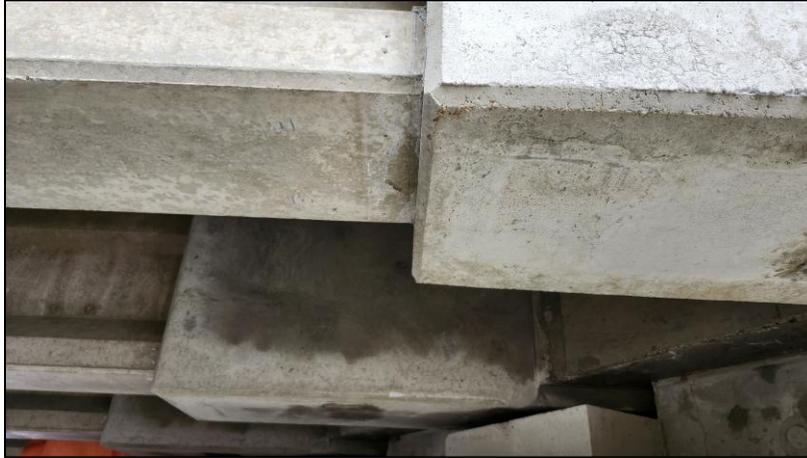
**Picture 35 – Encapsulated prestressed girder ends.**

Alternatively, bulk encapsulation of the deteriorated girder ends provide additional confinement to the girder ends and simplifies the concrete placement operation and shown in [Picture 35](#).

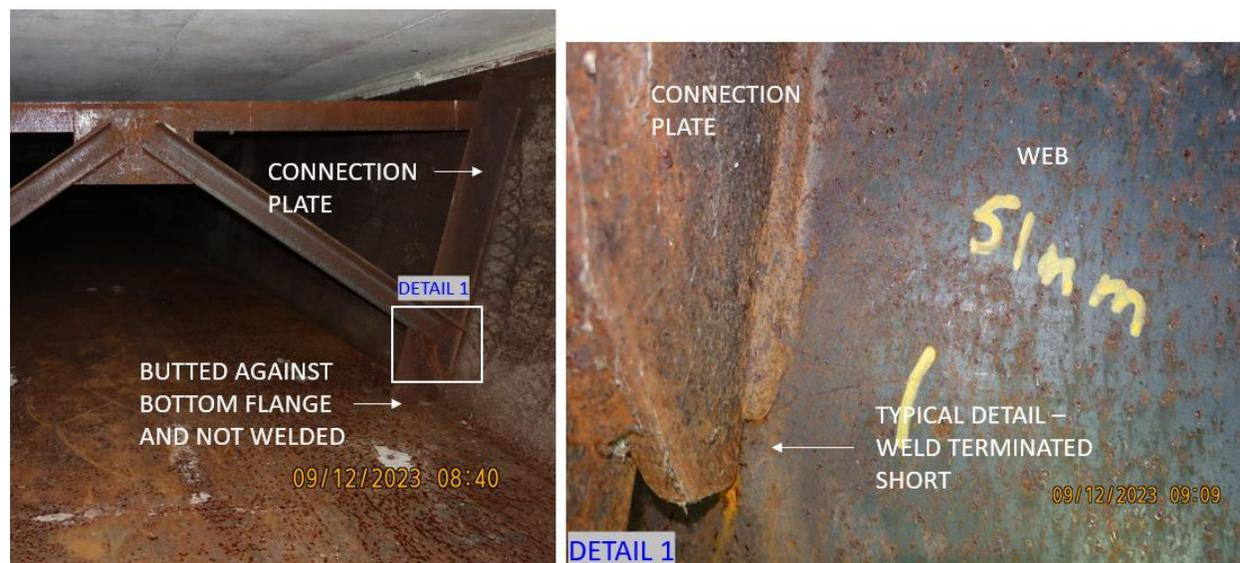
**Picture 36 – Typical internal bracing connection detail of box girder bridges constructed prior to 1990.**

For bridges constructed prior to the 1990s, it was common practice to cut the vertical stiffener short, leaving a 20 to 50 mm gap between the end of the stiffener and the flange. Often, the fillet welds attaching the stiffener to the web were also terminated short of the stiffener end, resulting in an even larger gap, as shown in [Picture 36 \(Detail 1\)](#).

If lateral movement of the top flange relative to the bottom flange takes place, large strains are imposed in the gap region because of the significant change in stiffness between regions of the web. Because of this, this phenomenon is sometimes described as ‘web gap distortion’. Distortion-induced fatigue is especially prevalent on bridges designed prior to the 1990s.

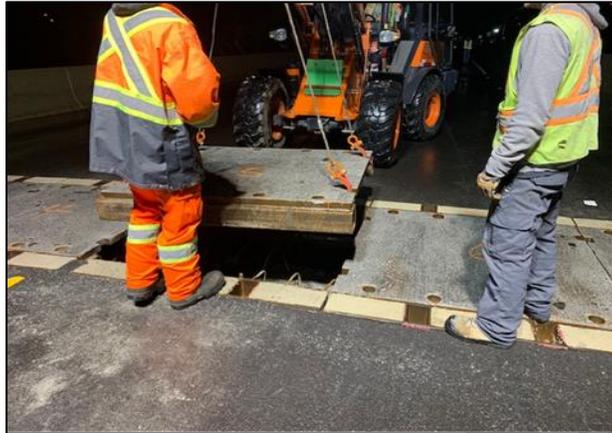
**Picture 37 – Removing bridging plate to access the expansion joint during a nightly closure.**

Temporary removable steel plates are installed spanning over the existing joint with temporary asphalt ramp on each side, allowing traffic to drive over them safely. When lanes are closed, the panels can be removed quickly, providing the contractor with access to the joint to complete the work, [Picture 37](#).

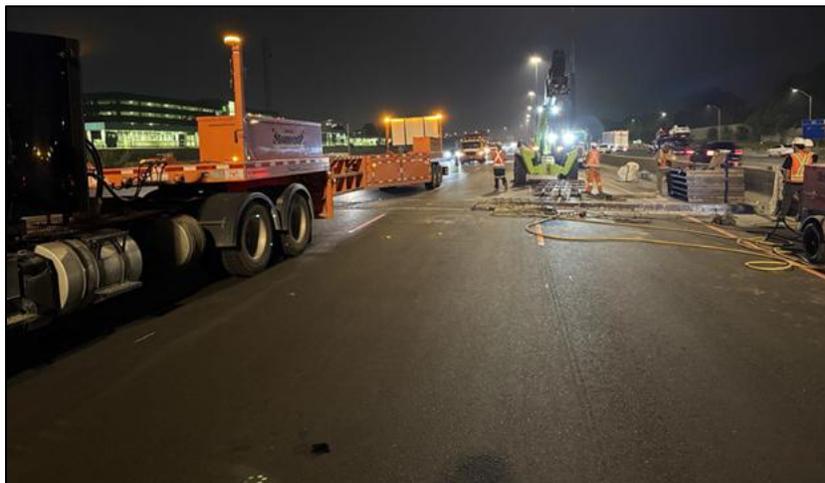
**Picture 38 – Nightly closure using mobile barrier.**

To maximize the limited working window, designers must consider alternatives to traditional temporary construction barriers, which require significant time to install and remove. Solutions such as quick-change moveable barriers or truck-mounted mobile barriers ([Picture 38](#)) can improve efficiency, but each has constraints that must be weighed early in design. Quick-change “zipper” barriers allow rapid lane reconfiguration but have high mobilization costs. Mobile barrier systems provide fast set up, but their limited availability and fixed lengths may necessitate staging the work in smaller segments. These factors must be evaluated early in the design process to ensure the selected traffic protection strategy aligns with project constraints and operational windows.
