PART 2 – DETAILED VISUAL INSPECTION

2.5.4.5 Delamination

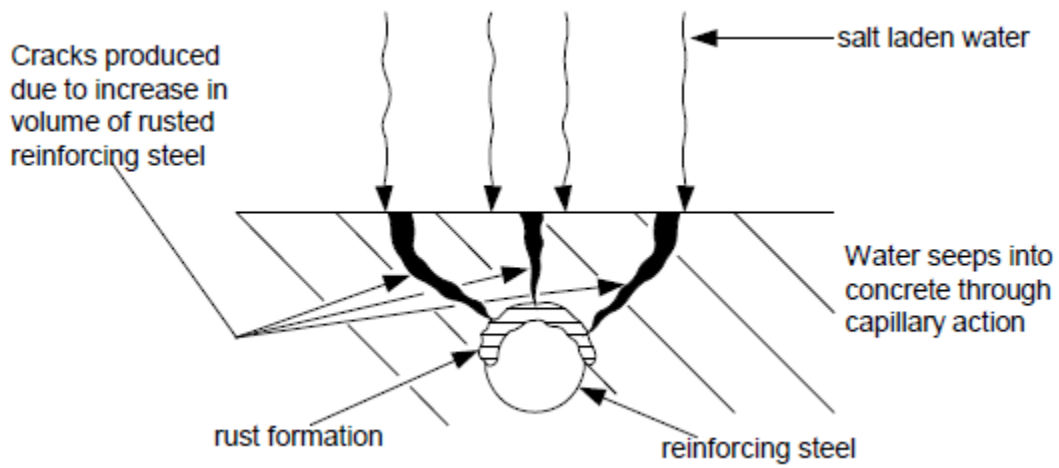
Figure 2.5.4.4 Process Leading to Corrosion of Reinforcement

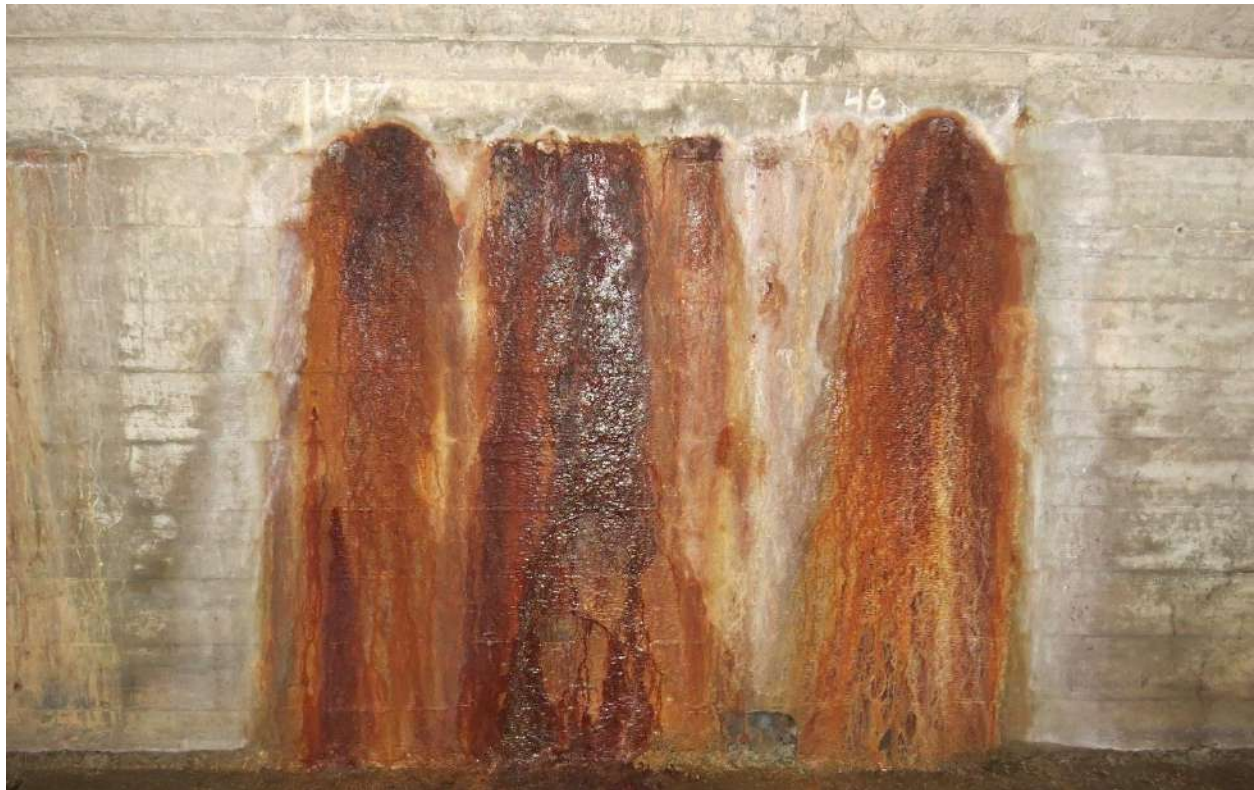
Figure 2.5.4.5 Stains on Concrete Surface Indicating Corrosion of Reinforcement

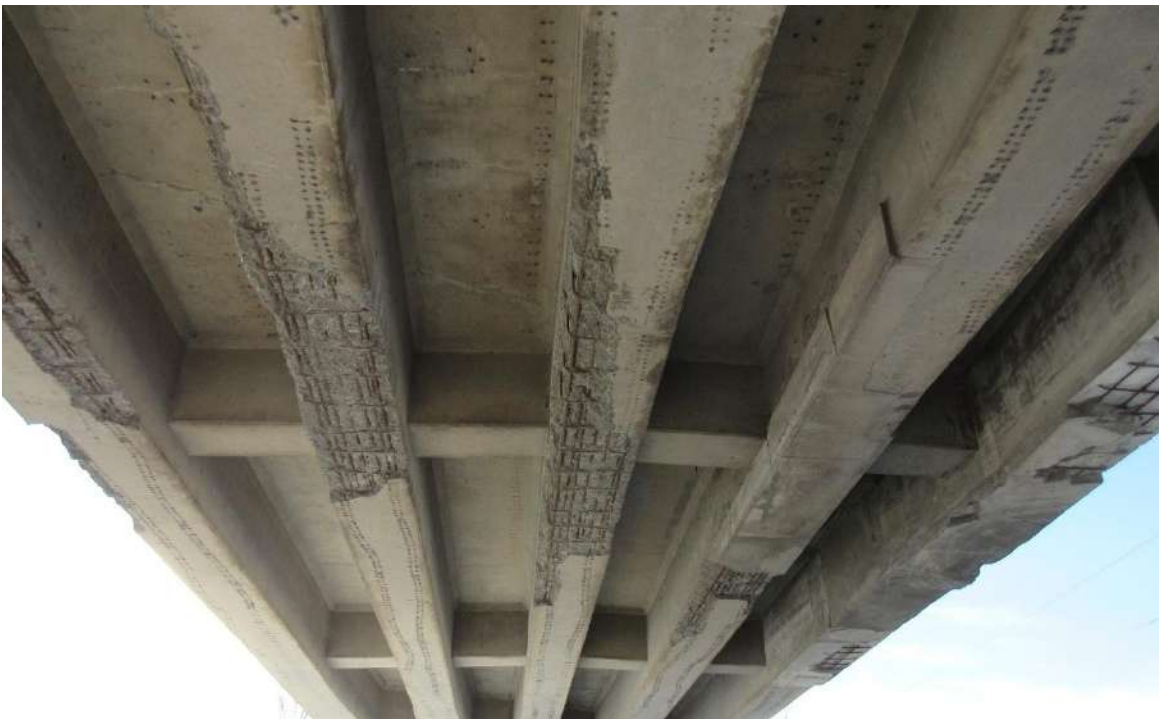
Delamination is defined as a discontinuity of the surface concrete which is substantially separated but not completely detached from concrete below or above it. Visibly, it may appear as a solid surface but can be identified as a hollow sound by tapping or chain dragging. Delamination begins with the corrosion of reinforcement and subsequent cracking of the concrete. However, in the case of closely spaced bars, the cracking extends in the plane of the reinforcement parallel to the exterior surface of the concrete. Delaminations in concrete beams is shown in Figure 2.5.4.6.

Figure 2.5.4.6 Severe Spalling and Delamination in Concrete Beams

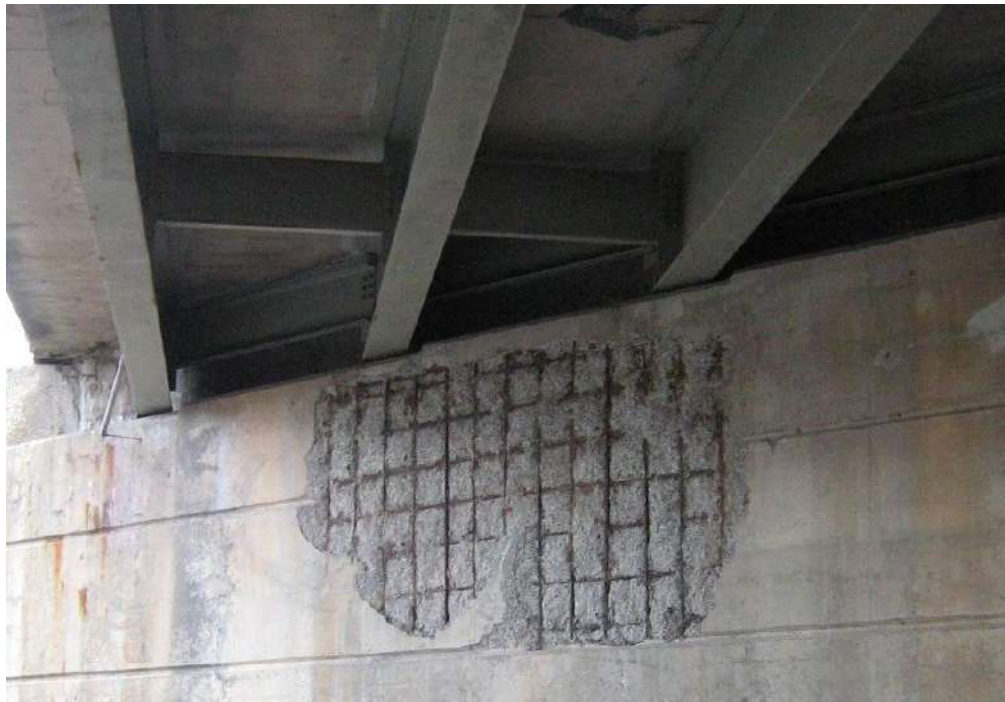
characterized by sharp edges. Severe spalling in an abutment and local severe spalling in a concrete soffit are illustrated in Figure 2.5.4.7 and Figure 2.5.4.8 respectively.

Figure 2.5.4.7 Severe Spalling in Concrete Due to Corrosion of Reinforcement

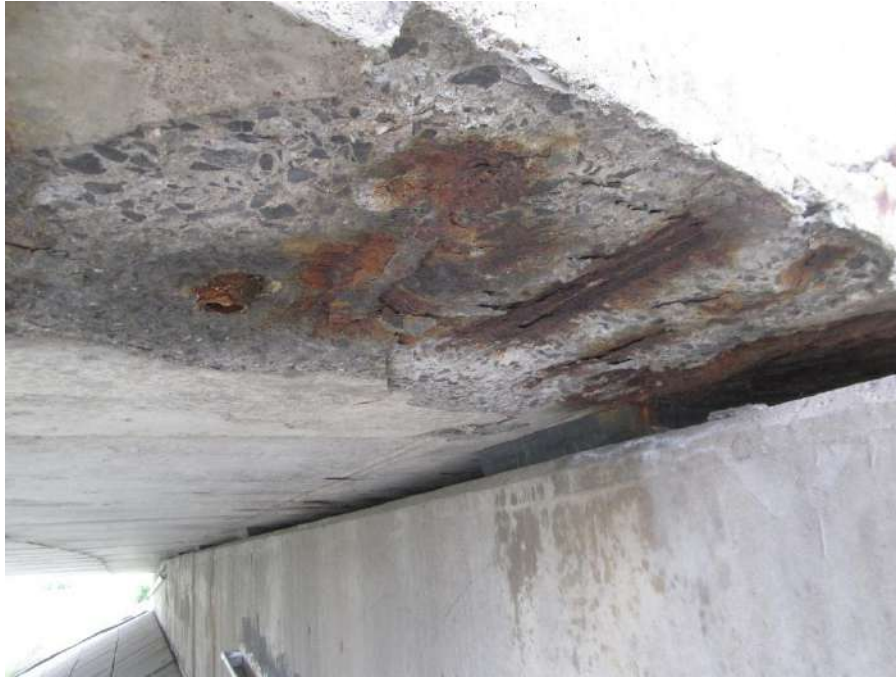
Figure 2.5.4.8 Severe Local Spalling

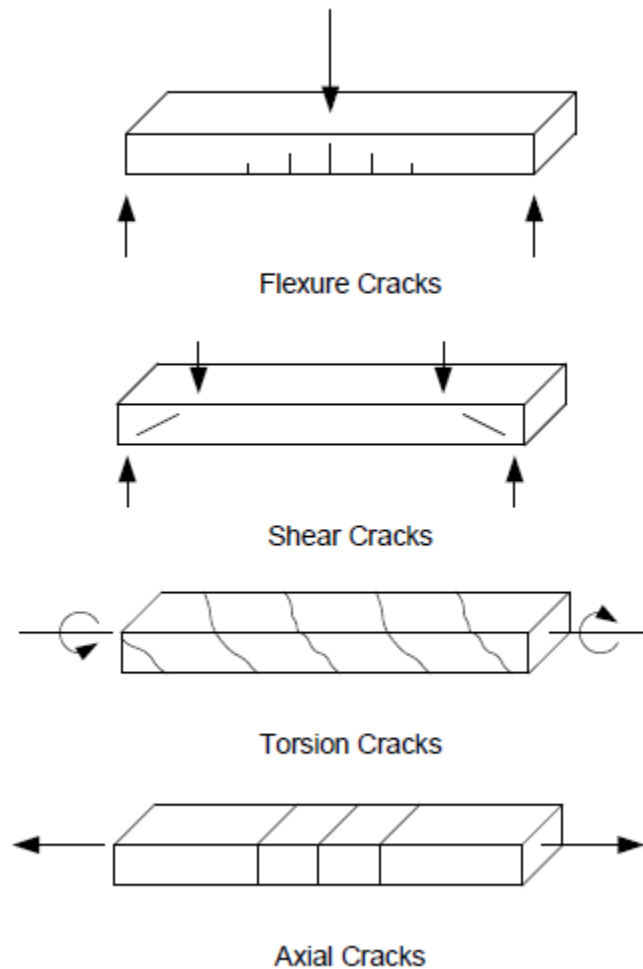
The build-up of tensile stresses and, therefore, cracks in concrete may be due to externally applied loads, external restraint forces, internal restraint forces, differential movements and settlements, or corrosion of reinforcement. Externally applied loads generate a system(s) of internal compressive and tensile stresses, in the members and components of the structure, as required to maintain static equilibrium. Cracks resulting from externally applied loads initially appear as hairline cracks and are harmless. However, as the reinforcement is further stressed the initial cracks open up and progressively spread into numerous wider cracks. Figure 2.5.4.9 shows typical flexure, shear, axial and torsional cracks due to applied external load.

Figure 2.5.4.9 Applied Loading Cracks

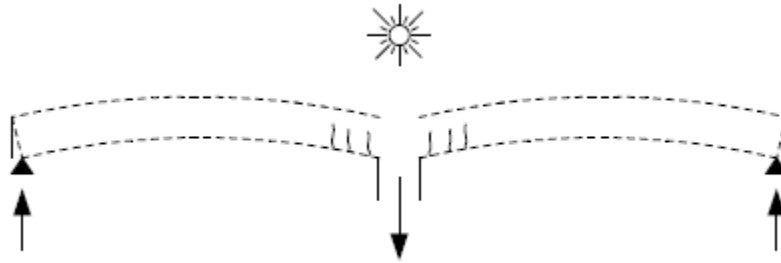
External restraint forces are generated if the free movement of the concrete in response to the effects of temperature, creep and shrinkage is prevented from occurring due to restraint at the member supports. The restraint may consist of friction at the bearings, bonding to already hardened concrete, or by attachment to other components of the structure. Cracks resulting from the actions of external restraint forces develop in a similar manner as those due to externally applied loads. Figure 2.5.4.10 shows restraint induced cracking due to an increase in temperature of the top surface of a beam.

Figure 2.5.4.10 External Resistant Induced Cracks (due to temperature increase in top surface of beam)

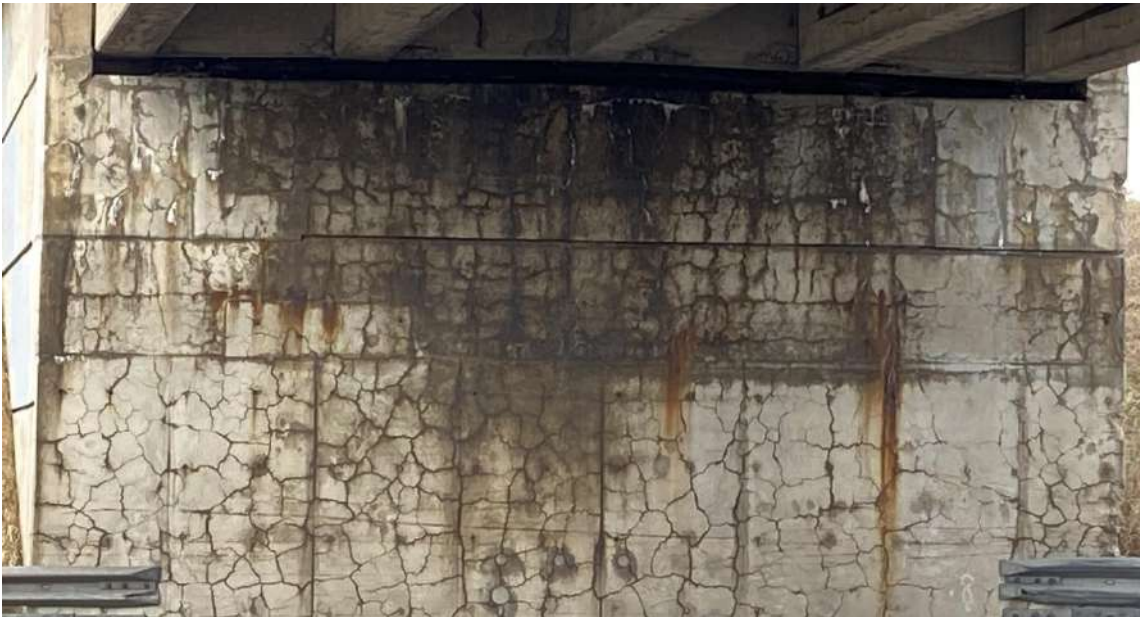
Internal restraint forces are caused by the differential expansion or contraction of the exterior surface of concrete relative to the interior mass of the concrete, as in plastic shrinkage. The resulting surface cracks are normally shallow and appear as pattern cracks, checking and D-cracks. Figure 2.5.4.11 shows pattern cracking in an abutment wall.

Figure 2.5.4.11 Pattern Cracks in Abutment

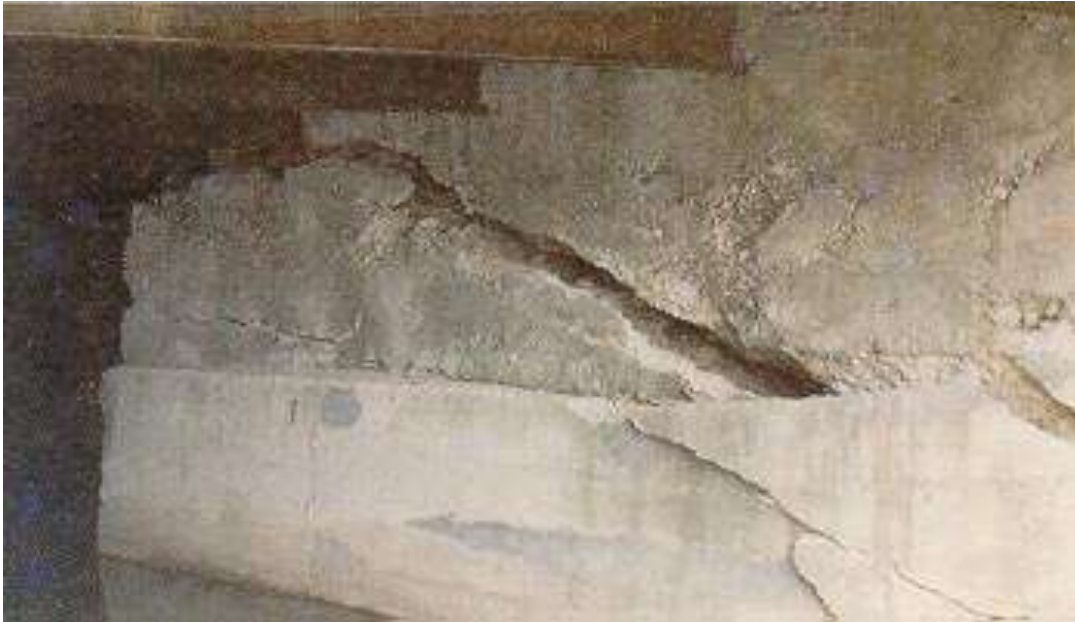
stresses and, therefore, cracking in the concrete components of the structure. Movement cracks may be of any orientation and width, ranging from fine cracks above the reinforcement due to formwork settlement, to wide cracks due to foundation or support settlement. Figure 2.5.4.12 shows a very wide movement or settlement crack in an abutment.

Figure 2.5.4.12 Very Wide Movement Crack in an Abutment

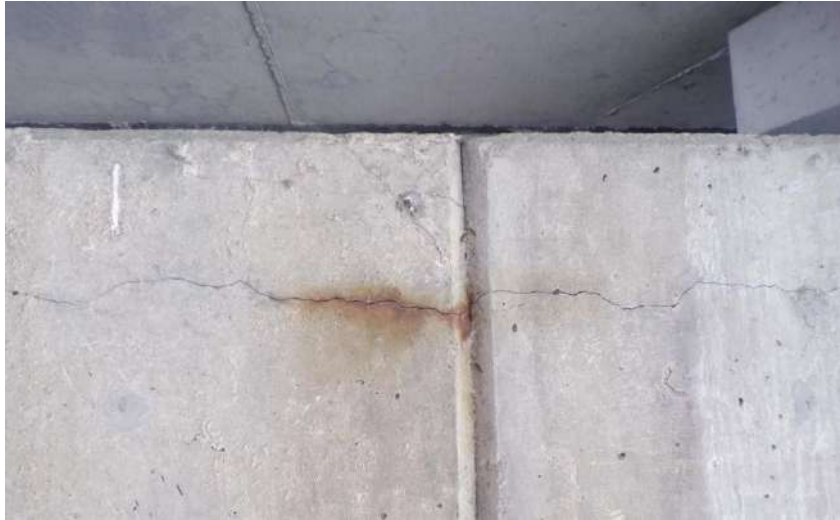
Corrosion of reinforcement produces cracks as described in Section 2.5.4.4. Corrosion related cracks are shown in Figure 2.5.4.13.

Figure 2.5.4.13 Medium Crack due to Corrosion of Reinforcement

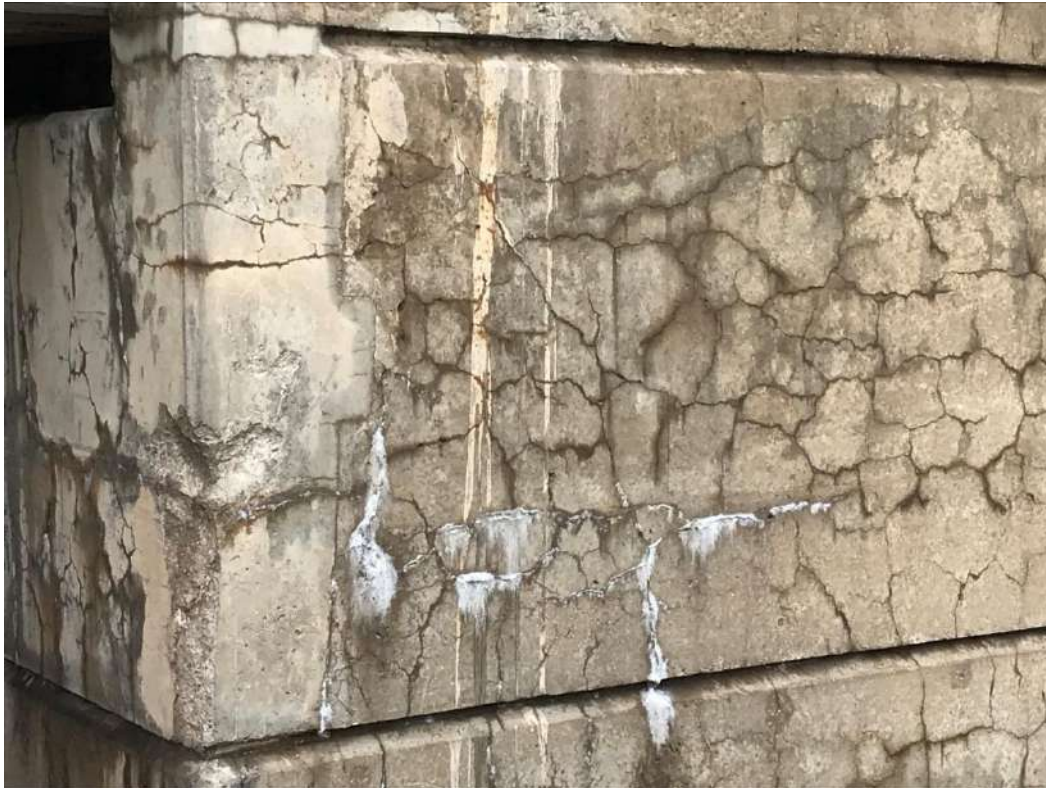
The two general types of reactions in Ontario are alkali-carbonate and alkali-silica reaction. The expansion of the gel and aggregates occurs due to hydroxyl ions in the concrete pore solution, which under moist conditions, leads to cracking and deterioration of the concrete. Normally, higher alkali content of the cement and higher cement content of the concrete will lead to a higher rate of expansion and cracking. The cracking occurs through the entire mass of the concrete (Reference 1). Alkali-aggregate reactions are generally slow by nature, especially at the start, and the results may not be apparent for many years. Once the alkali-aggregate reaction starts, there are no remedial measures to stop or reverse the process of deterioration; however, sealing the surface to reduce the moisture infiltration does slow down the reaction. The appearance of concrete affected by alkali-aggregate reactions is shown in Figure 2.5.4.14.

In all cases, ASR is typically identified by randomly oriented map cracking in elements that are unrestrained in all direction. When restrained in one or more direction due to internal confinement or reinforcing, expansion occurs in the direction of least restraint. In the case of reinforced concrete columns, cracks tend to align vertically. (FHWA, 2011). In precast girders cracks typically align horizontally along the length of the girder.

Figure 2.5.4.14 Severe Alkali-Aggregate Reaction

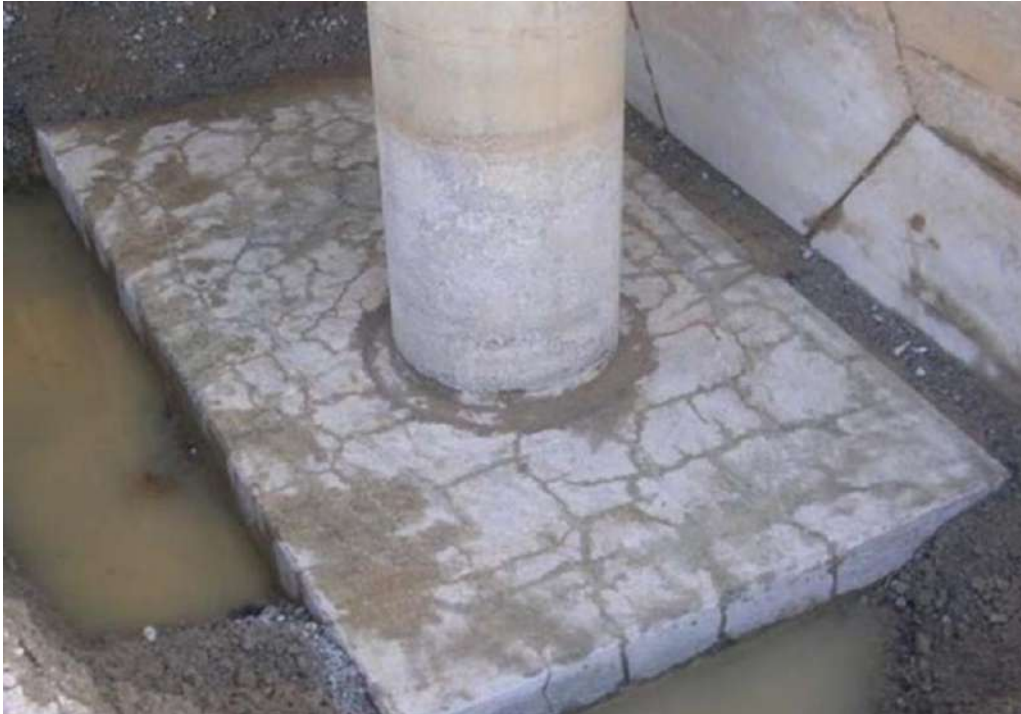
The appearance of concrete affected by DEF can be found in Figure 2.5.4.15.

Figure 2.5.4.15 DEF Pattern Cracks in Pier Footing

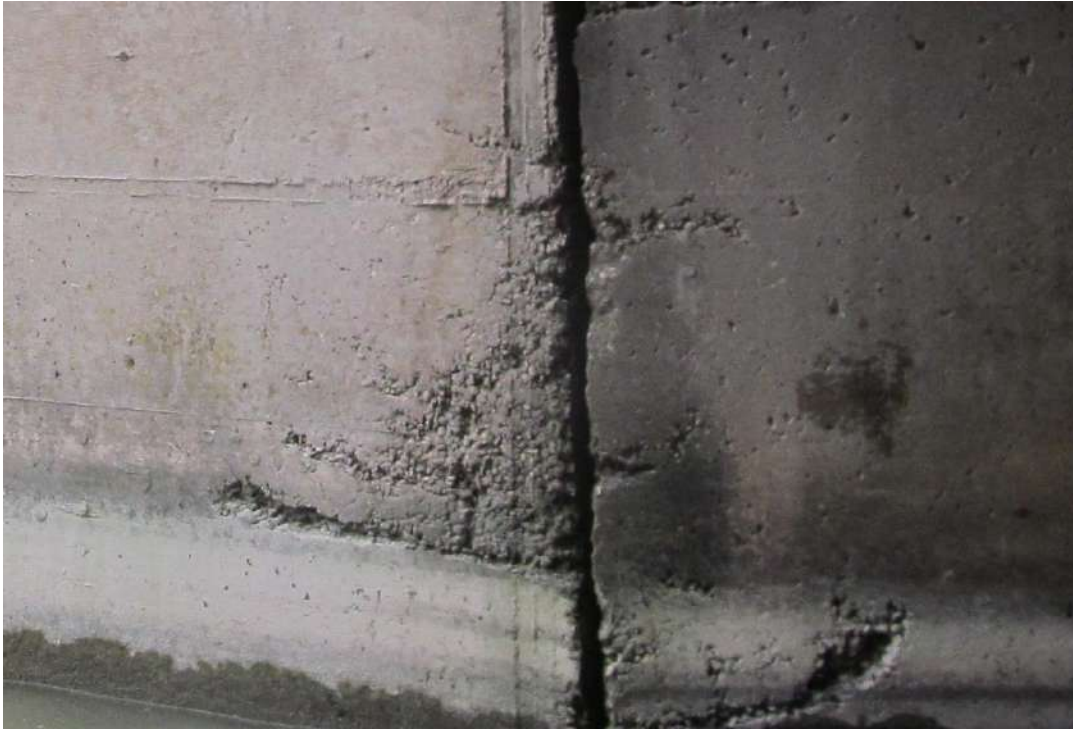
HONEYCOMBING is produced due to the improper or incomplete vibration of the concrete which results in voids being left in the concrete where the matrix failed to completely fill the spaces between the coarse aggregate particles. Figure 2.5.4.16 shows medium honeycombing on the corner between an abutment and wingwall.

Figure 2.5.4.16 Severe Honeycombing on an Abutment and Wingwall

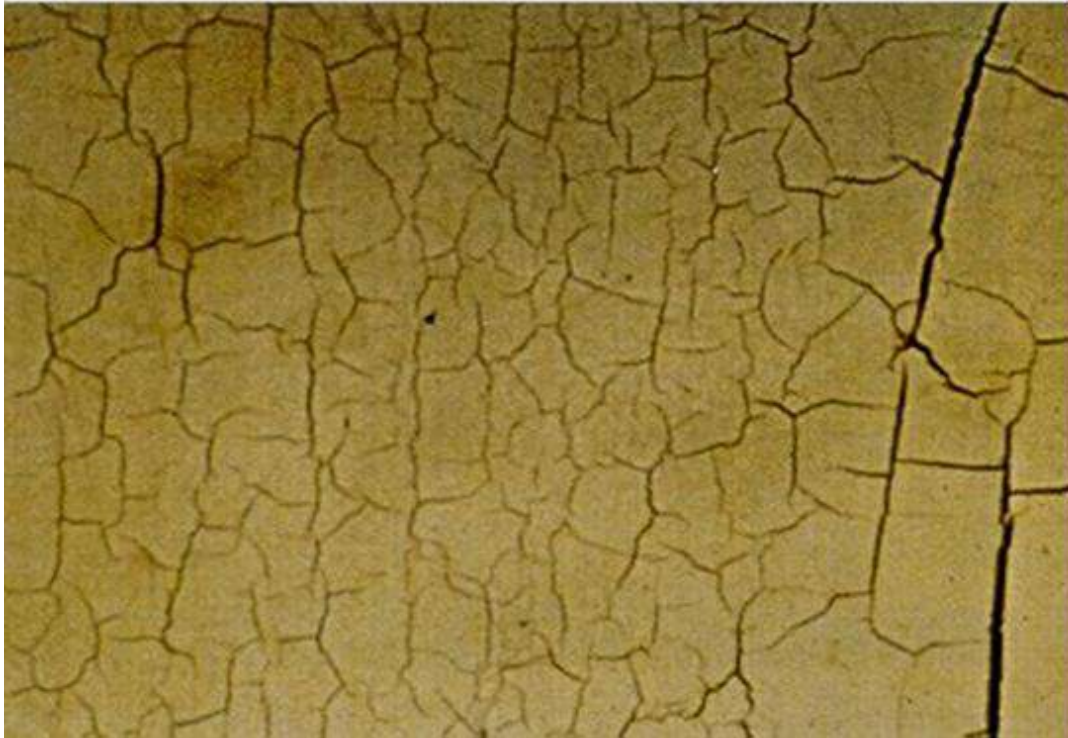
CHECKING or CRAZING usually appears as a fine system of minute cracks in a checkerboard pattern. This is a surface defect and does not necessarily penetrate the full depth of the coating. They are usually inherent in the coating as some pigments combined with some vehicles will tend to cause checking or crazing to occur. They may also be caused by the weathering process, including wetting and drying, heating and cooling, exposure to sunlight and contraction of the coating as it dries or cures Figure 2.5.5.1.

Figure 2.5.5.1 Checking

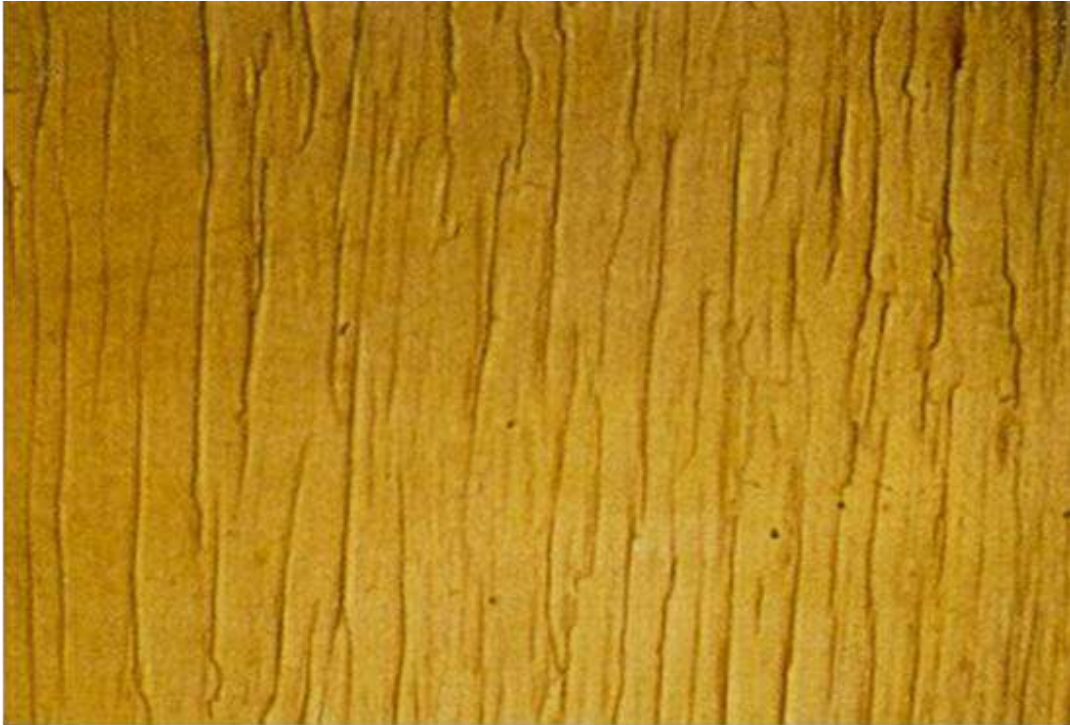
CRACKING may result from the effects of weathering or continued polymerisation of the coating materials over time. An oxidizing or catalyzed coating applied over a very smooth surface may crack due to shrinkage and poor adhesion to the substrate. Cracking is an extension of the checking process and usually occurs in a linear pattern and penetrates completely through the coating, Figure 2.5.5.2. The cracked coating tends to spall off exposing bare substrate.

Figure 2.5.5.2 Cracking

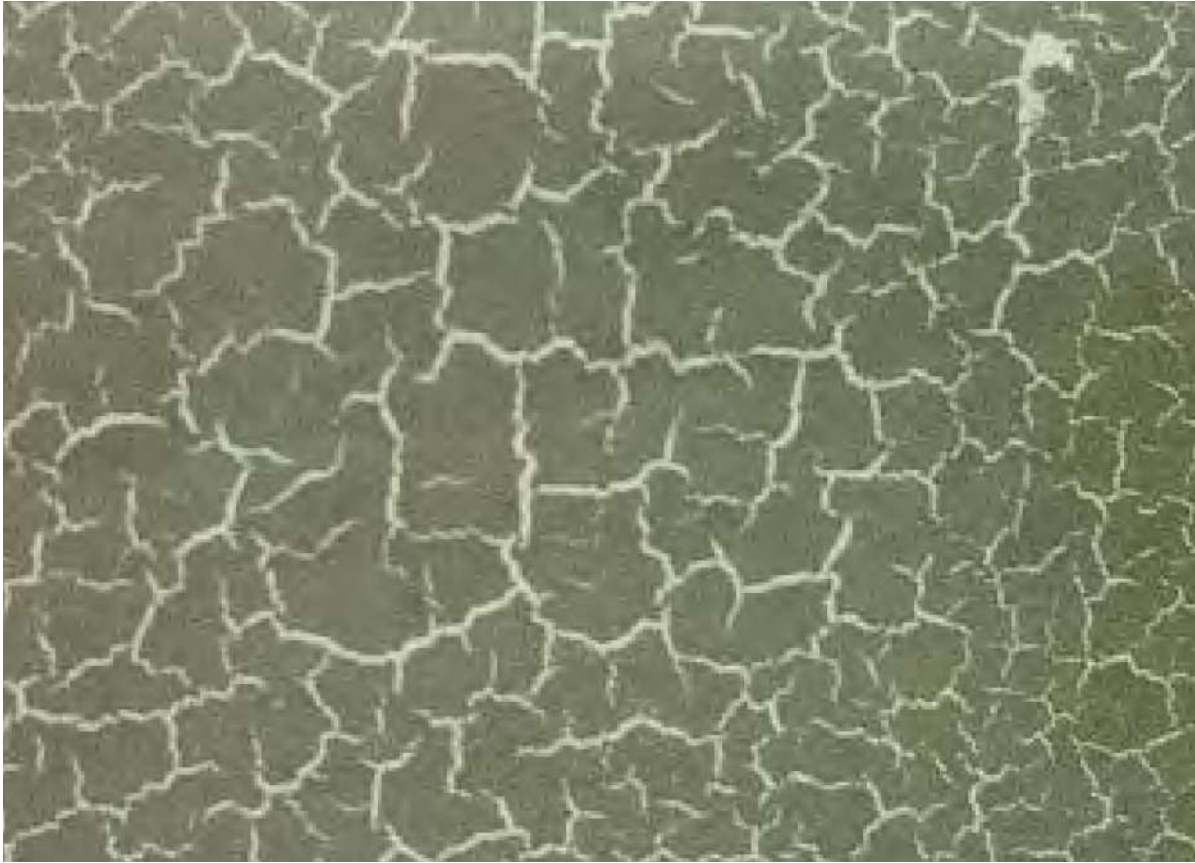
ALLIGATORING occurs if a hard, brittle or oxidizing top coat is applied over an extensible base coat, such as an alkyd over an asphalt base. As the surface hardens and shrinks, very large irregular checks, usually several centimetres across, are formed on the surface in a characteristic alligator pattern but do not go all the way through the coating. If not over-coated with compatible material; then, the mechanism will continue until it completely penetrates to the substrate, Figure 2.5.5.3.

Figure 2.5.5.3 Alligatoring (Typical Mud Crack Pattern)

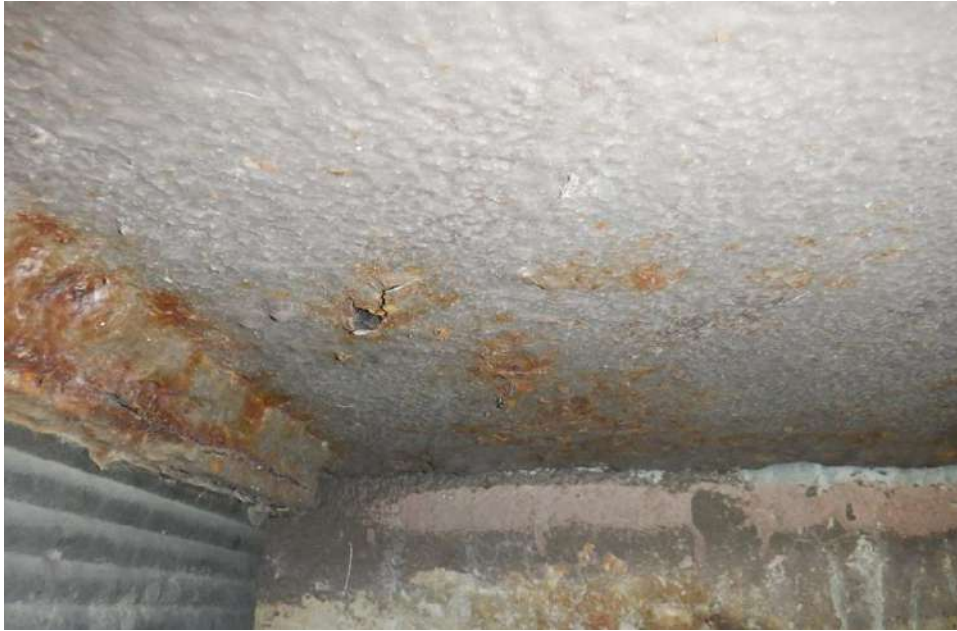
CHEMICAL ATTACK results as some coating materials may react adversely with some air-borne chemicals and pollutants, or as a result of accidental spillage. Oil base coatings such as alkyds are subject to damage by alkaline chemicals, Figure 2.5.5.4.

Figure 2.5.5.4 Chemical Attack

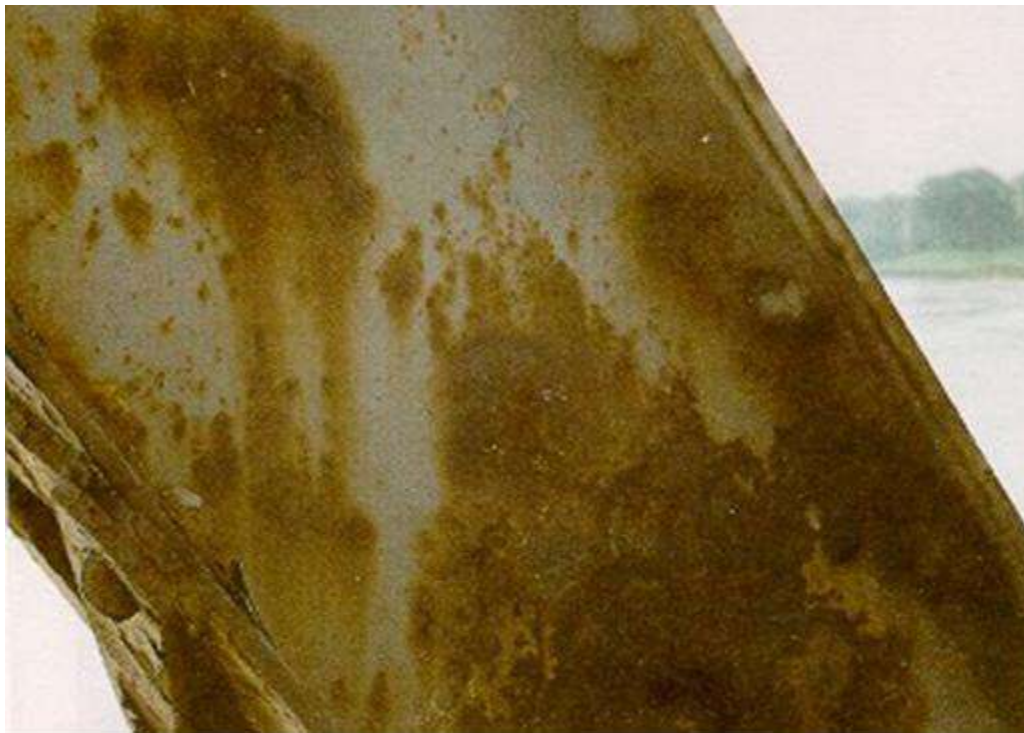
UNDERCUTTING is the spreading of corrosion underneath the coating from a break in the coating. It is usually caused by poor surface preparation and the application of the coating over surfaces which contain mill scale or rust; or which have oil, grease or dirt, and otherwise improperly cleaned surfaces. Undercutting can also be caused by application of the coating to surfaces that are very smooth or non-porous resulting in poor adhesion of the coating. Undercutting is also promoted by high moisture vapour permeability of the coating and penetration by oxygen and salts, Figure 2.5.5.5.

Figure 2.5.5.5 Undercutting

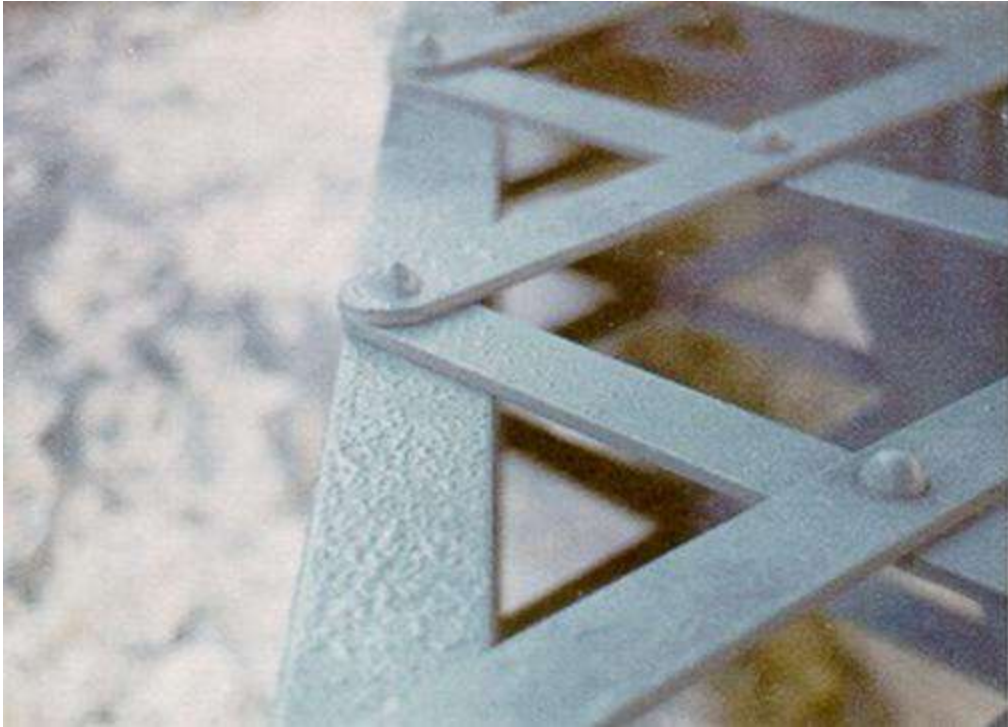
BLISTERS are dome shaped projections in paints arising from the detachment of one coat from another or from the substrate. It is generally caused either by solvents which are trapped within or under the paint film, or by water which is drawn through the paint film by the osmotic forces exerted by hygroscopic salts at the paint/substrate interface, Figure 2.5.5.6.

Figure 2.5.5.6 Blisters

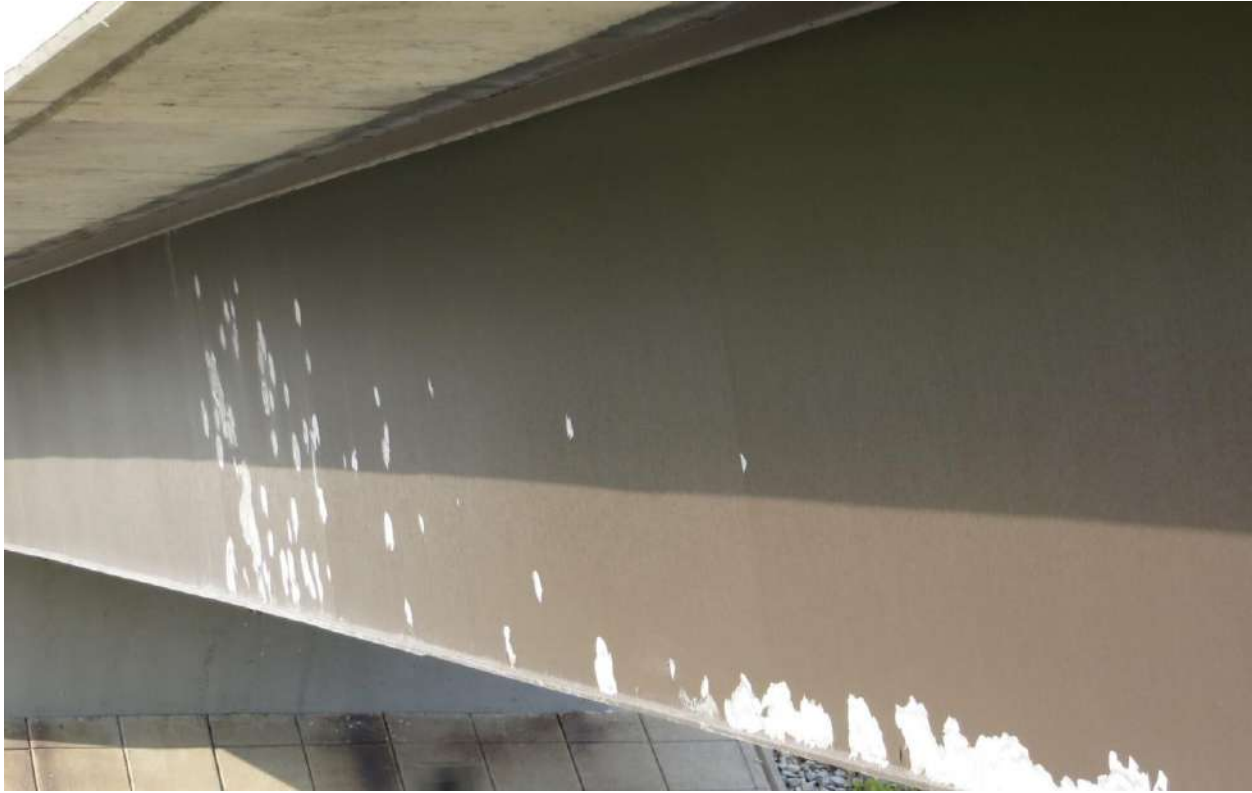
INTERCOAT DELAMINATION is where one coat separates from another and is usually related to poor coating application over contaminated surfaces or to too long a drying or curing period between coats, Figure 2.5.5.7.

Figure 2.5.5.7 Intercoat Delaminations

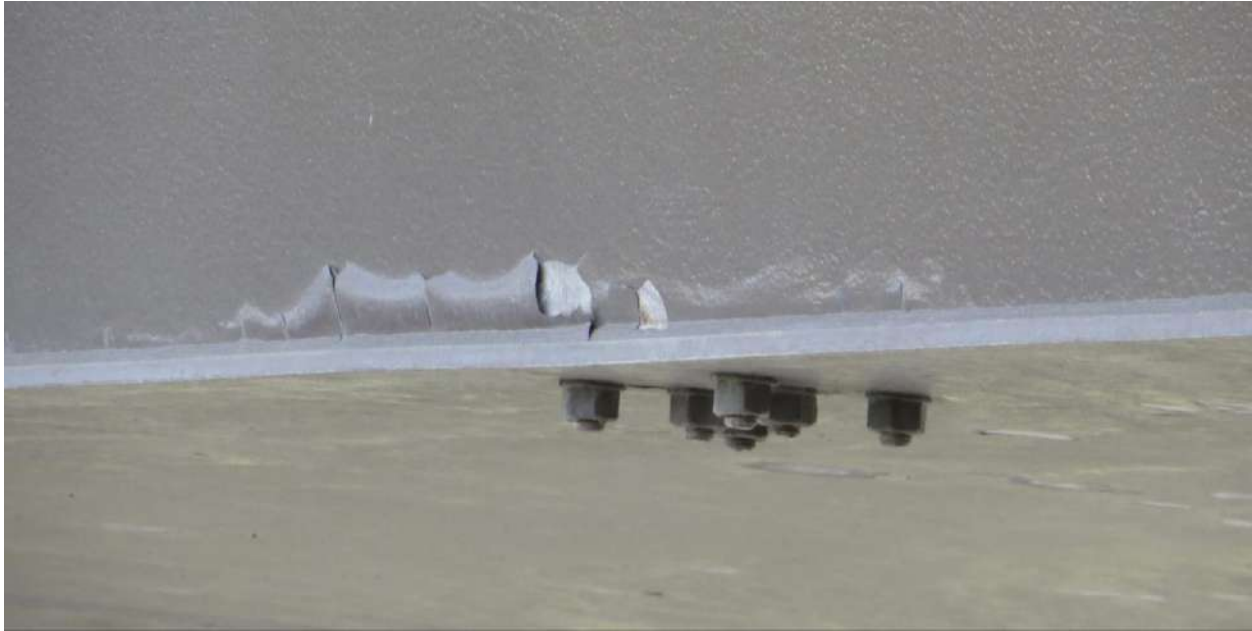
PEELING is also a result of poor adhesion of the coating either from the substrate or from a previously applied coating. It is related to the tensile strength of the coating film itself where, if the tensile strength of the film is greater than the adherence to the surface; then, the coating will tend to peel. Peeling between coats is usually caused by contamination of the surface of the previous coat, Figure 2.5.5.8.

Figure 2.5.5.8 Peeling

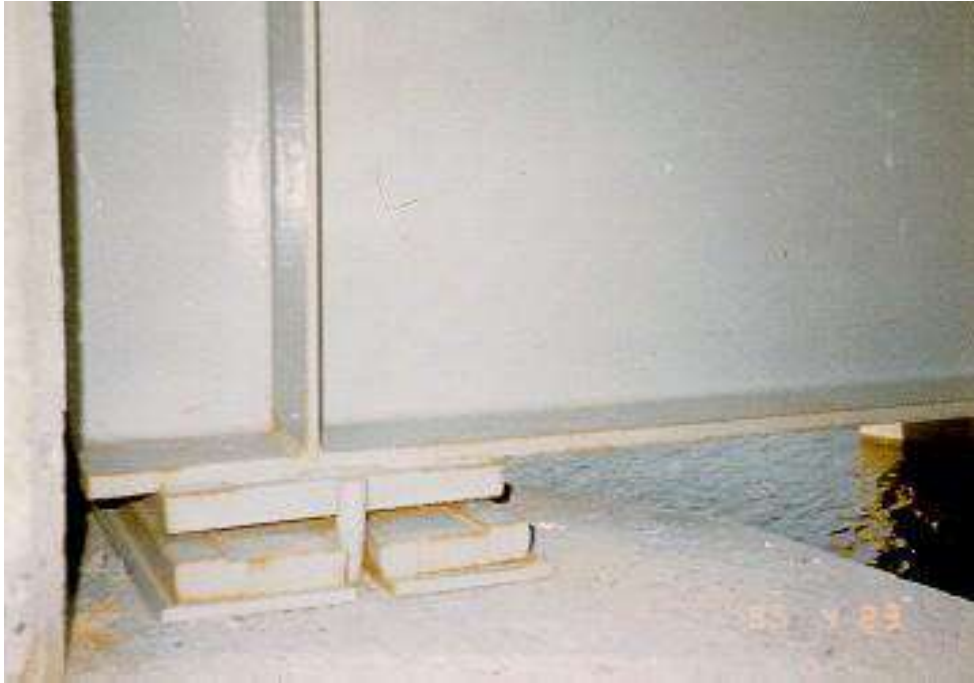
EDGE DEFECTS are a result of the improper or insufficient application of coatings to sharp edges and corners. The coating will tend to pull away from sharp edges and corners due to surface tension of the coating. This results in a thinner coating in these areas and, consequently, loss of film thickness and protection, Figure 2.5.5.9.

Figure 2.5.5.9 Edge Defects

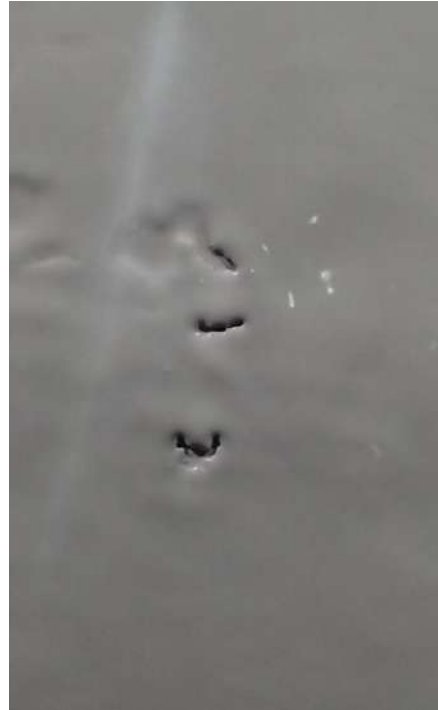
PINHOLING can be caused by holding the spray gun too close to the surface so that air bubbles are entrained into the coating creating voids throughout the depth of the coating. If pinholing occurs in one coat; then, it will also tend to occur in subsequent coats, thus providing a passage through the voids to the substrate. Pinholing usually occurs in fast drying coatings, Figure 2.5.5.10.

Figure 2.5.5.10 Pinholing
