PART 2 – DETAILED VISUAL INSPECTION

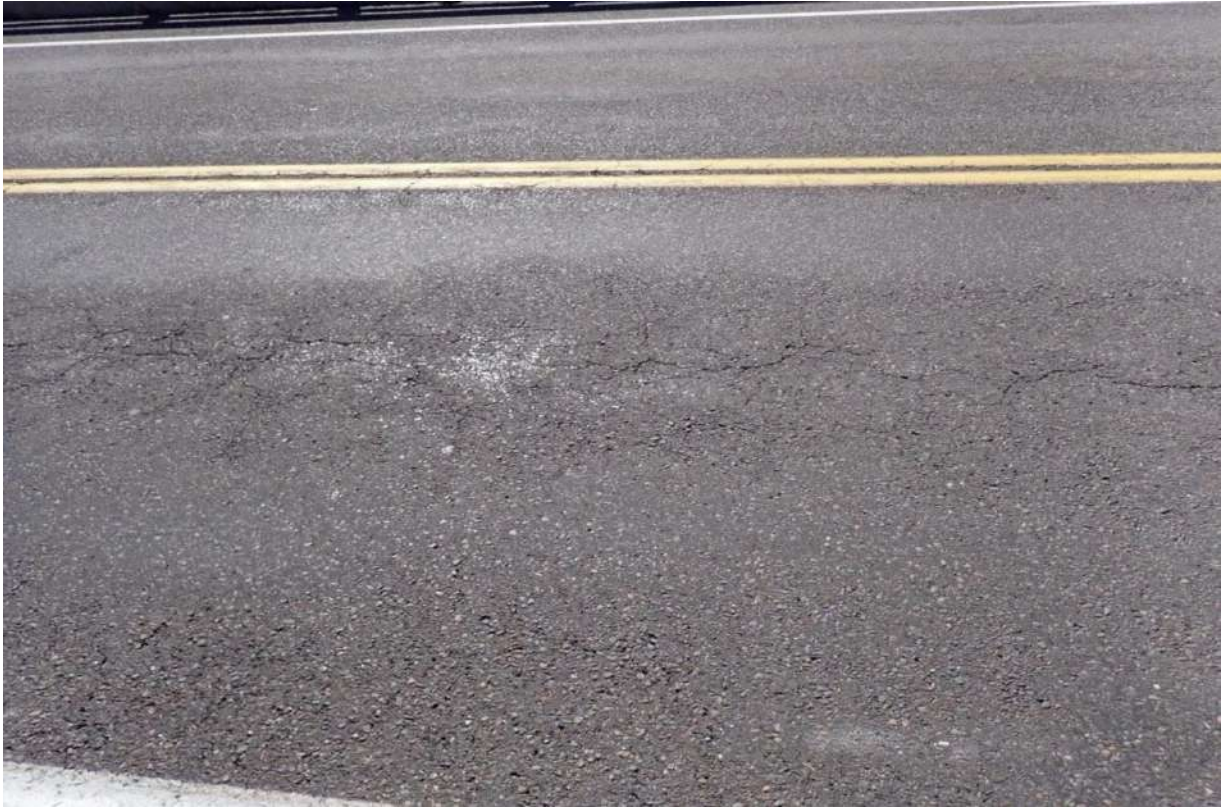
Figure 2.5.8.8 Light Ravelling

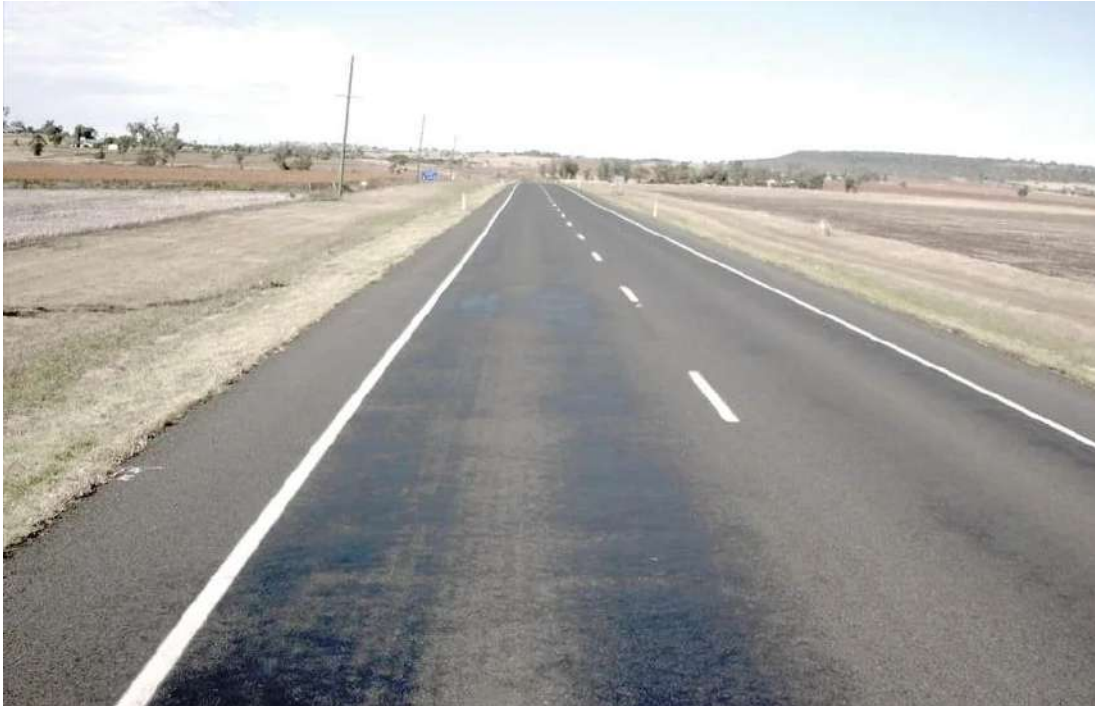
Flushing is the migration of asphalt cement upwards to the pavement surface in pavements with too much asphalt cement in the pavement. It commonly occurs in the wheel tracks, especially during hot weather, by the action of vehicle traffic pressing and squeezing the excess asphalt to the surface. Flushing of the surface of an asphalt pavement is illustrated in Figure 2.5.8.9.

Figure 2.5.8.9 Severe Flushing

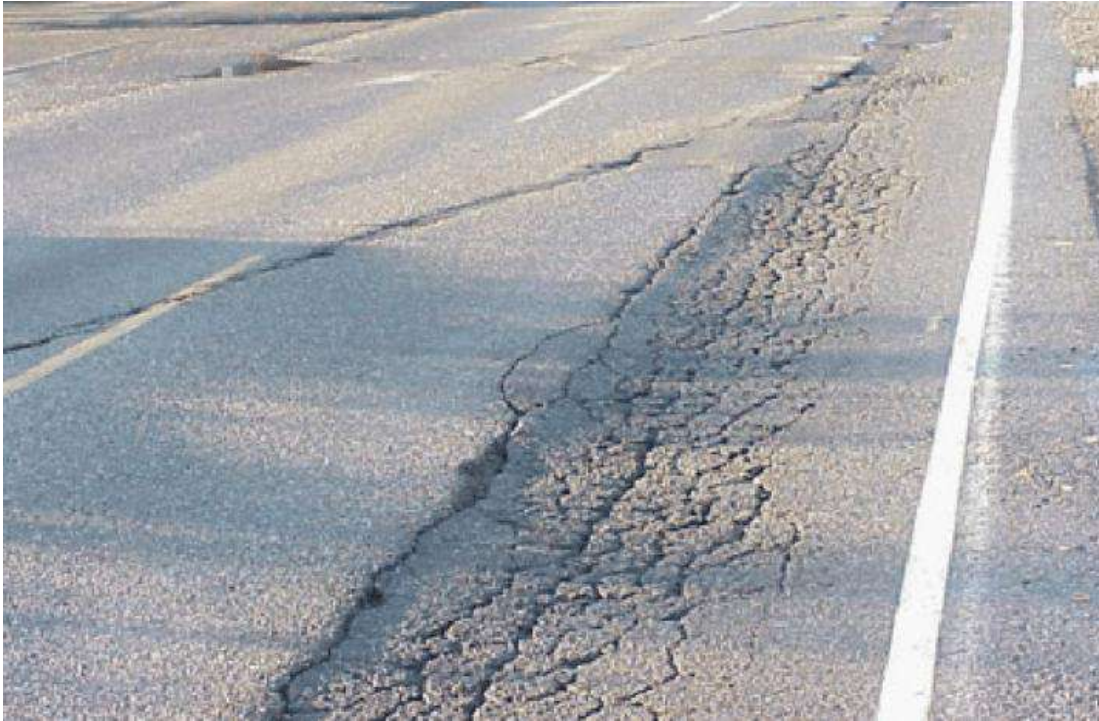
Wheel track rutting is the formation of longitudinal depressions in the pavement at the locations of the wheel tracks of vehicles resulting from the compaction and shoving of the pavement laterally under repeated vehicle traffic.

Wheel track rutting is illustrated in Figure 2.5.8.10.

Figure 2.5.8.10 Severe Wheel Track Rutting

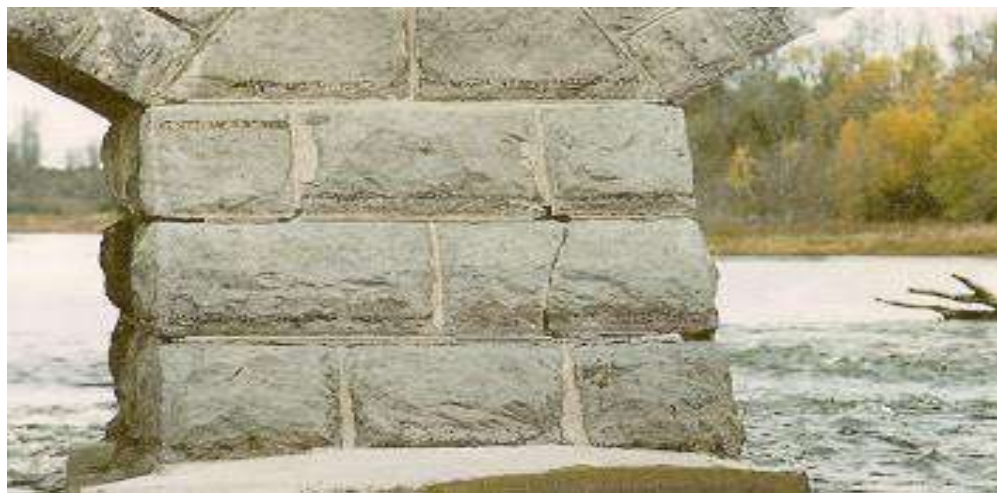
Cracks develop either at the interface between the stone and mortar, following a zig-zag pattern, when the bond between them is weak; or, go through the joint and stone, in a straight line, when the mortar is stronger than the stone, as shown in Figure 2.5.14.1.

Figure 2.5.14.1 Wide Crack Through the Stone in a Masonry Pier

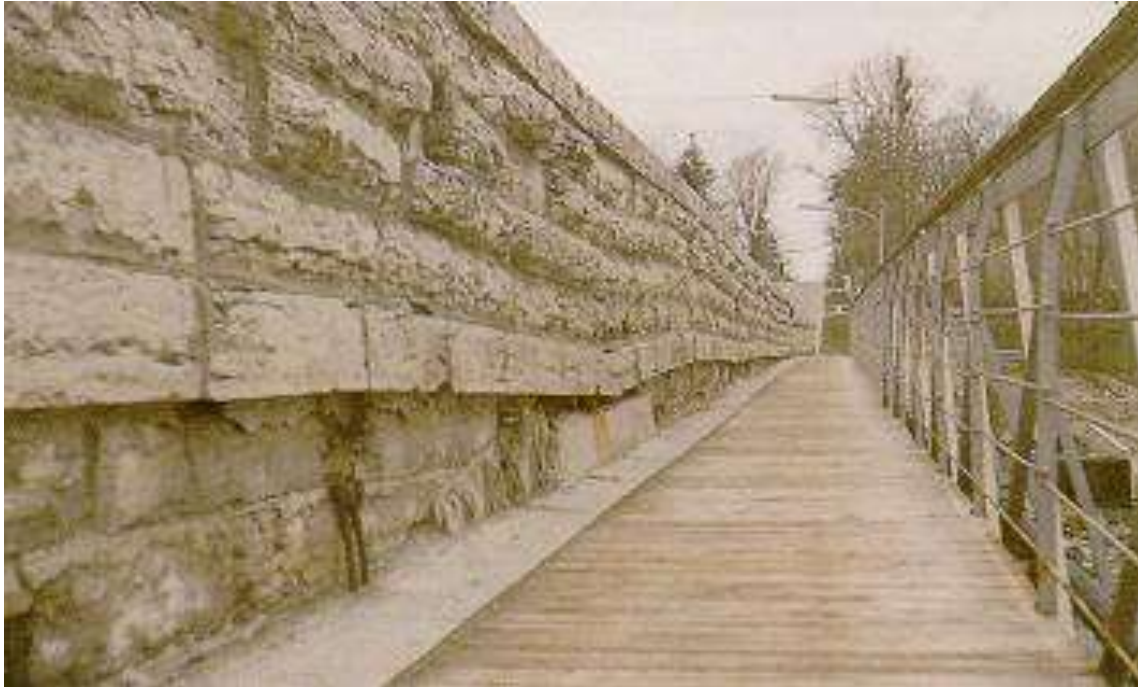
DISINTEGRATION is the gradual breakdown of the stone into small fragments, pieces or particles. The splitting, spalling and disintegration of masonry is caused by the actions of frost, weathering and abrasion; or, by the actions of acids, sulphates or chlorides, which cause deterioration in certain types of stones, such as limestone. The splitting, spalling and disintegration of masonry are shown in Figure 2.5.14.2.

Figure 2.5.14.2 Severe Splitting, Spalling, and Deterioration in Masonry

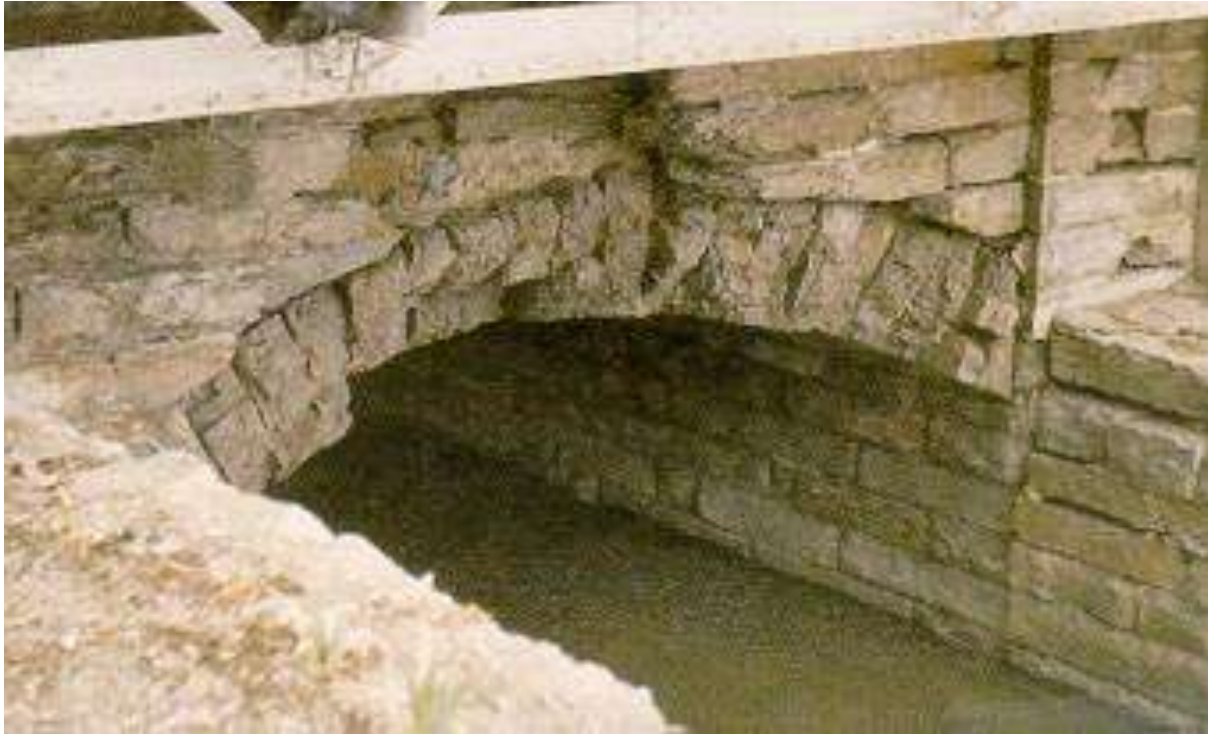
Loss of mortar is the result of the destructive actions of frost, erosion, plant growth or softening by water containing dissolved sulphates or chlorides. Once the mortar has disintegrated it may lead to loss of stones. It should be noted that some structures have been built without the use of mortar. Figure 2.5.14.3 shows evidence of loss of mortar in a masonry arch.

Figure 2.5.14.3 Severe Loss of Mortar and Stone in a Masonry Arch

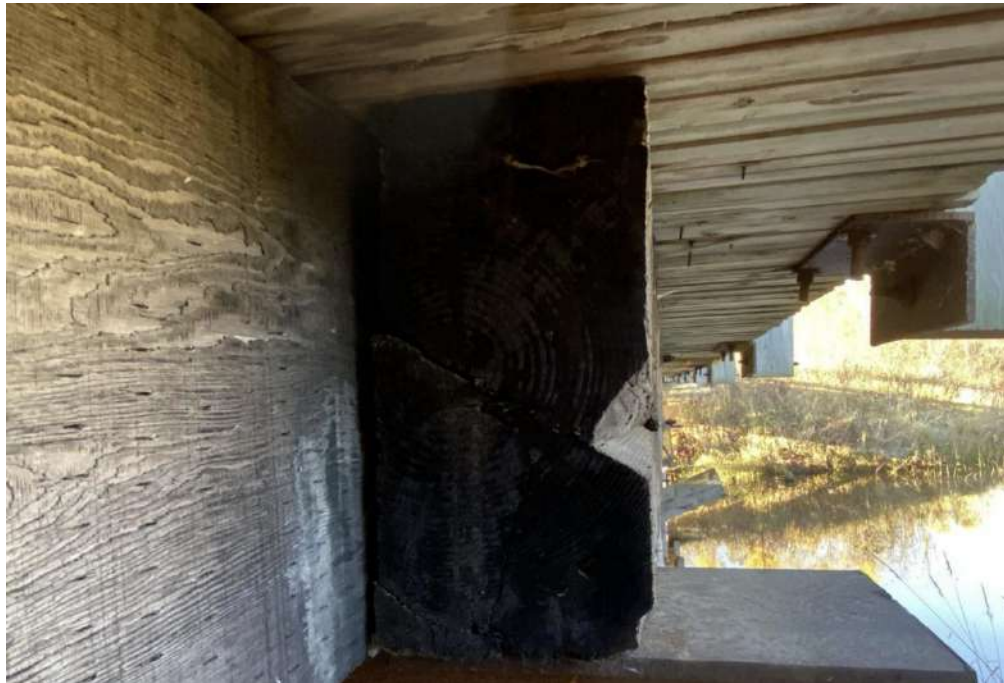
Figure 2.5.15.2 End Check in Wood Beam

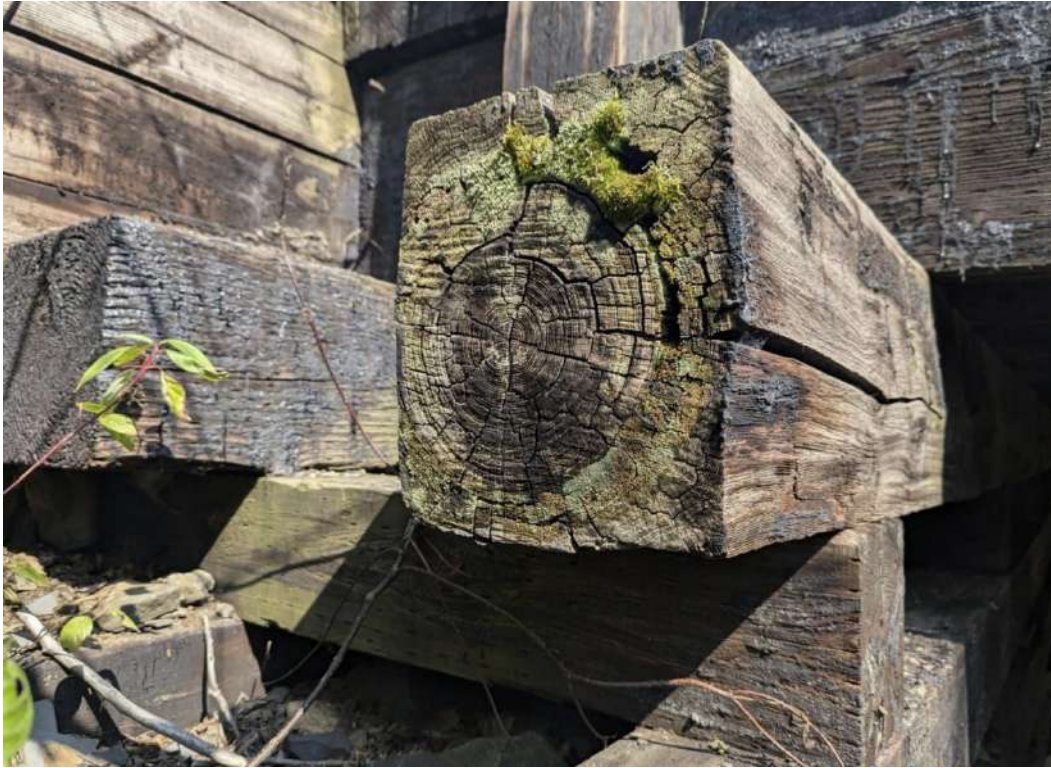
Figure 2.5.15.3 Severe Shakes in Wood Components

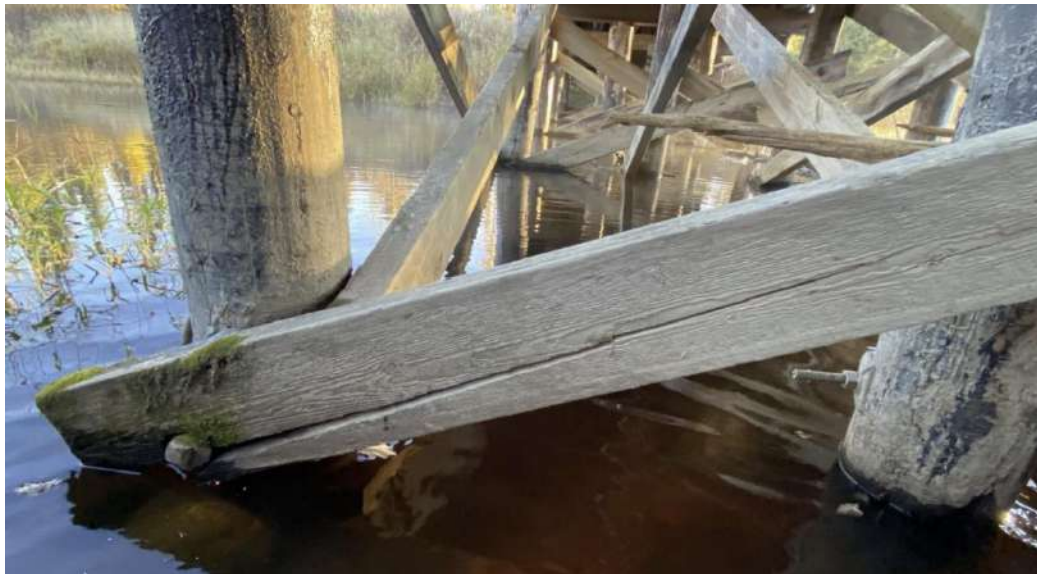
Figure 2.5.15.4 Severe Split in Wood Bracing

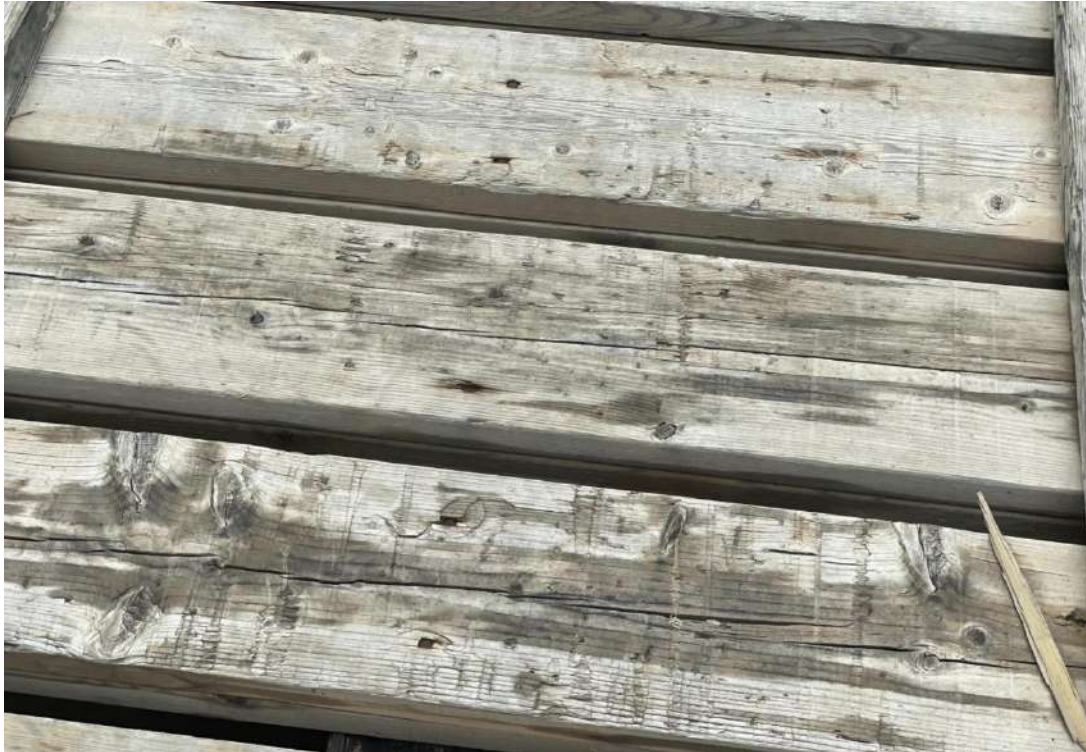
Weathering is the gradual deterioration of wood due to exposure to the actions of sun, rain, wind, frost and atmospheric pollutants. Weathering of untreated wood is accompanied by softening of the surface layer and a grey discolouration and "barn-board" appearance. Treated wood weathers more slowly to a gray-brown colour and may exhibit a rough "wash-board" appearance. Light weathering is shown in Figure 2.5.15.5.

Figure 2.5.15.5 Light Weathering with Medium Checks in Wood Components

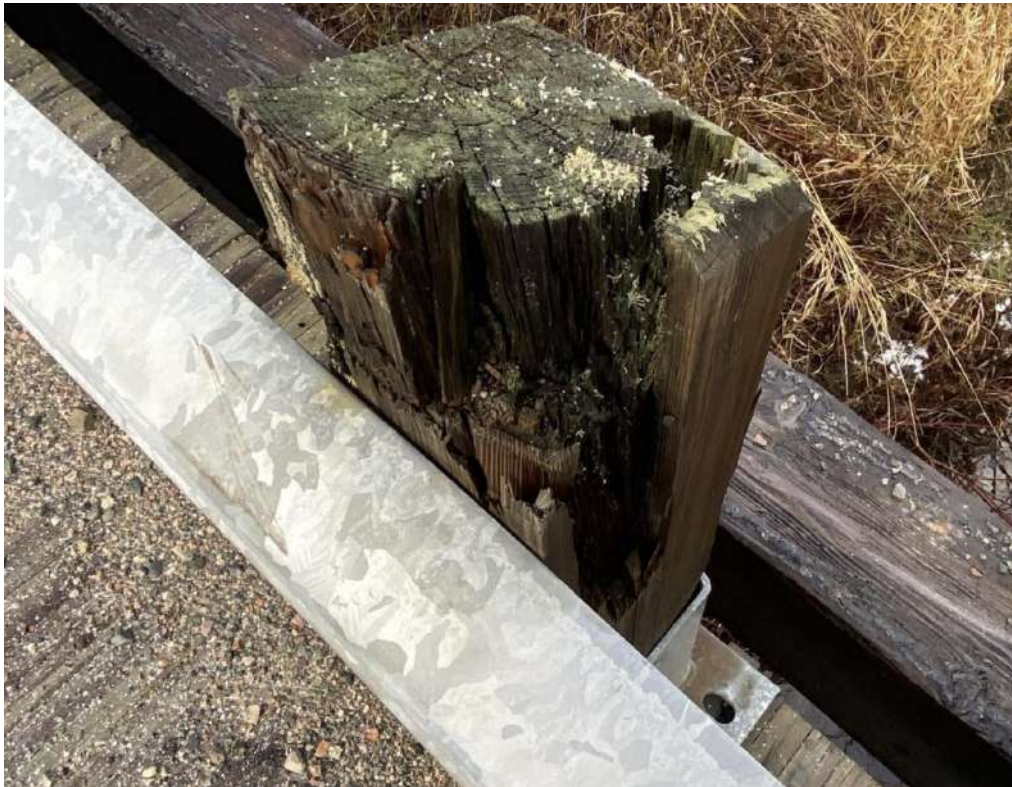
Brown rotted wood has a reddish-brown appearance, and in advanced stages the wood has a checked or crumbly surface. It develops at or above ground contact and may attack both the surface and interior portions of wood.

The surface appearance of rotted wood is shown in Figure 2.5.15.6.

Figure 2.5.15.6 Severe Brown Rot

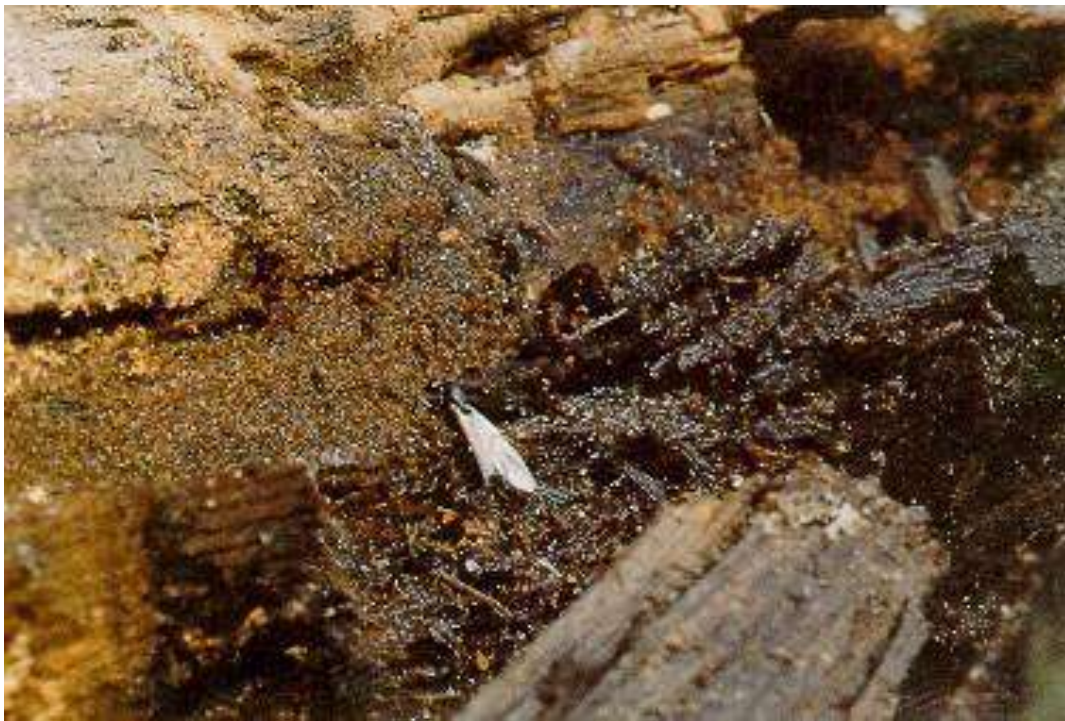
Defects in wood caused by insects are a consequence of the tunnelling and boring by larvae or mature insects through the wood resulting in loss of section. Termites, carpenter ants and wood-boring beetles are the most common insects that attack wood in Ontario. Their appearance is shown in Figure 2.5.15.7, and the resulting appearance of insect damaged wood is shown in Figure 2.5.15.8.

The severity of the insect damage can be judged by the number of holes and tunnels on the surface of the wood and by the number of insects around the area.

Figure 2.5.15.8 Severe Insect Damage in Wood

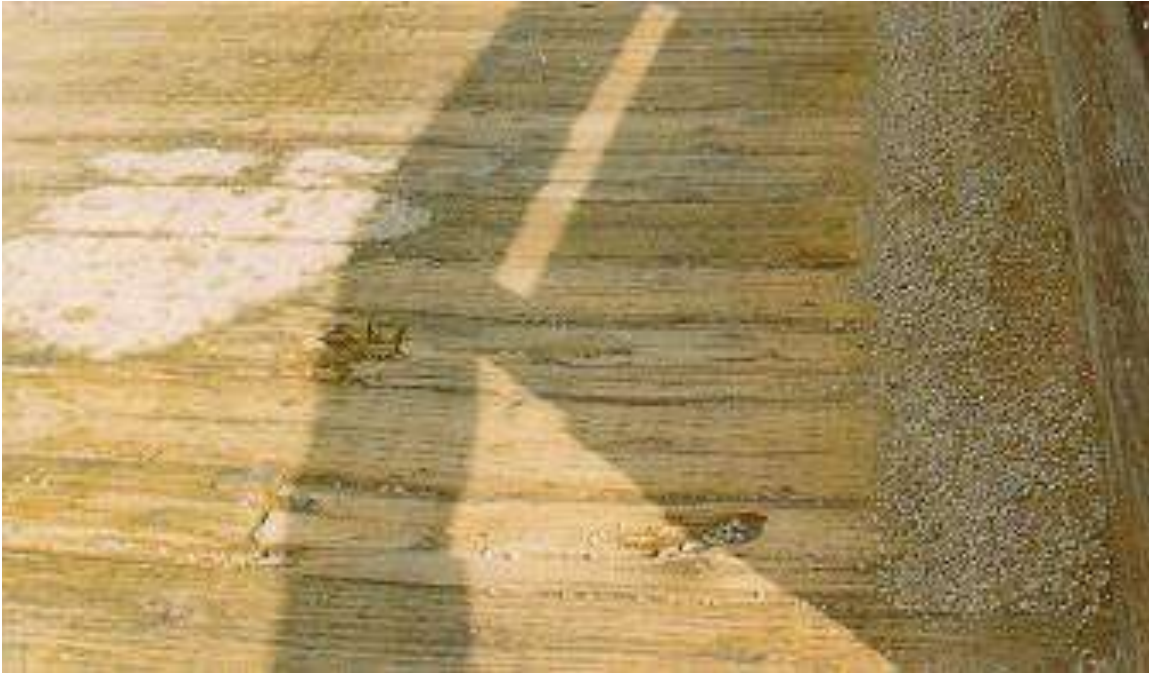
Wear is usually the result of dynamic and/or frictional forces generated by vehicular traffic, coupled with the abrasive influence of sand, dirt or debris. It can also result from the friction of ice or water-borne particles against partly or completely submerged members. The surface of the wood appears worn and cracked with some loss of section. Wear of a wood deck an by ice and abrasion on wood crib are illustrated in Figure 2.5.15.9 and Figure 2.5.15.10 respectively.

Figure 2.5.15.9 Severe Wear in a Wood Deck

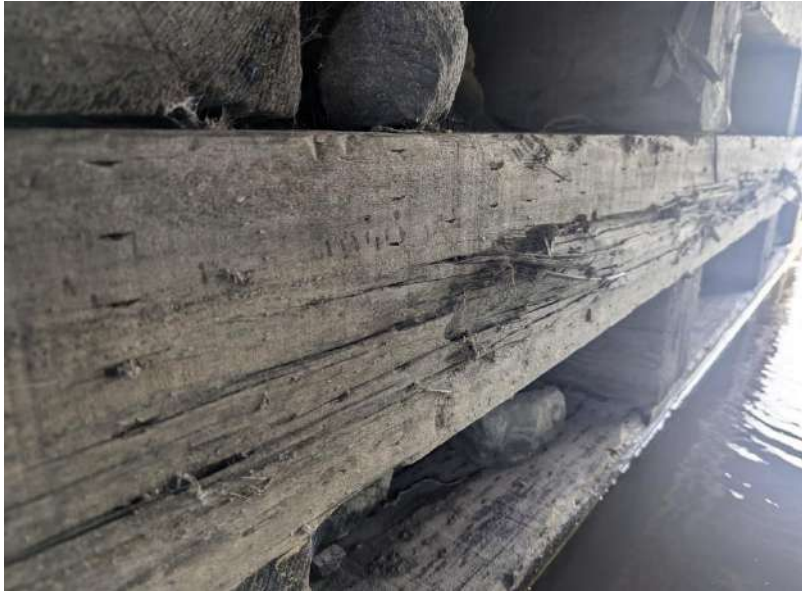
Abrasion is the deterioration of wood brought about by vehicles or snowplough blades scraping against wood surfaces, such as, decks, curbs, railings or piers.

Figure 2.5.15.10 Severe Abrasion and Medium Checking on Wood Crib

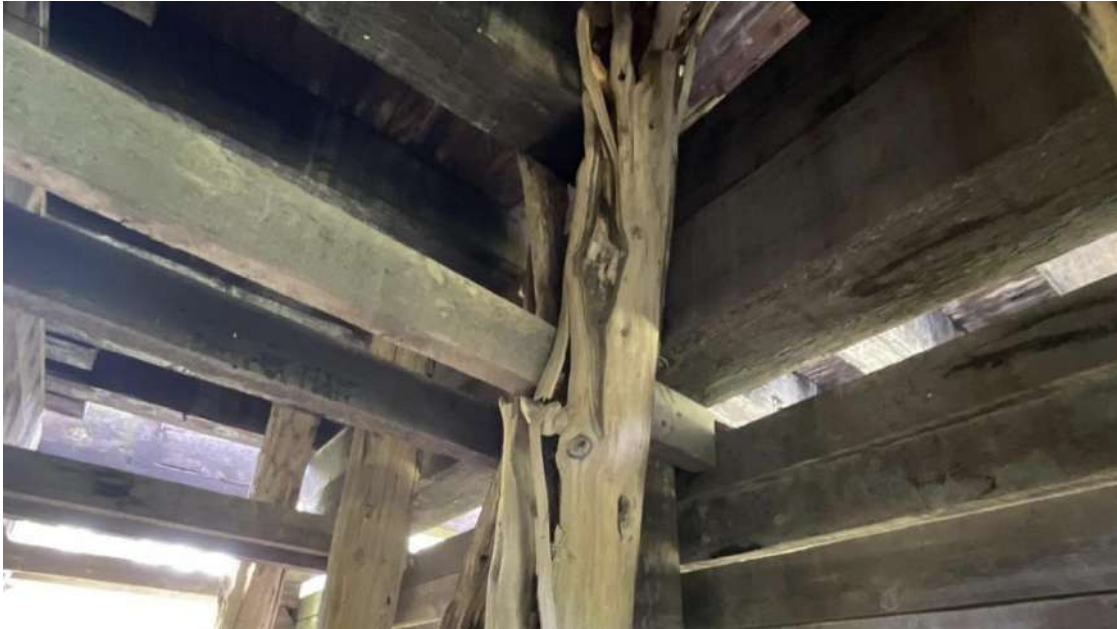
Crushing and splintering of wood pier is shown in Figure 2.5.15.11.

Figure 2.5.15.11 Severe Splitting of Wood Pier

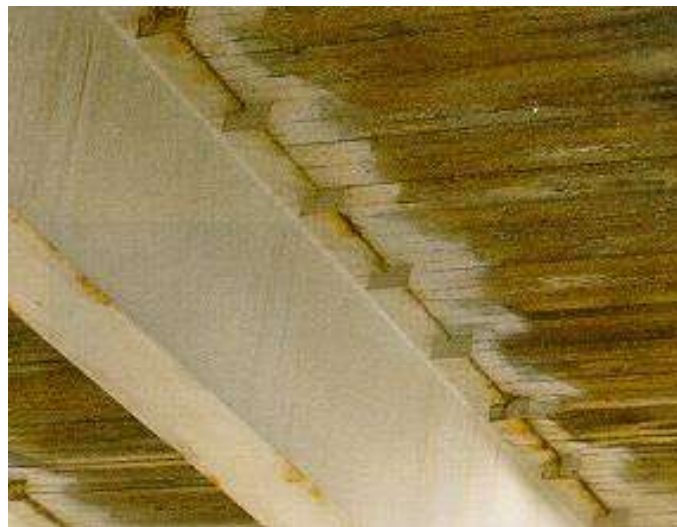
Chemical damage may result from the use of non-preservative chemicals on the wood surface over a long period of time, or where the wood comes in contact with corrosive chemicals resulting from accidental spills. Such damage affects the wood surface and metal connectors. The effect of chemicals on the wood is a softening of the surface accompanied by loss of strength. The effect on metal connector plates and fasteners is less critical except in certain circumstances, for example, on fasteners with low corrosion resistance.

Figure 2.5.15.13 Light Chemical Damage on Underside of a Wood Deck

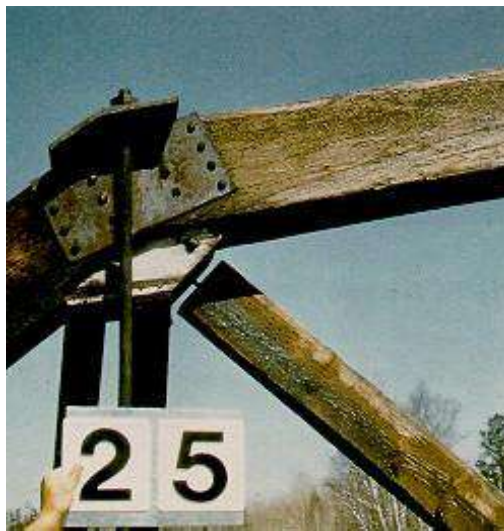
A loose connection joining wood members is shown in Figure 2.5.15.14.

Figure 2.5.15.14 Loose Connection in Wood (25 mm gap measured)

The severity of the connection deficiency shall be based on the condition of the worst component within the connection. This means that the connection will be rated based on the looseness, decay or corrosion of the worst component. In the case of truss members, the connection shall be taken as the entire joint or node location, including both gusset plates in and out of plane, with all members that frame into the connection.

The location of the loose or missing fasteners, as well as areas of corrosion any gusset plates, should be described. Any unintended gaps that are observed should be measured and recorded.
