PART 2 – DETAILED VISUAL INSPECTION

2.5.19 Streams And Waterways

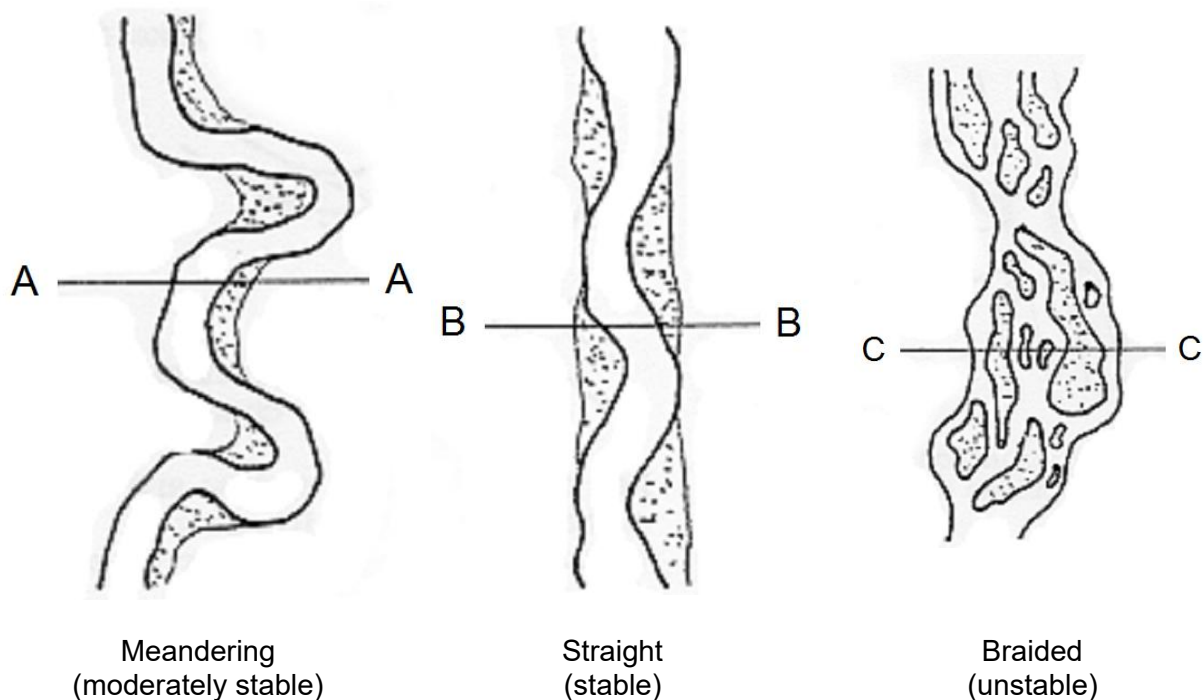
Figure 2.5.19.1 Principal Types of Streams

There are three principal types of streams; namely, meandering, straight and braided.

A meandering stream is characterized by alternative S-bends which migrate laterally downstream. Bank erosion occurs on the outside radius while deposition occurs on the inside radius at each bend in the stream. Meandering streams may be unstable.

A braided stream is identified by numerous unstable interlacing channels separated by gravel or sand bars and small islands. Braided streams are usually highly unstable.

The above three types of streams are illustrated in Figure 2.5.19.1.

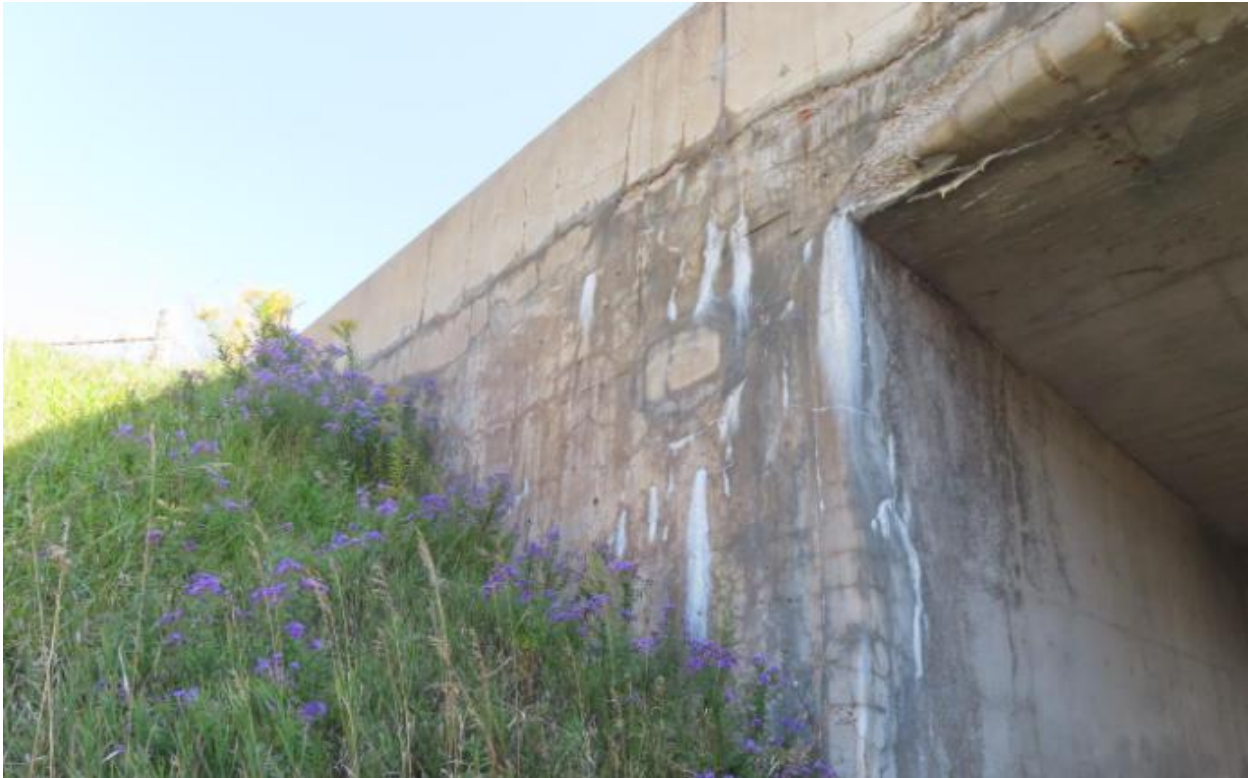
Figure A.1 (a) Concrete Wingwall.

Condition State: Fair/Poor	Performance Deficiency: None
Numerous medium cracks and several wide cracks with penetration of water through wall and efflorescence.

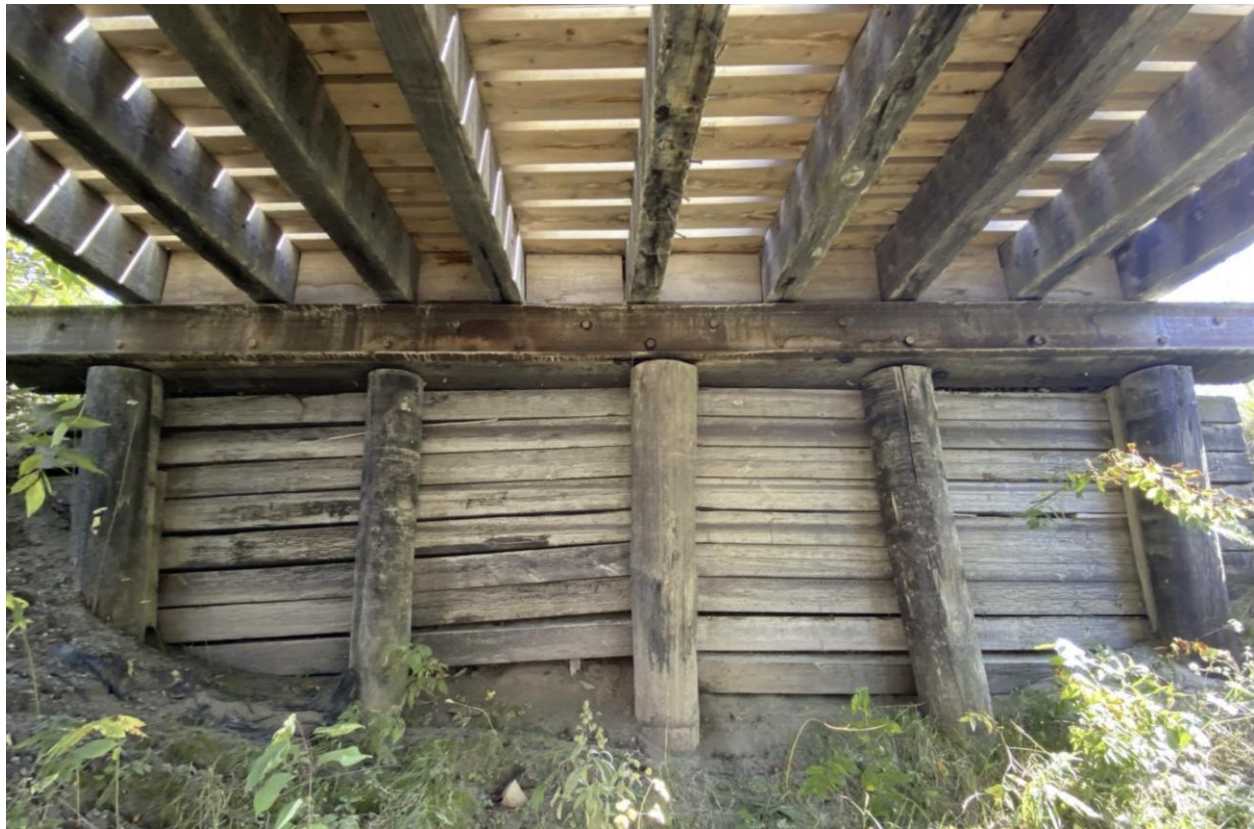
Figure A.1 (b) Wood Lagging – Abutment Wall

<p>Condition State: Good</p>	<p>Performance Deficiency: Settlement concern.</p>
<p>Light weathering of wood.</p>	<p>Movement of \ lagging has opened gaps between timbers. Although movement appears to have stabilized, deck drainage occurs through gaps in deck timbers, providing a direct source of water for continued removal of fill materials. Continued loss of fill will result in approach settlement, causing possible damage to vehicles and an increase in maintenance activities. No significant effect on other components</p>

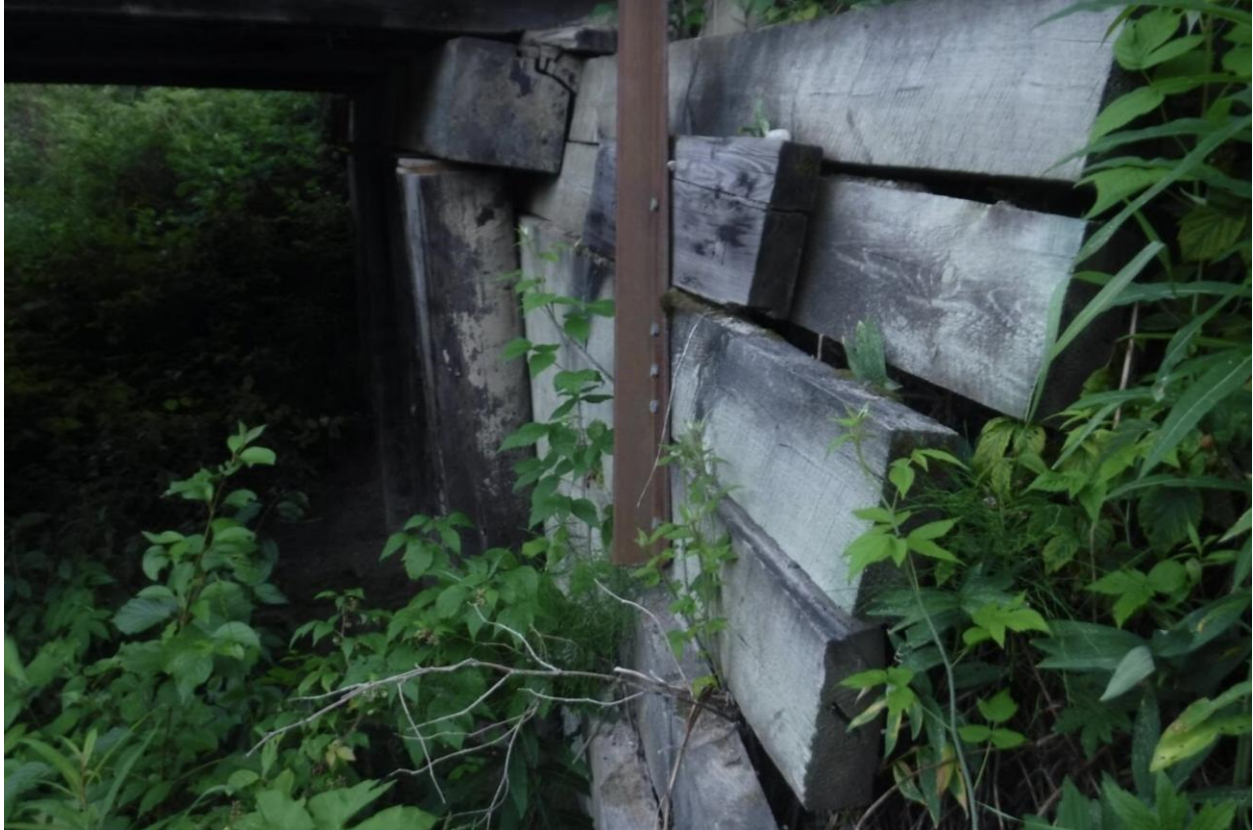
Figure A.1 (c) Wood Post and Lagging Abutment Wall

Condition State: Poor	Performance Deficiency: Load Carrying Capacity, Continuing Movements
Displacement of lagging member. Pile cap not bearing fully on piles. Severe rotation of piles.	Continuing rotation causing eccentric loading to abutment. Separation between horizontal lagging members and medium deformation.

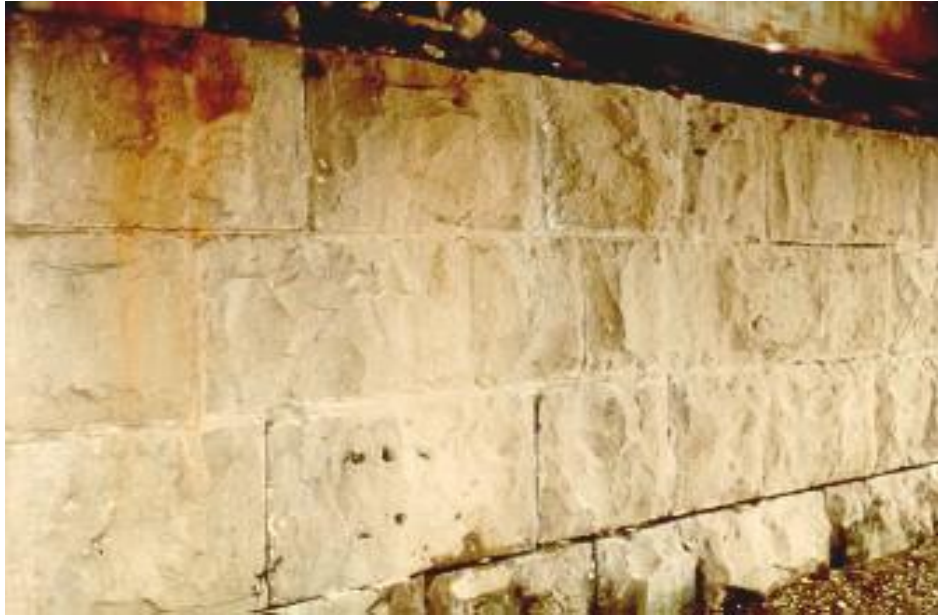
Figure A.1 (d) Masonry Abutment Wall

<p>Condition State: Fair</p>	<p>Performance Deficiency: None</p>
<p>Medium loss of Mortar</p>	<p>Wall is satisfactorily supporting superstructure loads</p>

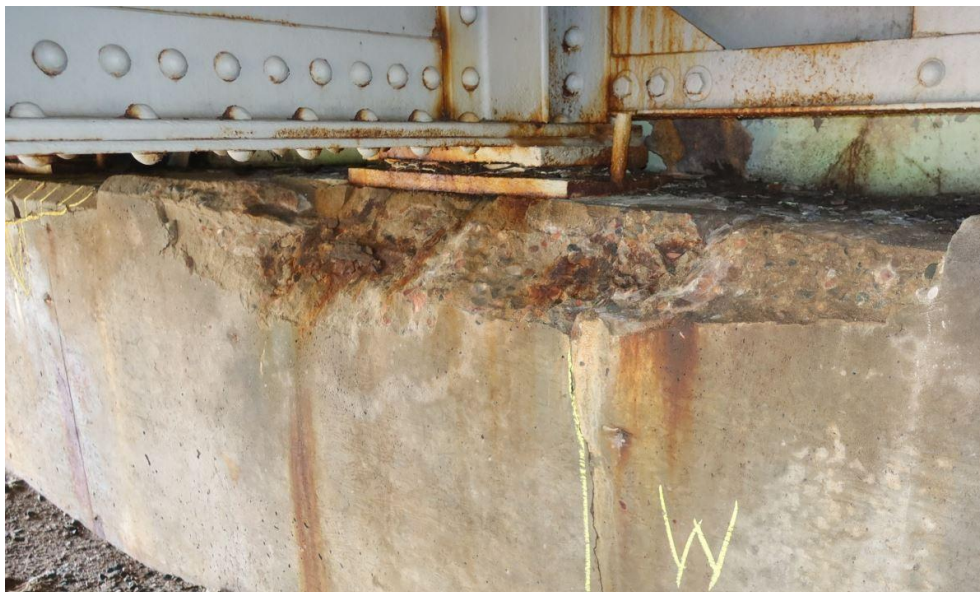
Figure A.1 (e) Concrete Abutment Wall

<p>Condition State: Poor</p>	<p>Performance Deficiency: Bearing Not Uniformly Loaded/Unstable</p>
<p>Severe spall with exposed rebar undermining bearing seat.</p>	<p>Bearing seat area reduced. Undermining should be monitored especially if it is occurring under multiple girders. Future evaluation may need to be considered.</p>

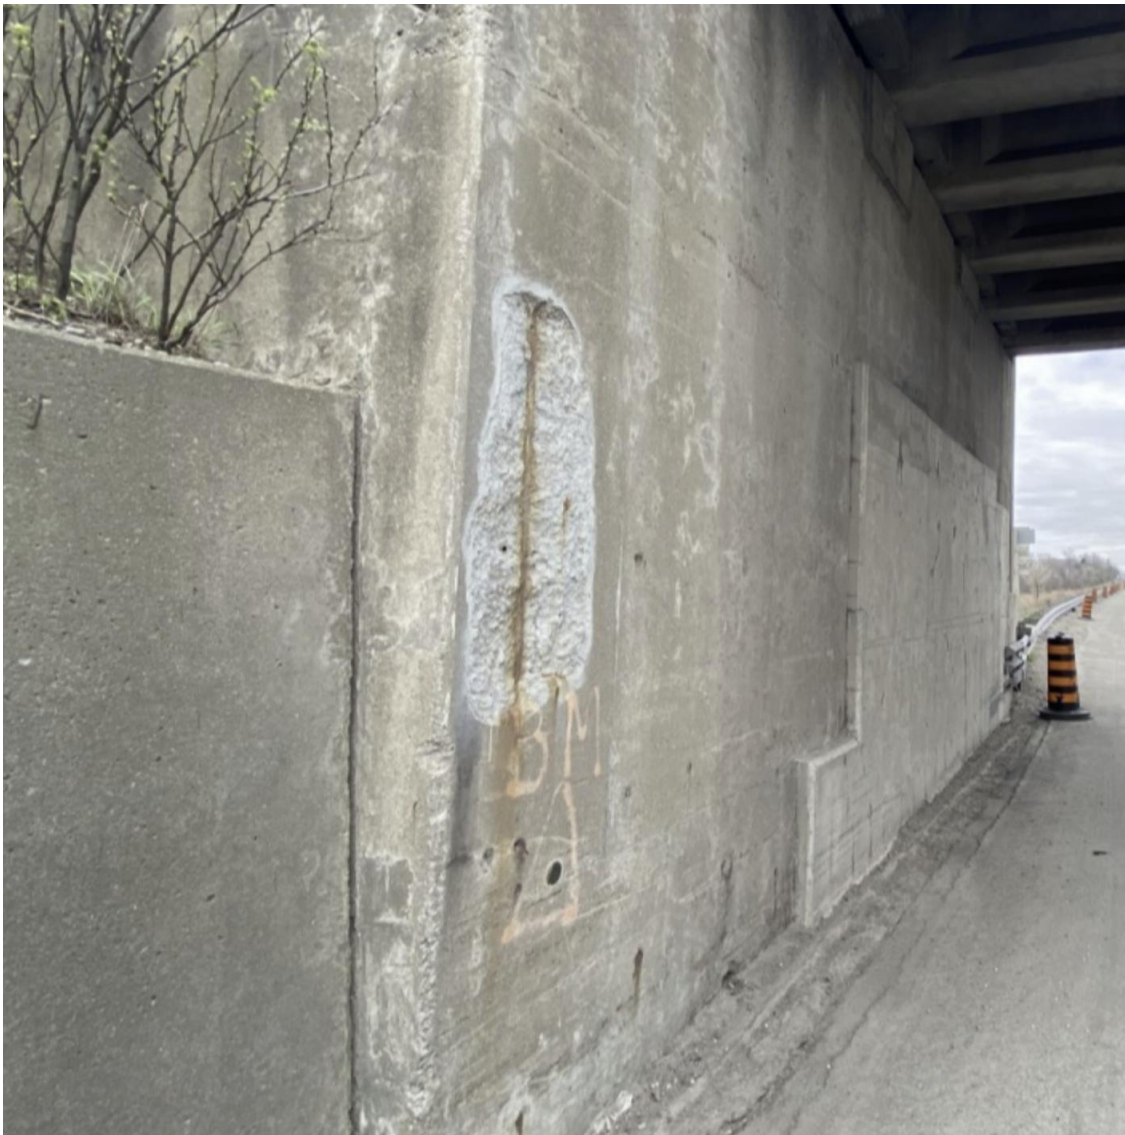
Figure A.1 (g) Abutment Wall

<p>Condition Statement: Poor</p>	<p>Performance Deficiency:</p>
---	---------------------------------------

None
Spall with exposed rebar.

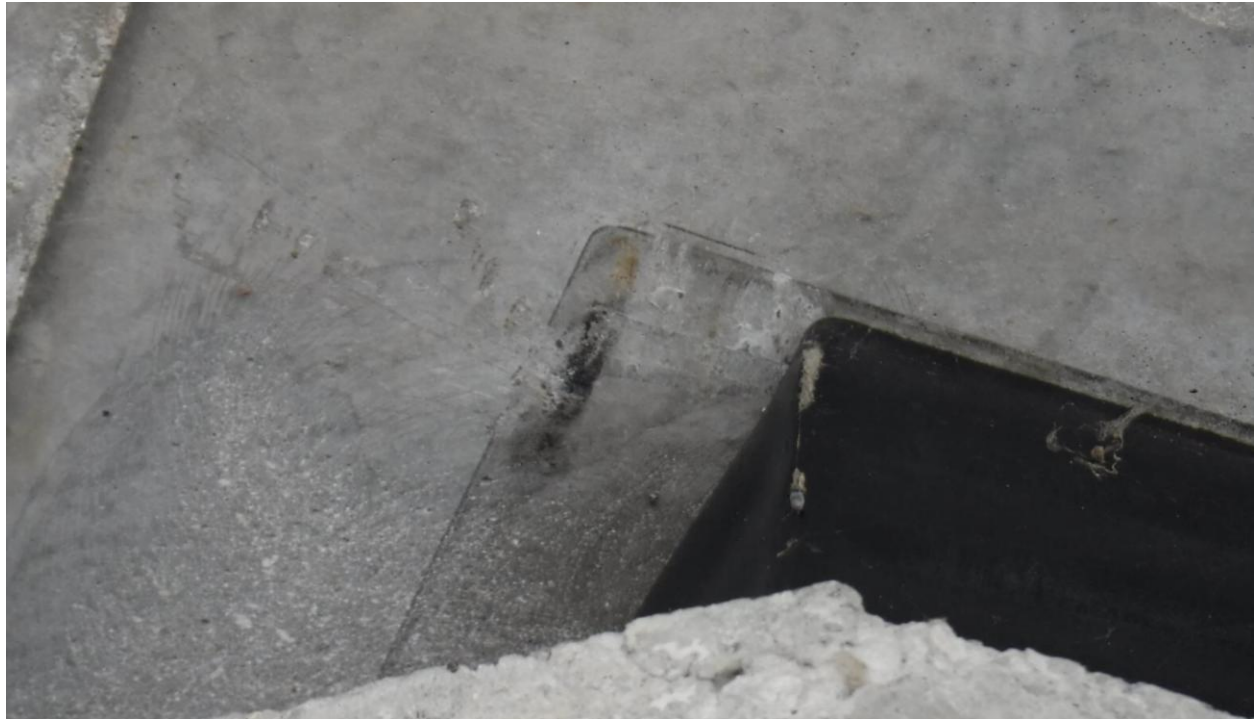
FigureA.1 (h) Abutment Bearing: Looking up at deck soffit and elastomeric bearing

Condition State: Good	Performance Deficiency: None
No material defects observed	The black stains on the soffit indicate that the elastomeric bearing is walking. The inspector should monitor and make notes in the report to ensure that the bearing remains uniformly loaded.

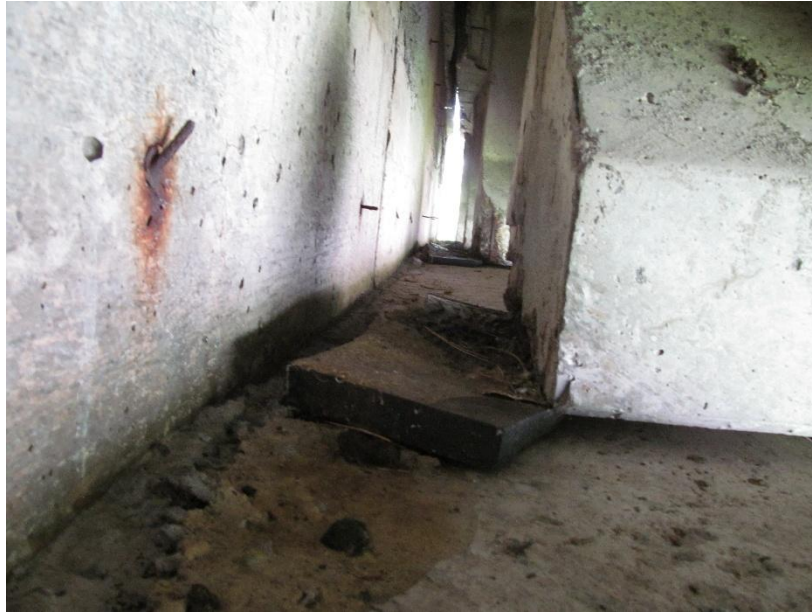
Figure A.1 (i) Elastomeric Bearing

Condition State: Fair	Performance Deficiency: Continuing Movement
Elastomer overloaded due to lack of contact surface.	Bearing walking out from under girders, providing inadequate support. Concrete-concrete contact imminent.

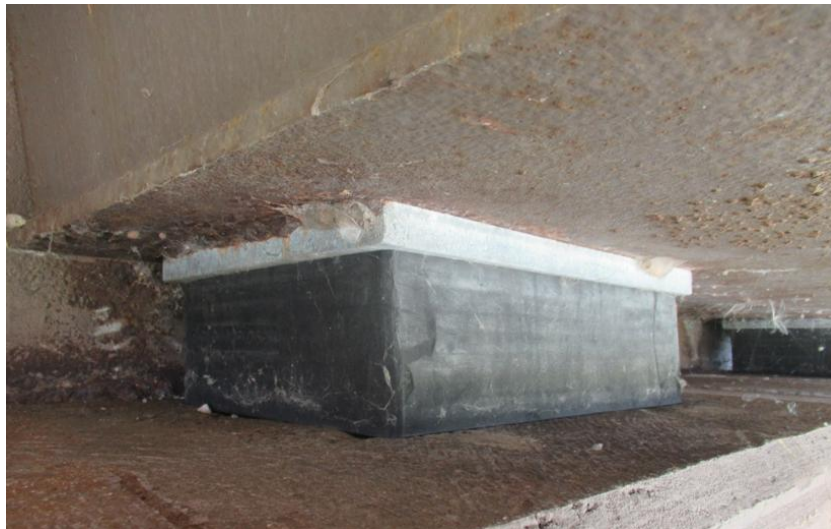
Figure A.1 (j) Laminated Elastomeric Bearing

Condition State: Good	Performance Deficiency: None
------------------------------	-------------------------------------
