PART 2 – DETAILED VISUAL INSPECTION

APPENDIX B – COMBINED SUMMARY OF MATERIAL DEFECTS AND CONDITION STATES

PART 3 – ADDITIONAL INVESTIGATIONS

PART 4 – MATERIAL CONDITION SURVEYS**4.1 STRUCTURAL STEEL****4.1.1 Non-Destructive Testing Methods For Detection Of Defects In Steel Components**

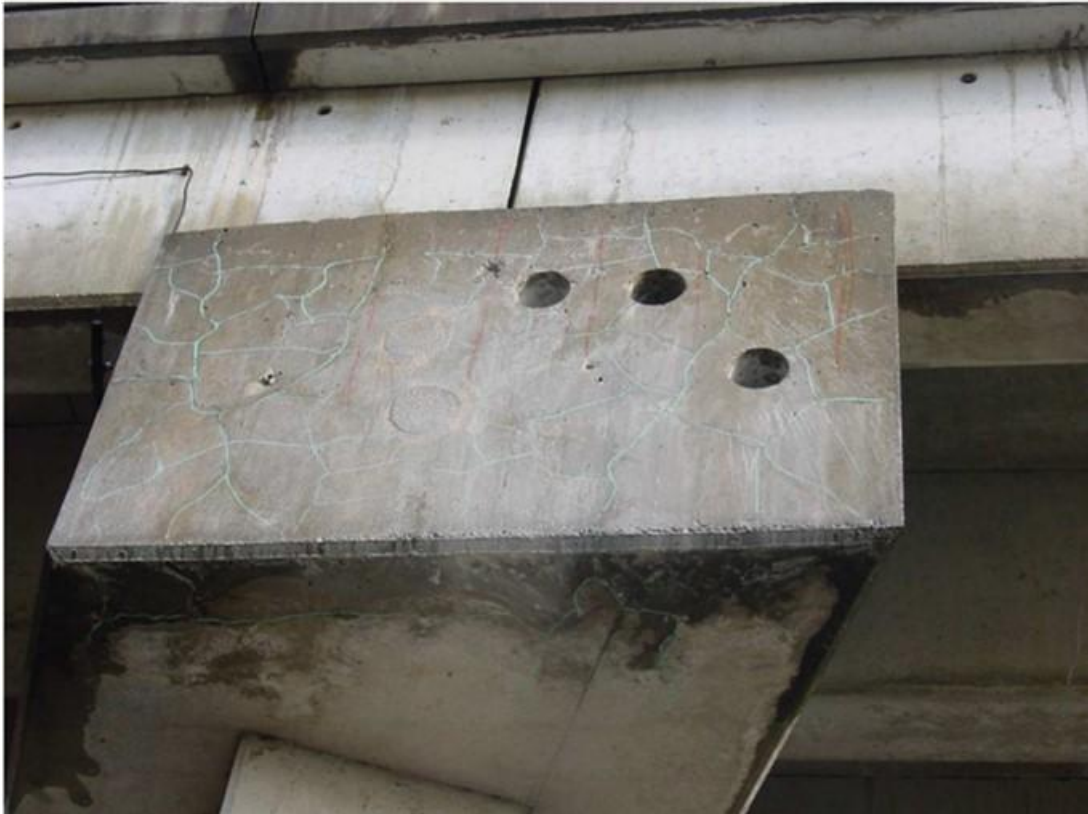
Figure A.12 (g) – Pier Cap

Condition State: Poor	Performance Deficiency: None
Narrow to medium map cracking in pier cap looks like AAR but, the structure is built prior to 1986 (the implementation of the Aggregate Resources Act). This map cracking could be Delayed Ettringite Formation (DEF) as it is a large concrete element.	Inspector should monitor cracking to observe the rate of deterioration.

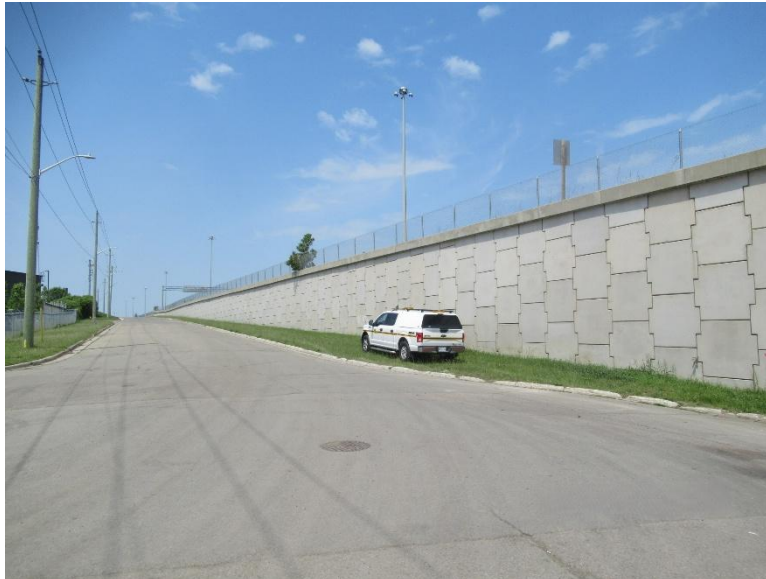
Figure A.13 (a) Precast Concrete Retaining Wall

Condition State: Excellent	Performance Deficiency: None
	No evidence of movement. Wall satisfactorily retaining fill

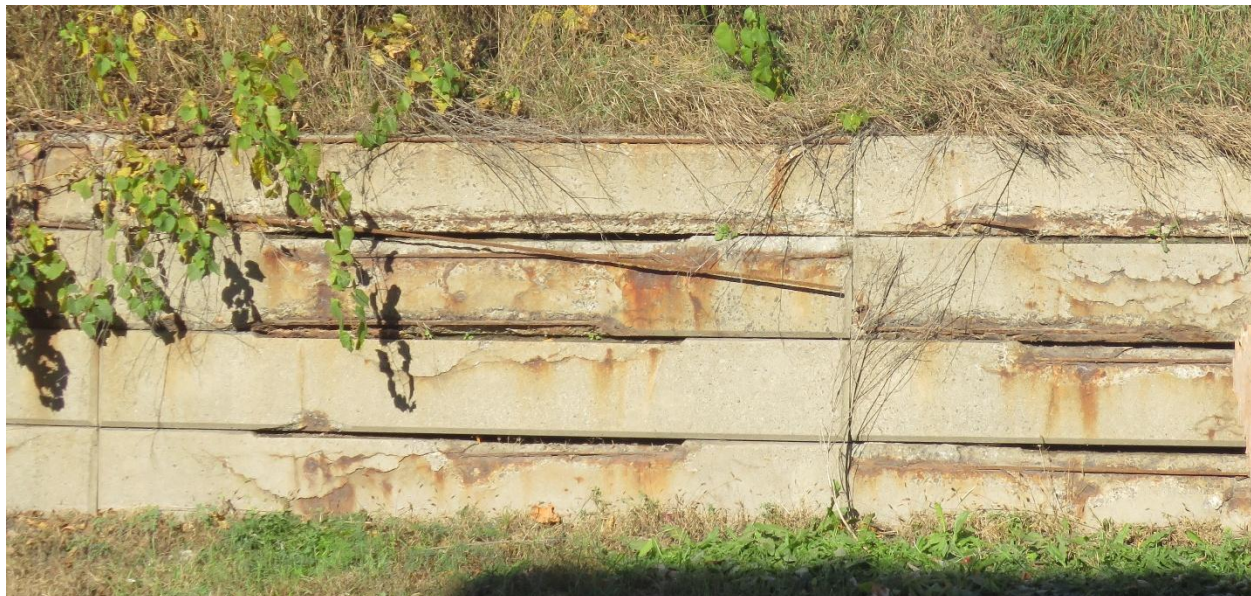
Figure A.13 (b) Pre-Cast Concrete Retaining Wall

Condition State: Poor	Performance Deficiency: None
Extensive spalling of precast elements with exposed reinforcing steel	Wall satisfactorily retaining fill. Vegetation growth should be removed.

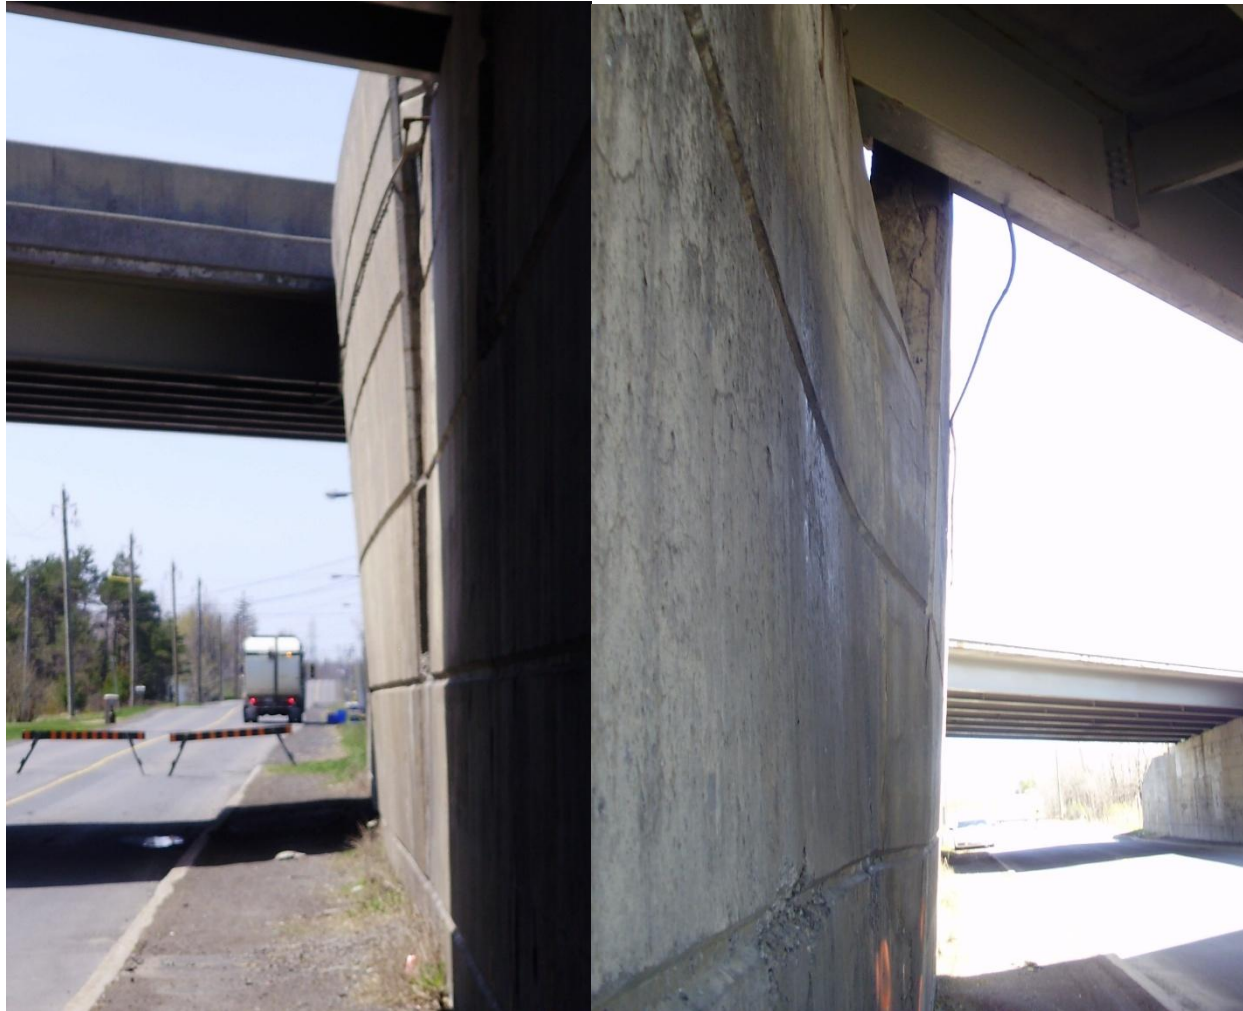
Figure A.13 (c) Cast-in-place Retaining Wall

Condition State: Poor	Performance Deficiency: Continuing Movement/Load Capacity
Median retaining wall was originally plumb and keyed to both EB & WB abutments. Wall appears rotated vertically, but has a curve at ground level, with a horizontal bow along top. Keys and keyways to both abutments damaged, with large section of EB abutment concrete following wall movement (see RH	Wall is failing with root cause insufficient lap length of back face reinforcing steel. Wall was stabilized with deadman anchors before its replacement.

photo). LH photo shows large spalls on WB abutment caused by retaining wall movement.

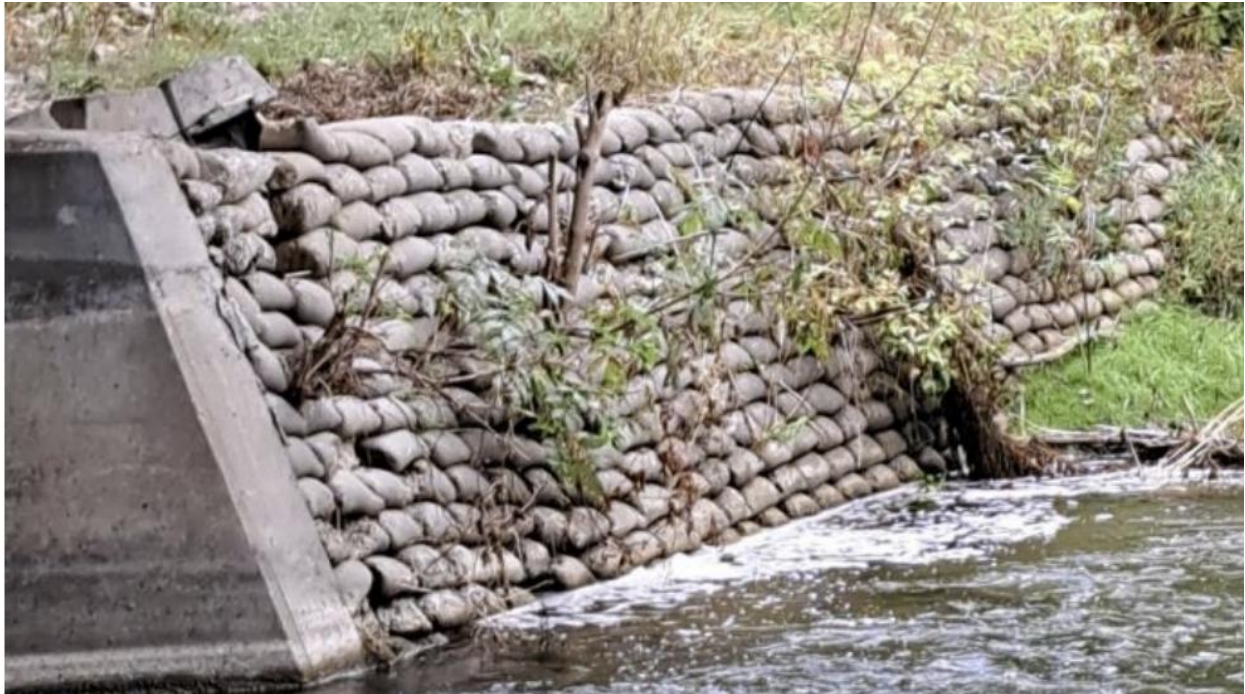
Figure A.13 (d) Bag-mortar Retaining Wall

Condition State: Fair	Performance Deficiency: None
Several areas with large vegetation growing through wall, creating openings in face of wall.	Wall satisfactorily retaining fill. Vegetation growth should be removed.

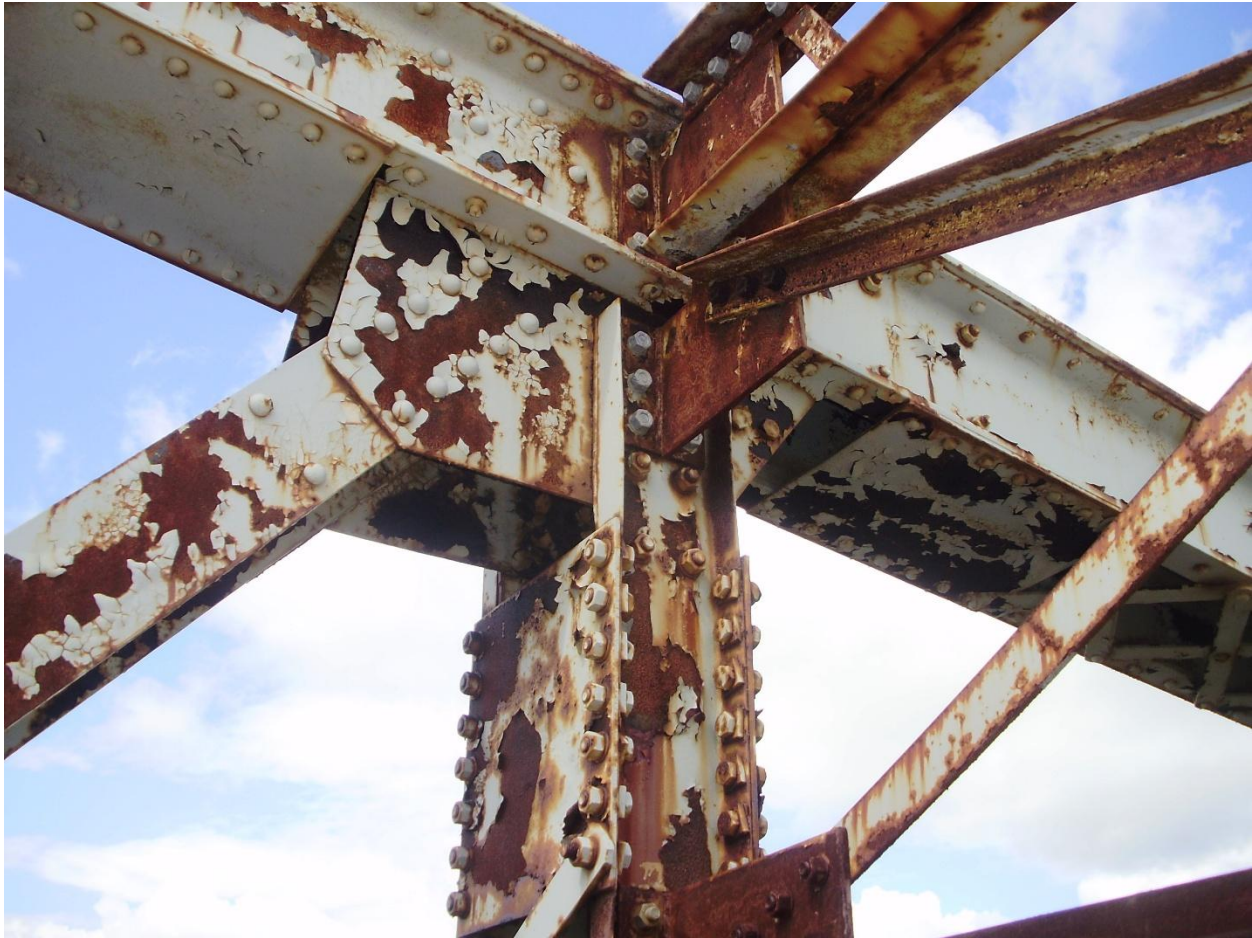
Figure A.14 (a) Steel Through Truss Connection

Condition State: Poor	Performance Deficiency: Load Carrying Capacity
<p>Coating is poor on all painted bolts and rivets. Galvanized bolt coating in good condition, but some galvanized bolts have insufficient grip length. Some section loss on primary and secondary members, gusset plates and bolts/rivets. Evidence of rust jacking on some built-up members.</p>	<p>Possible loss of load carrying capacity. Joint very congested, with difficult access for assessing condition of many bolts/rivets within the top chord. Stitch welding visible on top chord cover plates. Bridge should have a fatigue inspection performed with attention paid to areas with stitch welding, rust jacking and section loss.</p>

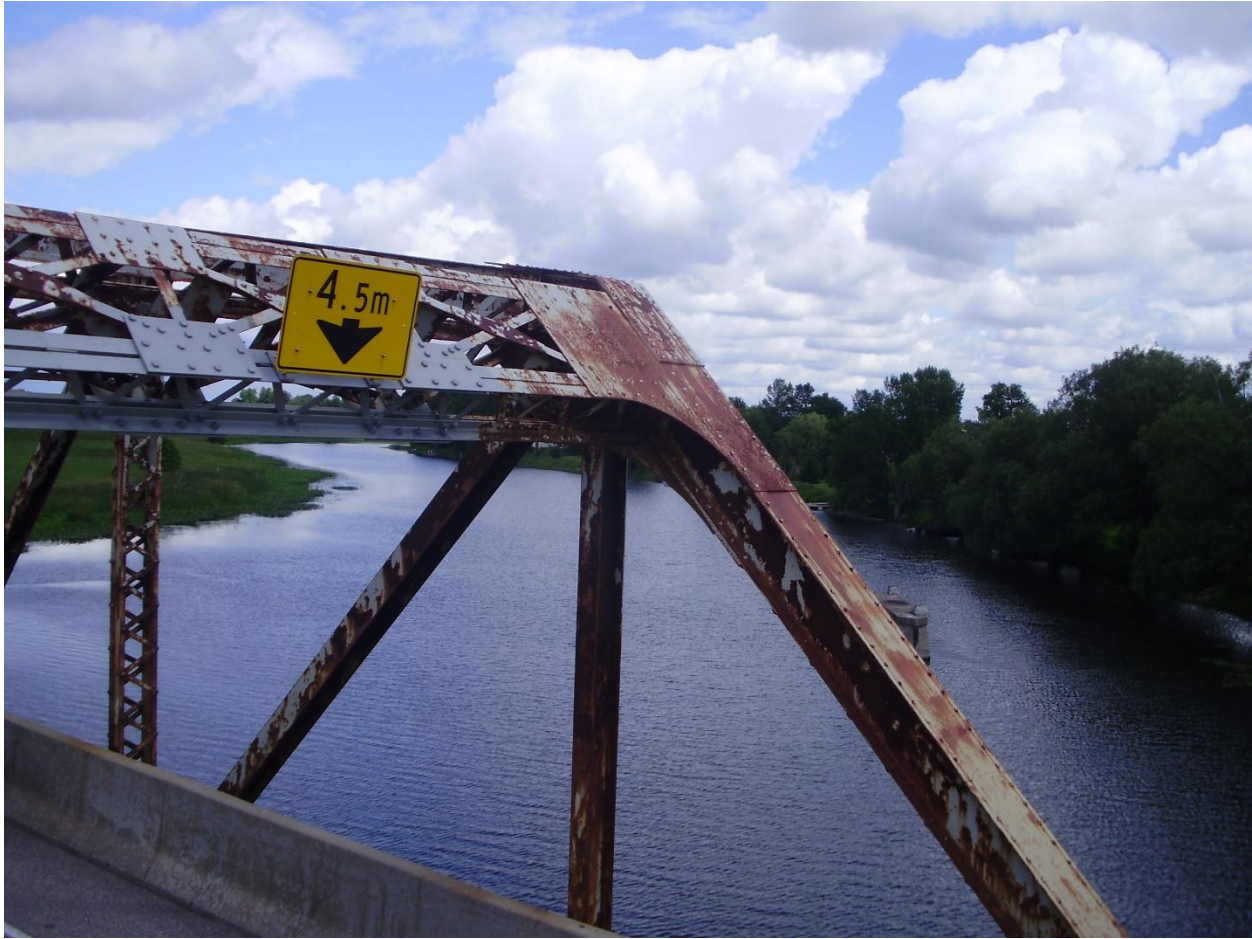
Figure A.14 (b) Sway Frame Connection

Condition State: Fair	Performance Deficiency: None
Medium corrosion over more than 40% of the connection. Some evidence of section loss on sway frame to end post gusset plate.	An evaluation of gusset plate thickness and capacity should be performed if bridge is to remain in service.

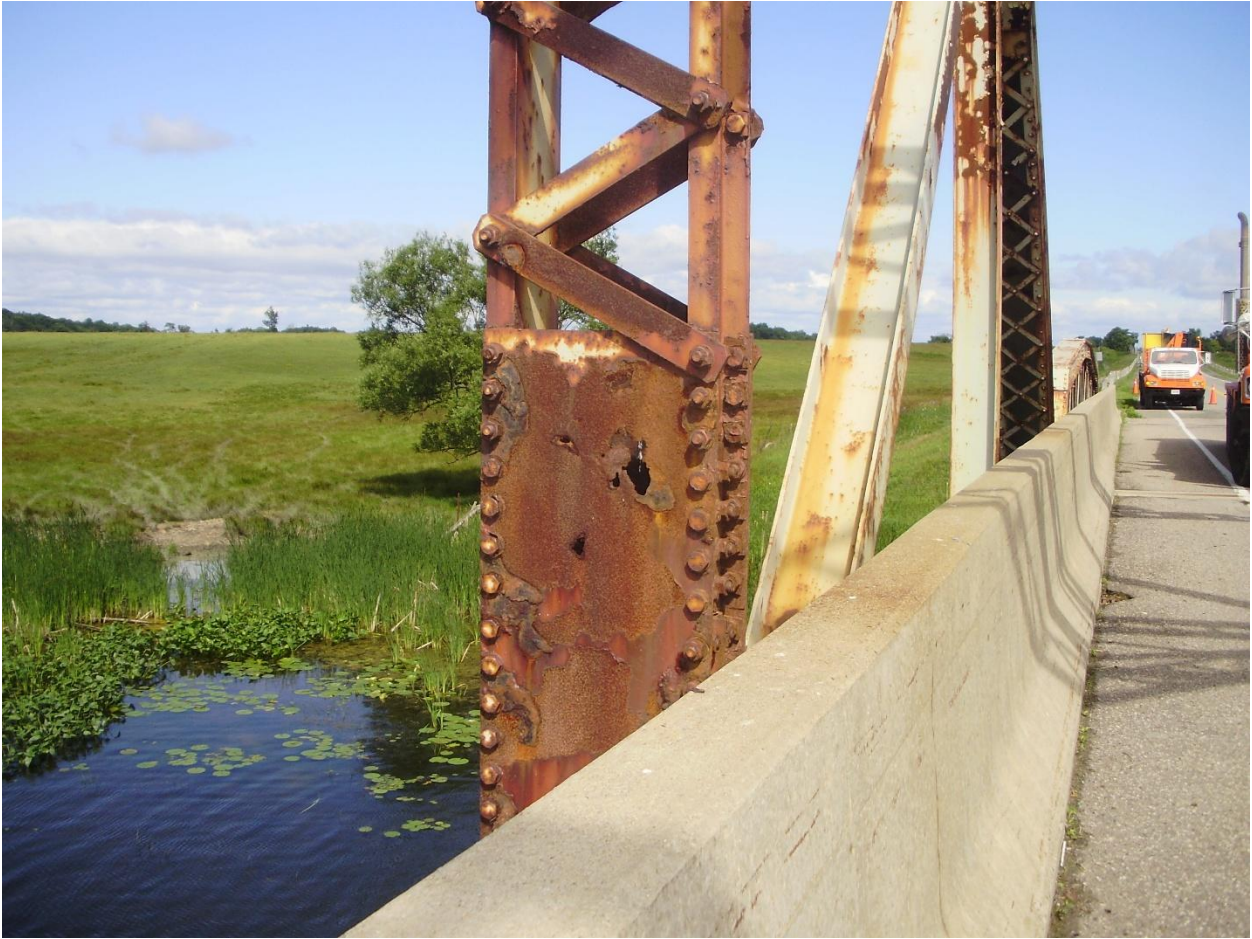
Figure A.14 (c) Vertical Member of Steel Through Truss

Condition State: Poor	Performance Deficiency: Load Carrying Capacity
Section loss 15% to 20% on panel used to reinforce vertical member	Possible loss of load carrying capacity due to loss of section.

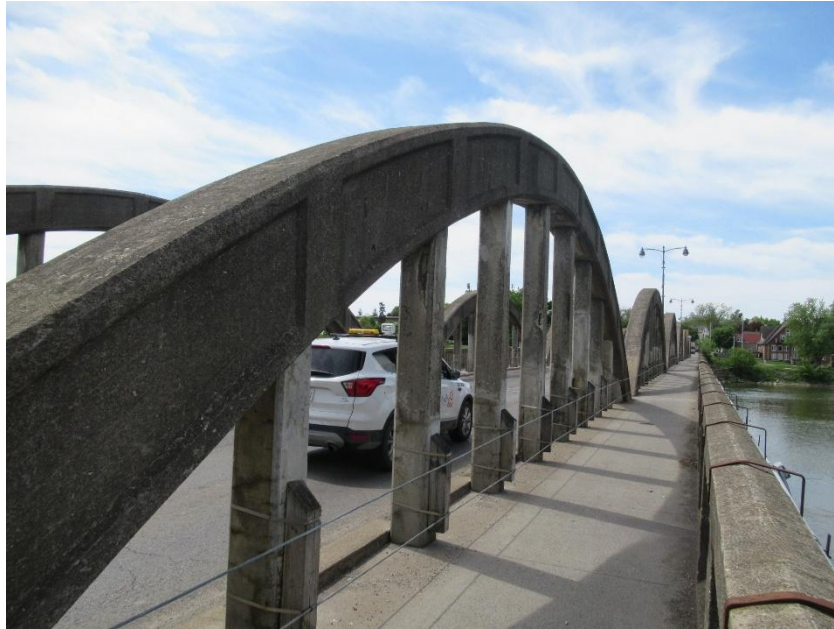
Figure A.14 (d) Concrete Bowstring Arch

Condition State: Fair	Performance Deficiency: None
Some scaling, spalling and cracking on the surface	Marginal loss of performance. Material defects unlikely to cause reduction in load carrying capacity

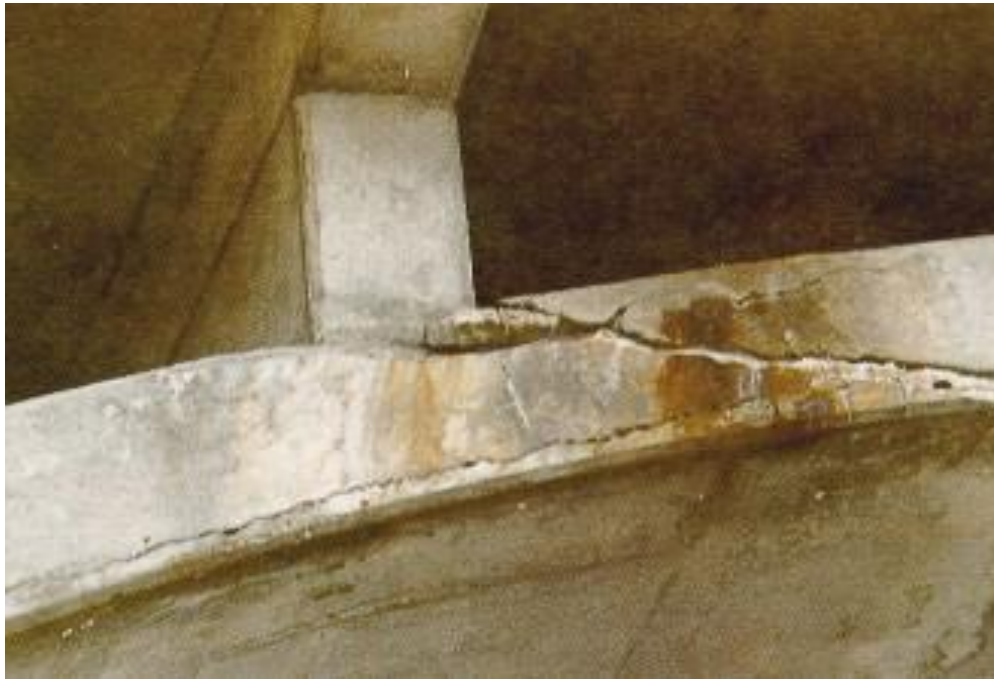
Figure A.14 (e) Concrete Spandrel Arch

Condition State: Poor	Performance Deficiency: None
Very wide crack in the arch rib	Crack extends about 100 mm into the rib. Material defects unlikely to cause reduction in load carrying capacity
