Ministry of Transportation
Standards and Contracts Branch
Structures Office Report

Guidelines for Inspection and Field Acceptance of Glass Fibre Reinforced Polymer (GFRP) Reinforcing Bars

STR-00X

September 2022

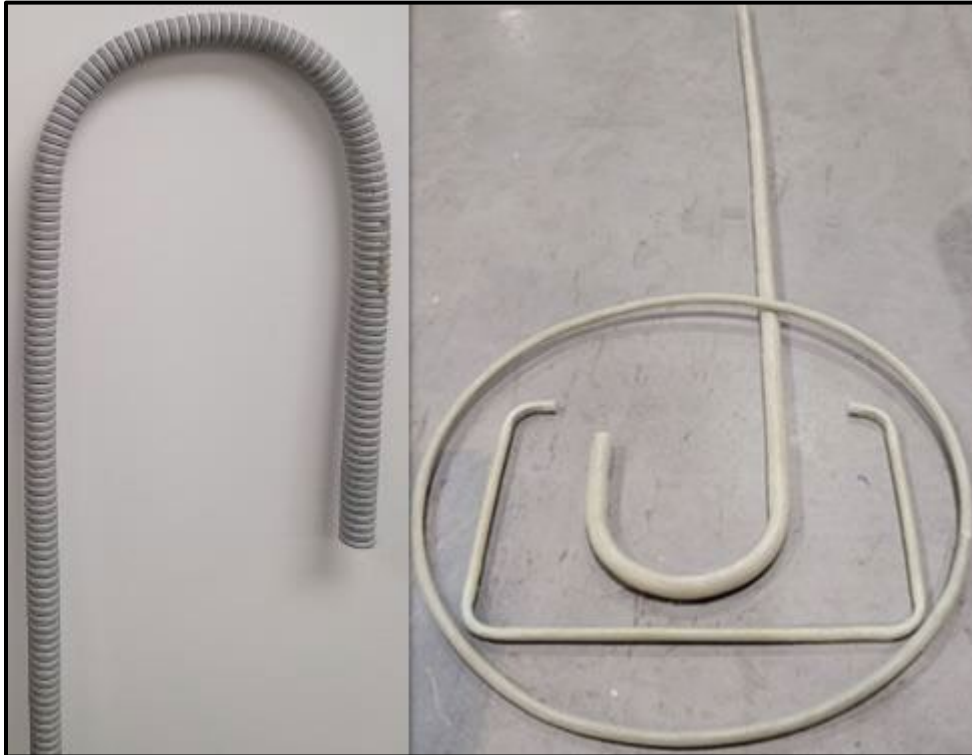
Figure 2 – MST-BAR: bent shapes

The left image in Figure 2 is the approved bar coating that was supplied until November 2020. The right image is the approved bar coating that is being supplied after November 2020.

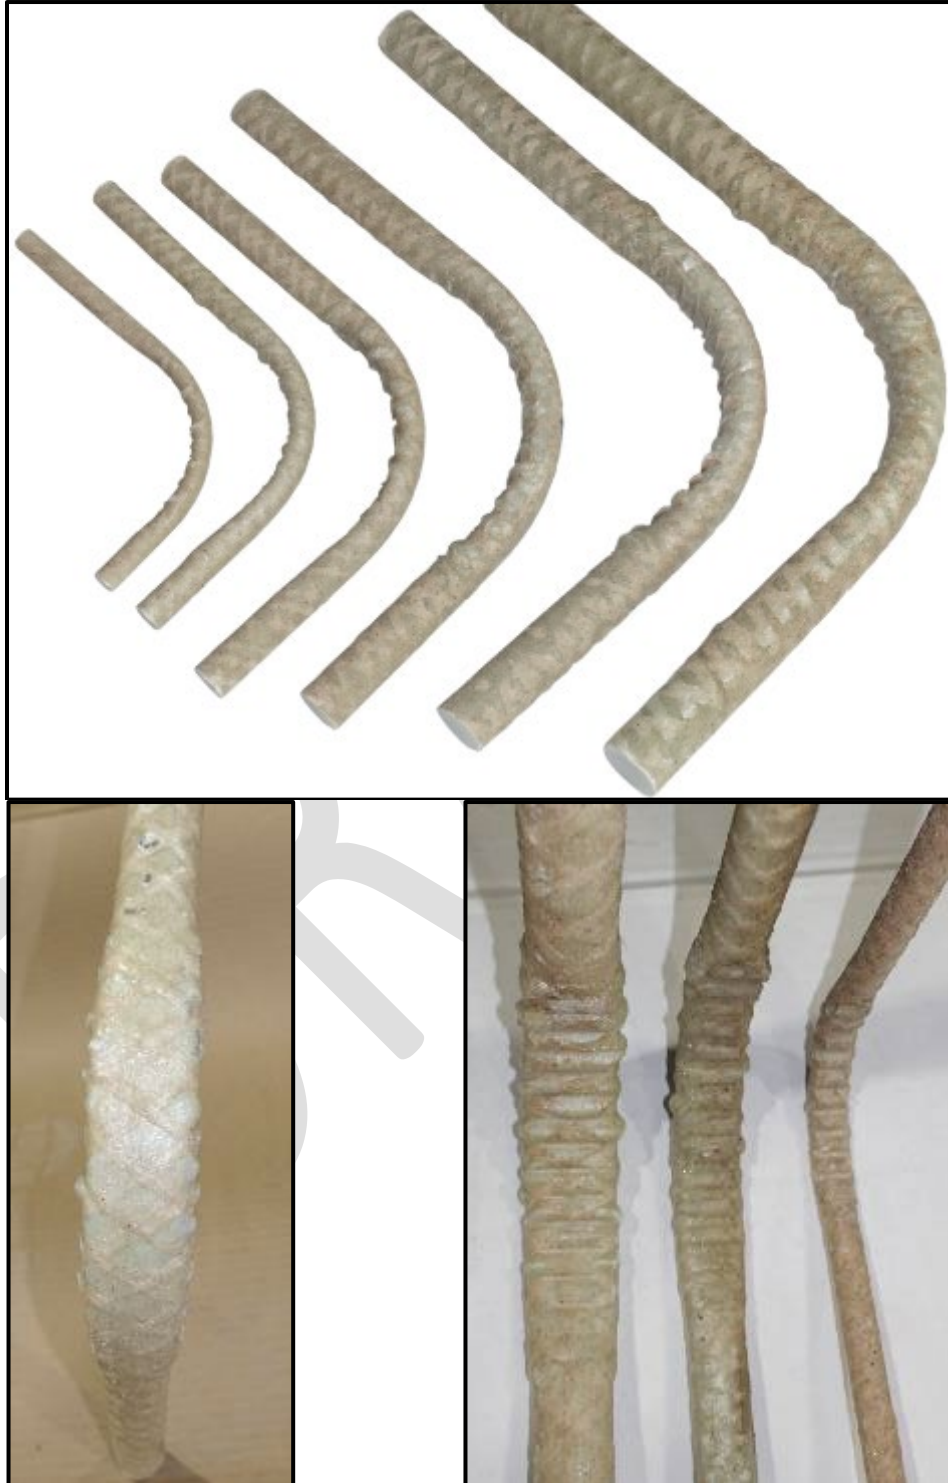
Figure 10 – TUF-BAR: bent bars (Clockwise from top: sizes, inside of bend, outside of bend.)

The small protrusions or bumps on the inside radius of the TUF-BAR bent bars in Figure 10 are an intentional part of the fabrication process. The ribbed profile is consistent and perpendicular to the piece.

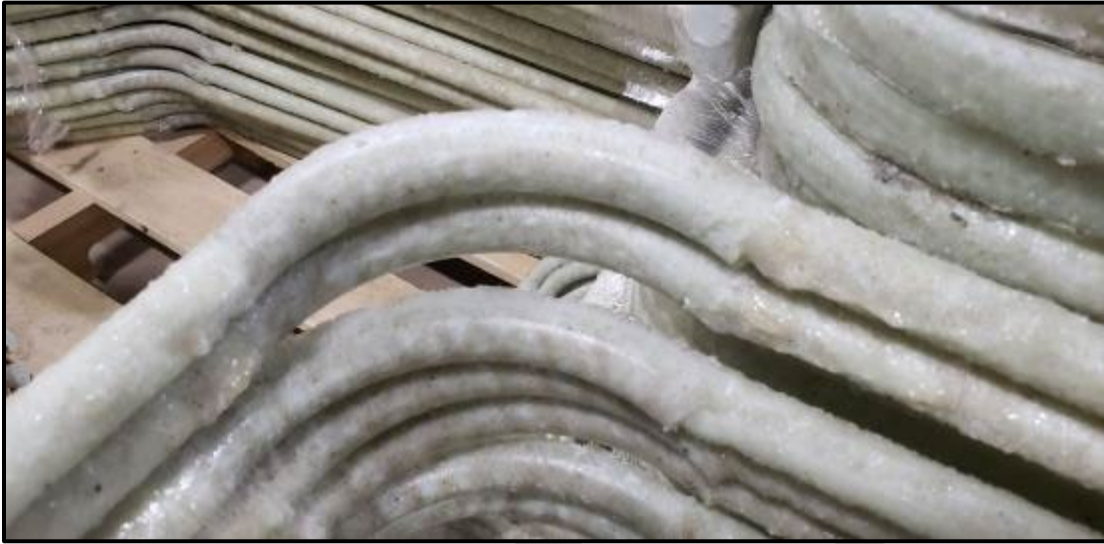
Figure 21 – Inside of bend

The bars shown in Figure 15 to Figure 25 are typical for sand-coated bars and have a uniform distribution of resin and sand particles. It is acceptable to have a loss of sand coating on the inside surface of the bend, over the arc of the bend as shown in Figure 21. The exterior of the bend must have a uniform sand coating.

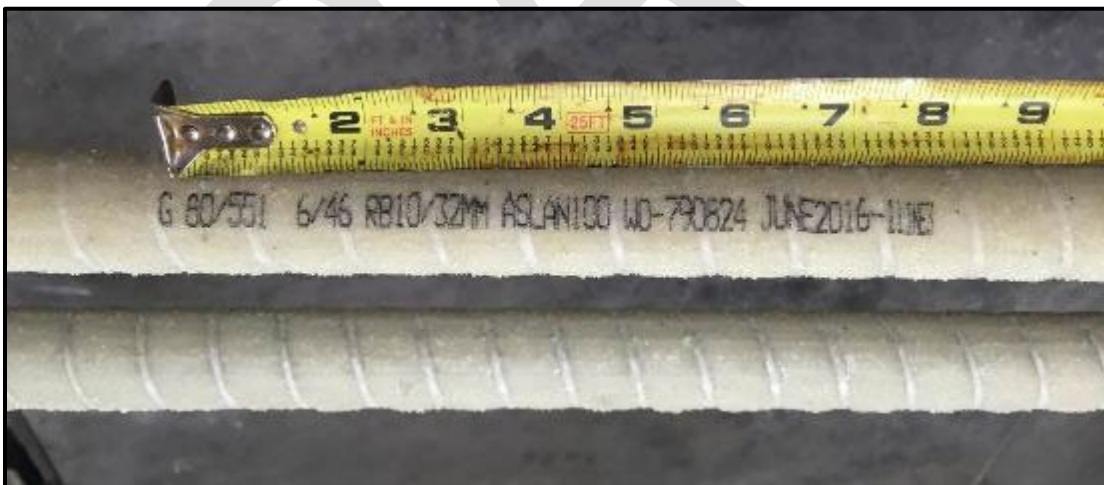
Figure 28 – Legible bar marking.

The rebar in Figure 28 is an Aslan GFRP rebar, manufactured by Hughes Brothers, Inc. This product is no longer listed on the ministry's DSM.

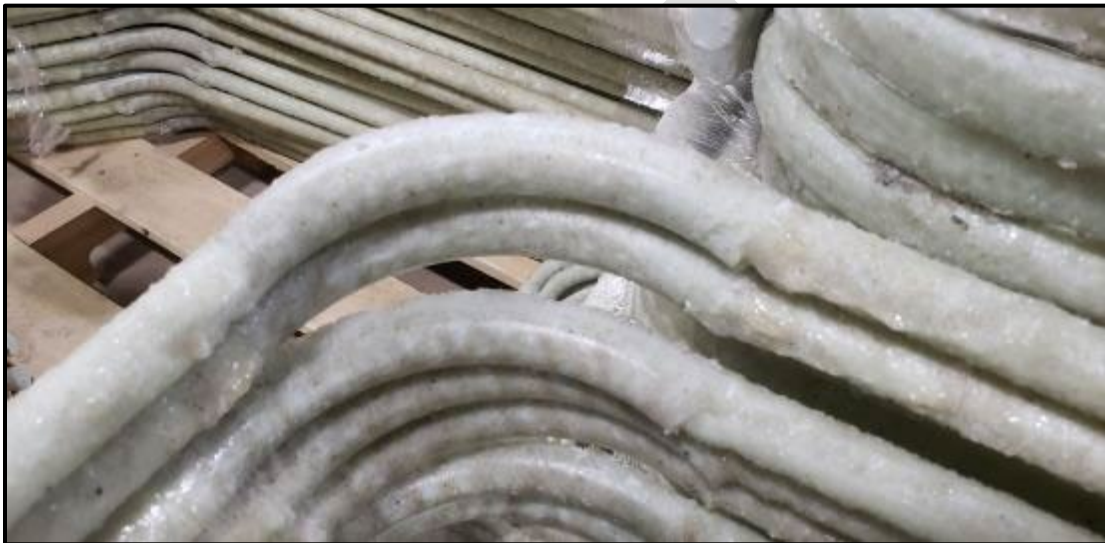
Figure 31 – Inside of bend loss of sand coating

Over the arc of the bend of bent bars, it is acceptable to have a loss of sand coating on the inside surface of the bend such as in Figure 31. The exterior of the bend should still have a uniform sand coating.

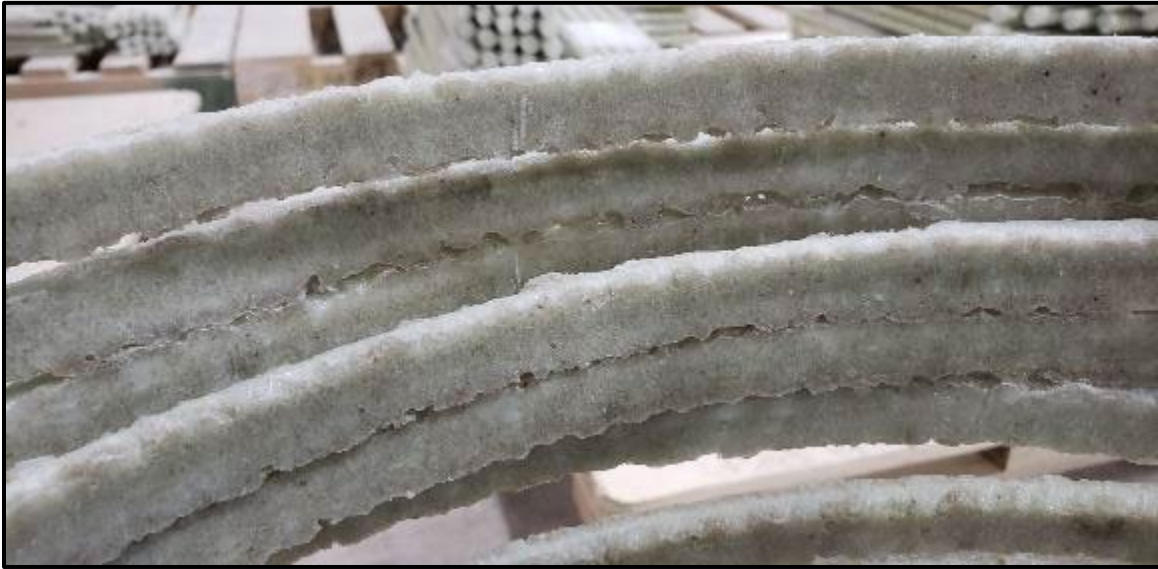
It is acceptable for the inside surface of bent bars to be flat through the bend provided the flatness is uniform through the bend and there is no loss in cross sectional area of the bar.

Figure 32 – Typical spiral with uniform, flat surface on inside of bend

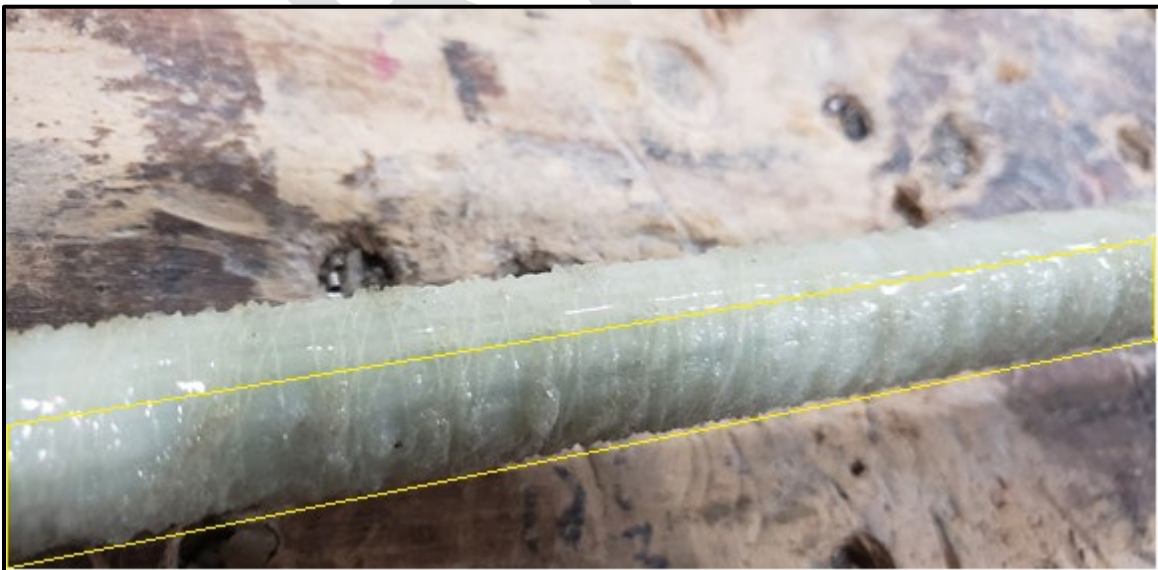
The examples in Figure 33 to Figure 37 include small accumulations and runs of excess resin which are smaller than 4mm. These defects are within the permissible size limits of other defects in the specification and may be considered acceptable.

Figure 33 – Resin run along straight portion of bent bar (usually smooth and shiny)

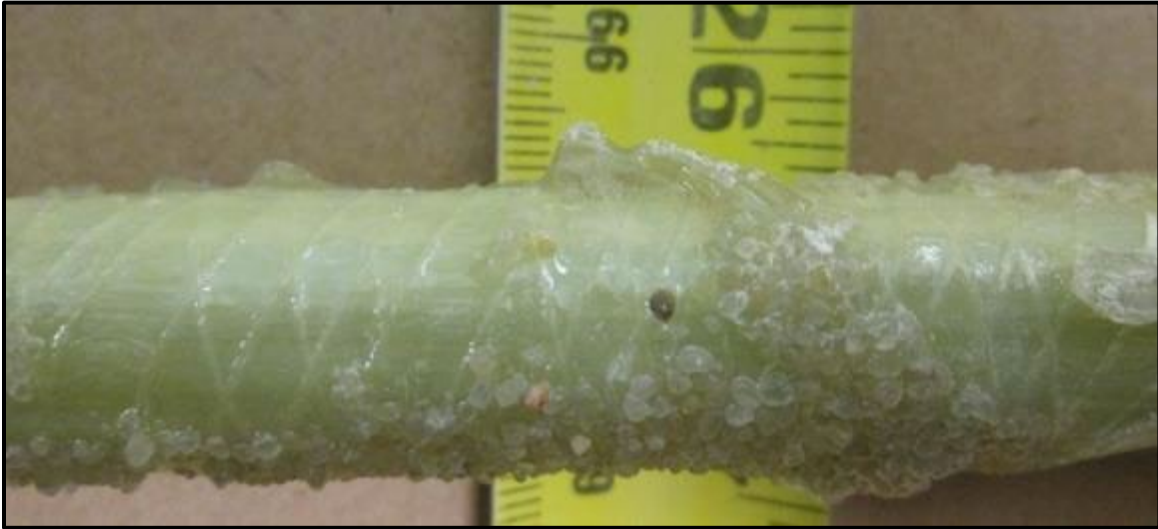
Figure 34 – 4mm resin accumulation

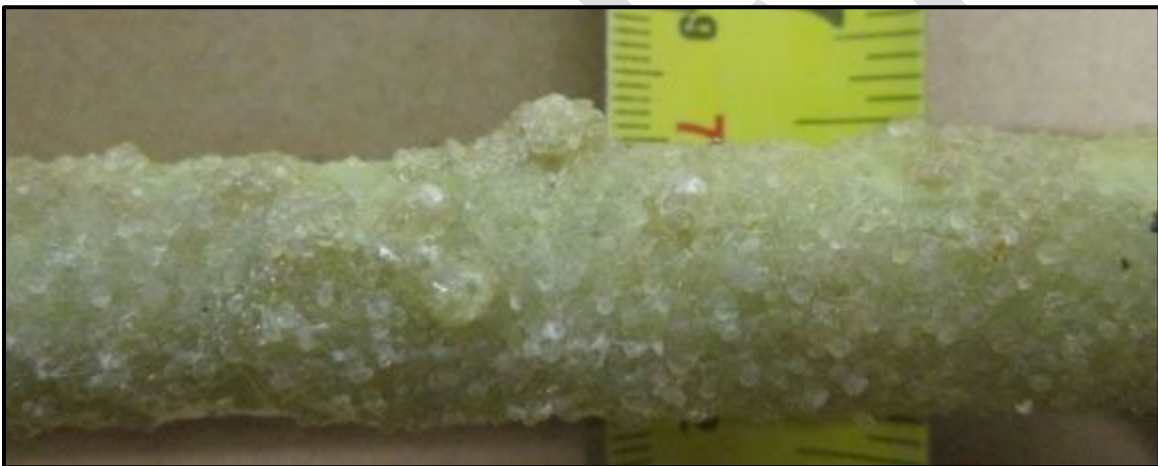
Figure 35 – 3mm resin accumulation

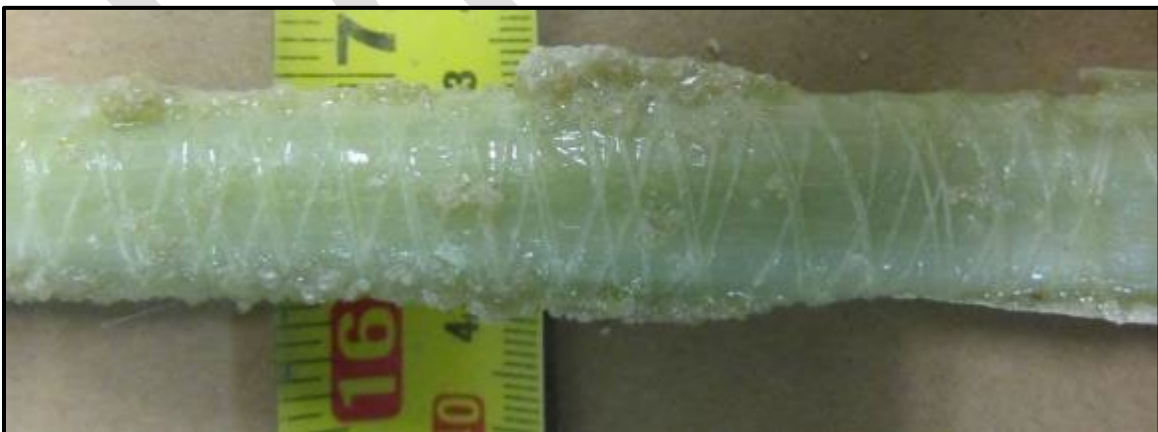
Figure 36 – 4mm resin accumulation

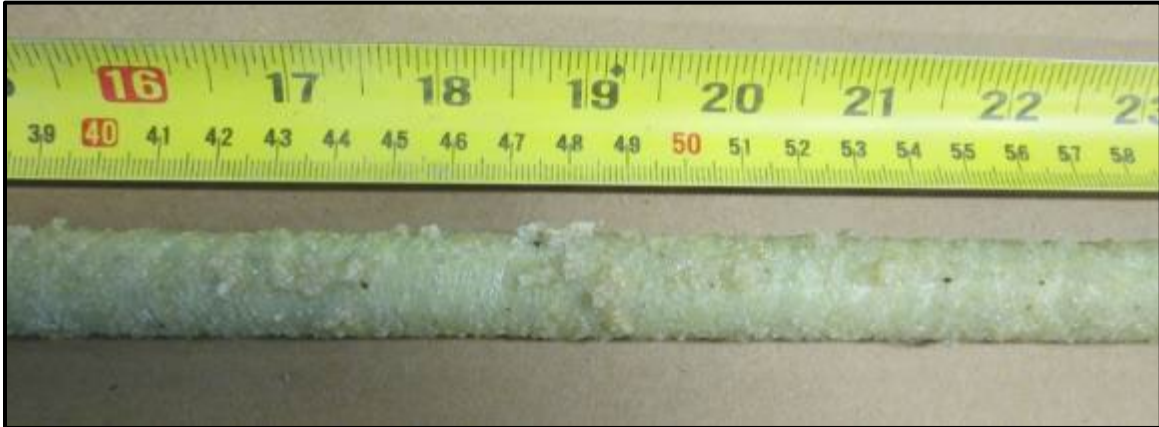
Figure 37 – Random resin accumulations

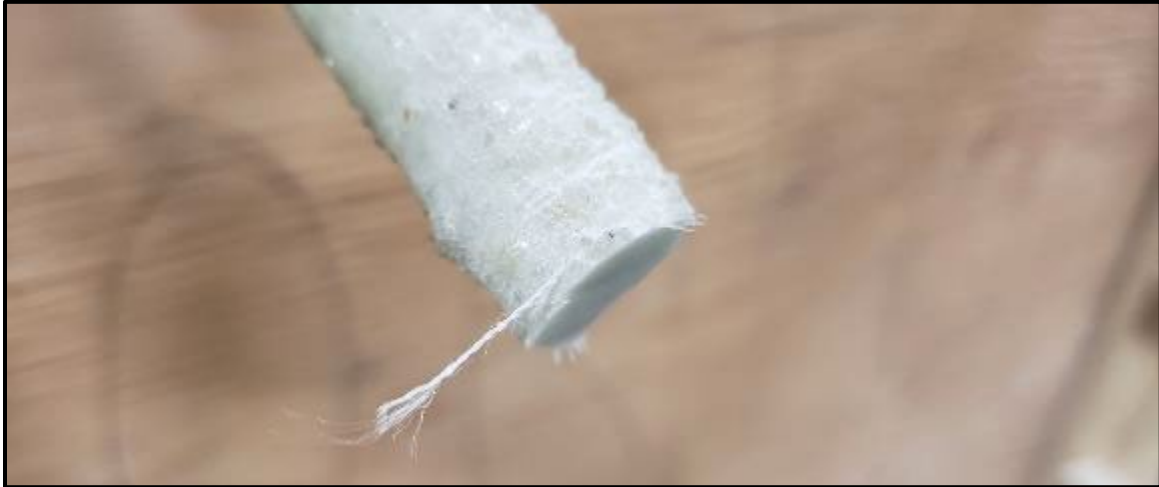
Figure 39 shows a nylon strand detached from the bar exterior, but this does not constitute a core fibre of the reinforcement contributing to tensile properties. There may be multiple detached exterior strands, but they should not appear frayed and should not involve any core fibres.

Figure 39 – Detached nylon strand

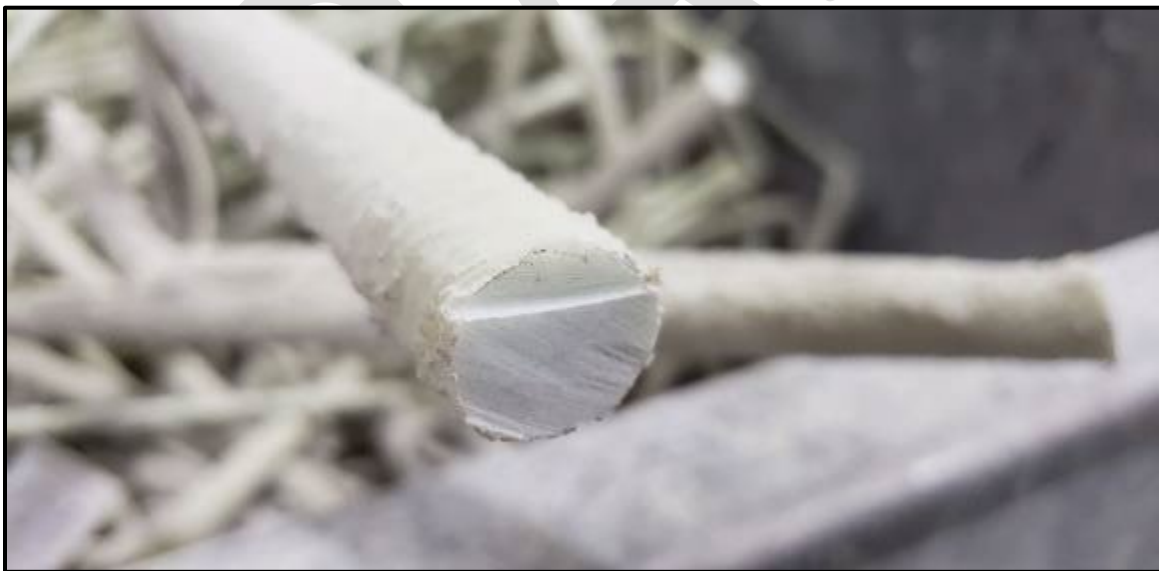
Figure 40 is an irregular cut, however it is at the end of a bar. Ends of bars may have irregular or non-uniform cuts. Shallow cuts not at ends, less than 0.7 mm deep for bars of size 15 or less, and less than 1.0 mm deep for larger bars are also acceptable (Figure 41).

Figure 40 – Irregularly cut bar end

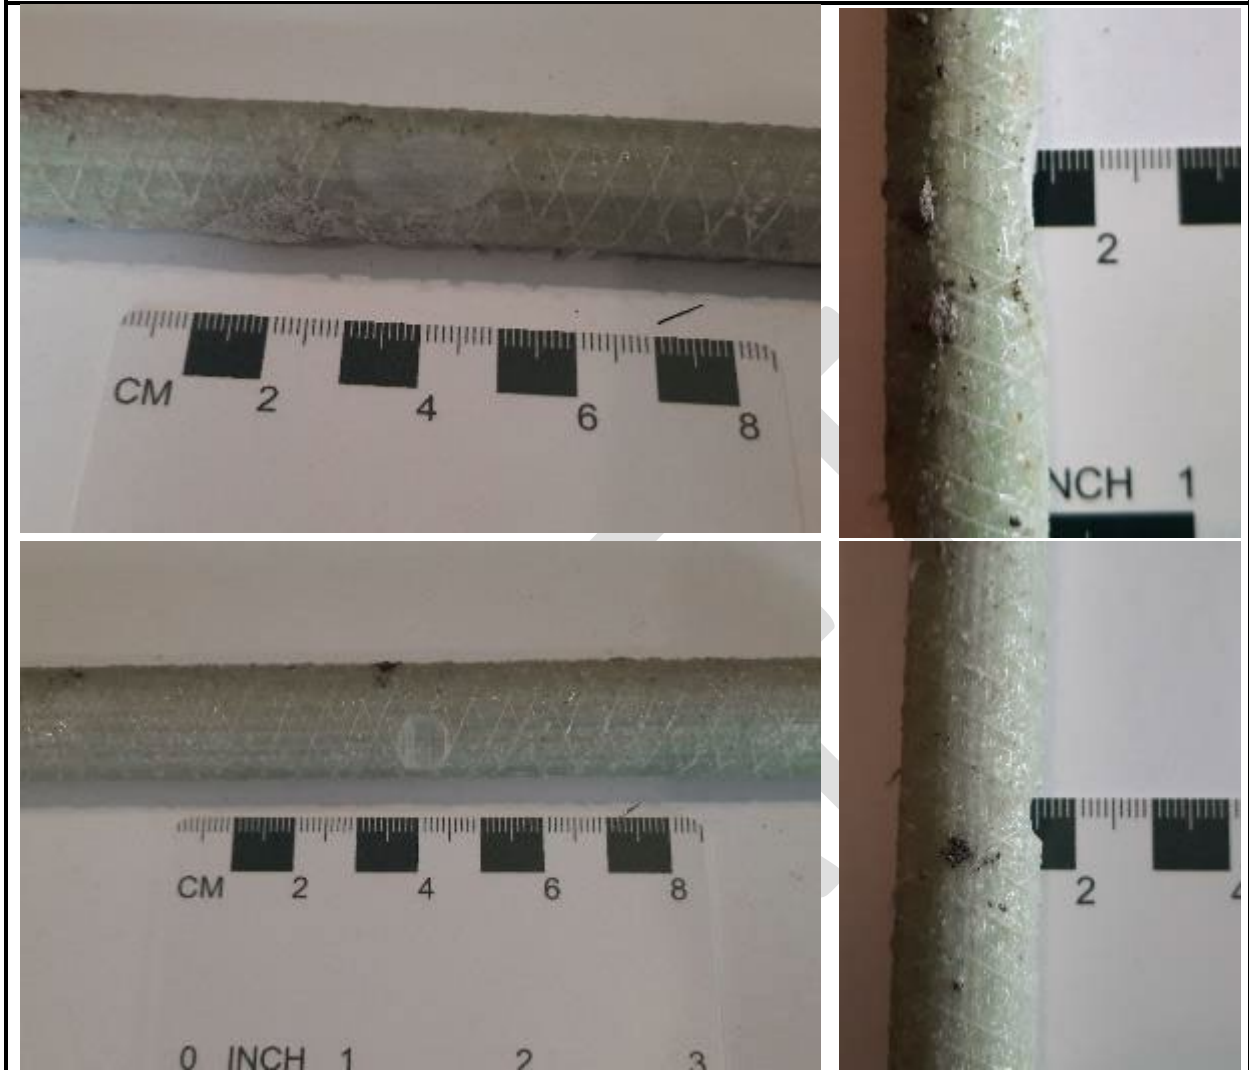
Figure 41 – Shallow cuts

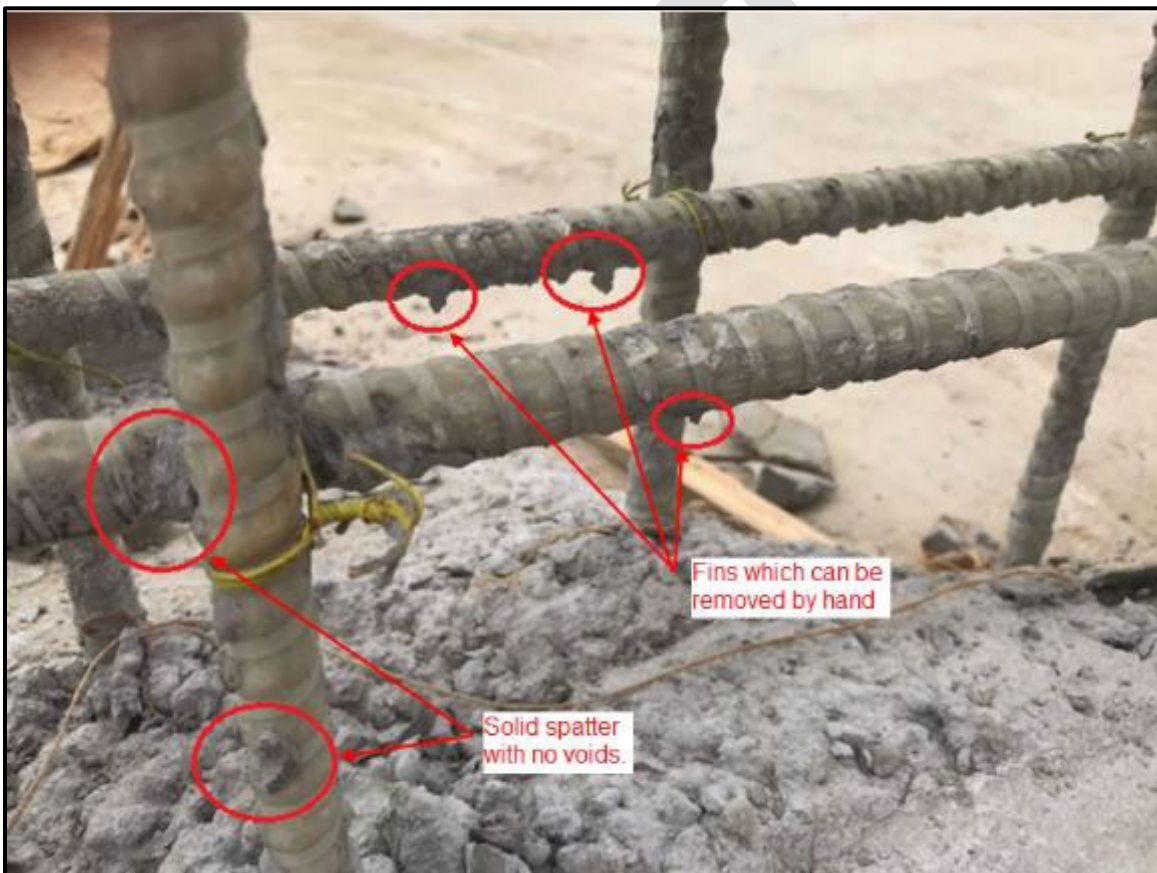
Where the contractor has proposed to leave concrete contaminated bars in the work, the Contract Administrator will need to make a subjective evaluation of the contamination. The quantity of contamination should be small; the appearance should be uniform and not include voids. GFRP bars are brittle, but they are not fragile. Where possible, concrete contamination may be removed by hand and light manipulation, but bars shall not be struck by tools such as hammers to remove concrete. Figure 42 is an example of concrete contamination that was incorporated in the work of a construction contract.

Figure 42 – Example of incorporated concrete contamination

The fins should be broken off by hand and the remaining concrete should be checked to ensure it is comprised of solid, well bonded pieces.

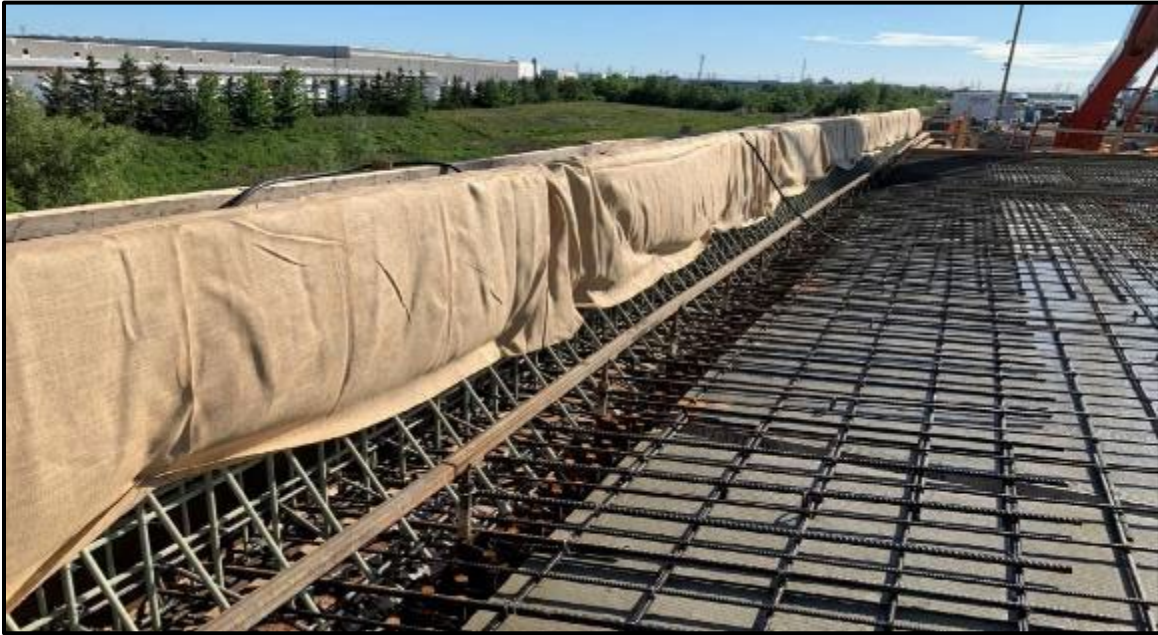
Figure 43 – Barrier GFRP covered with burlap

It is preferable to provide a system to protect bars from any contamination to avoid this situation. Examples of protection used on MTO construction contracts has included draped plastic and/or burlap over bars (Figure 43), and plywood sheets between concrete discharge and adjacent bars. The bottom of the barrier GFRP in Figure 43 should also be covered to at least the bottom of the screed rail during concrete placement.

It is suggested that white polyethylene sheeting is a cost-effective way of protecting installed bars from both element exposure and concrete contamination.

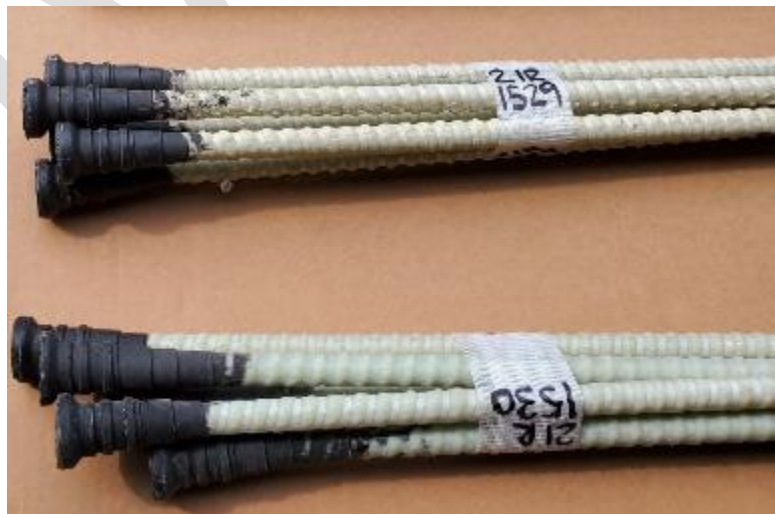
Figure 44 shows different coloured anchor-headed bars from the same production lot. The colours are uniform and are likely related to typical batch-to-batch variations in colourants (additives) during manufacture. This may be considered acceptable.

Figure 44 – Different coloured headed bars from the same production lot

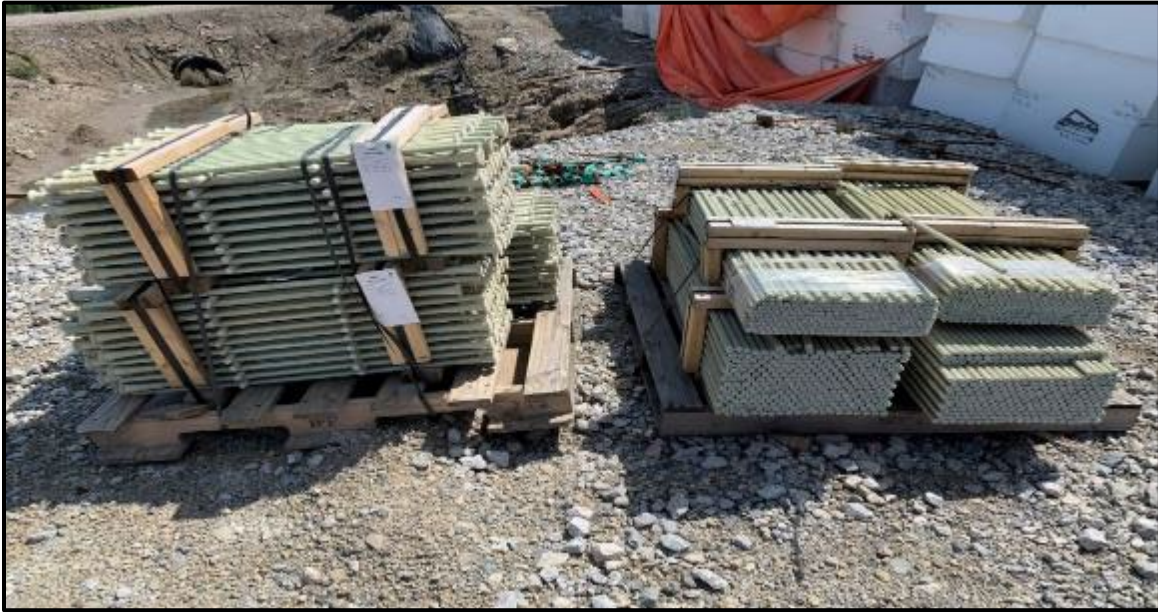
Figure 45 is an example of good storage cribbing for GFRP on site and keeps bars away from direct contact with the ground. When there is not ongoing work to place bars, they shall be covered, protected from sunlight and rain exposure.

Figure 45 – Good storage cribbing

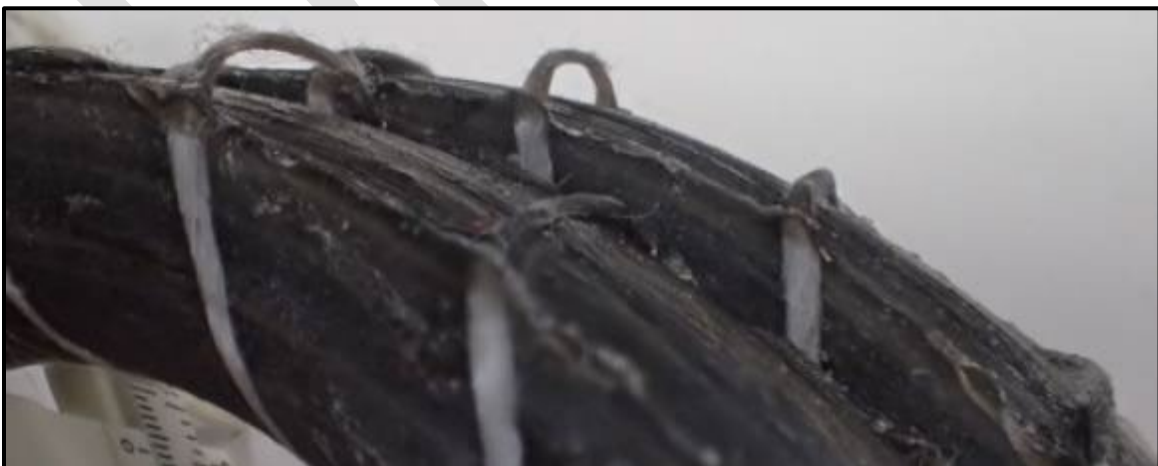
The loose wrapping in Figure 46 does not contribute to the strength of the bar. The wrapping helps maintain bar shape during fabrication but has no structural function in the cured bar. These bars are acceptable.

Figure 46 – Loose wrapping

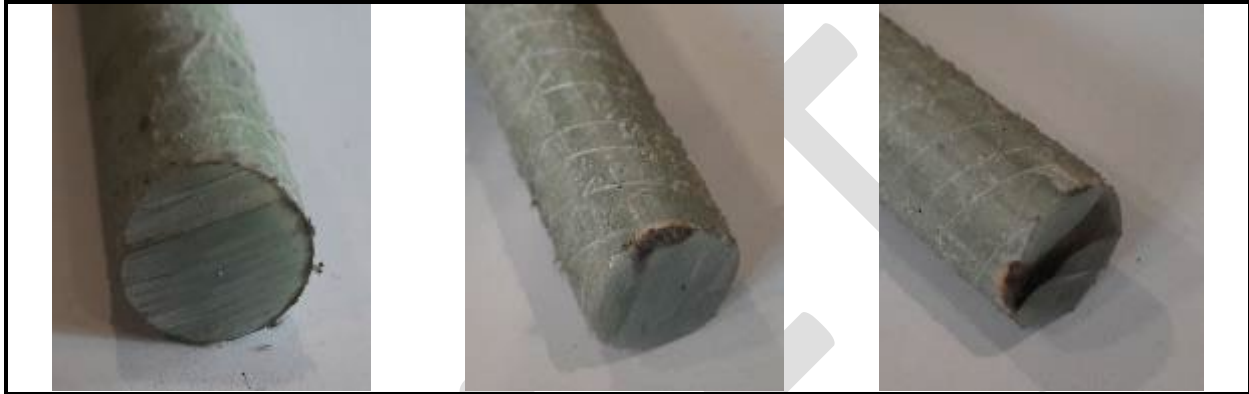
It is expected that factory produced bar cuts will have clean faces with no damage. Where there is field cutting of GFRP bars, there may be some minor burn marks at the cut ends depending on the tools used. The photos in Figure 47 show some slight burn marks which may be considered acceptable. The leftmost photo shows some light streaking at the cut end with a thin burn around the circumference of bar which was imparted by a grinding wheel. The second two photos are burn marks from a high-speed cutter.

Figure 47 – Various acceptable burn marks

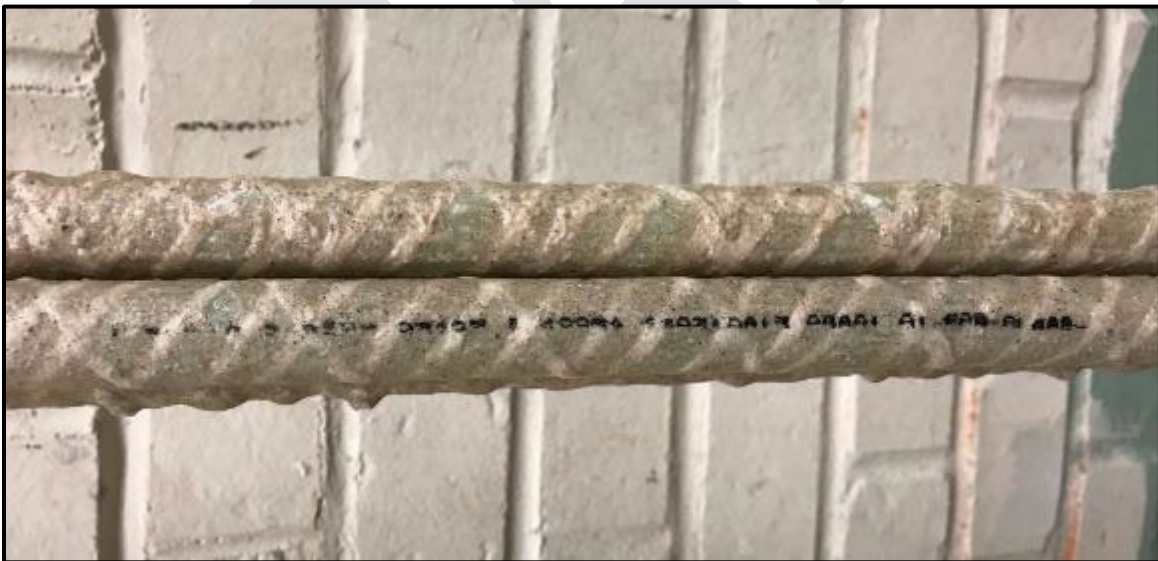
Below is an example of an unacceptable bar identification as the bar marking is not legible or clearly displayed.

Figure 57 – Illegible bar marking

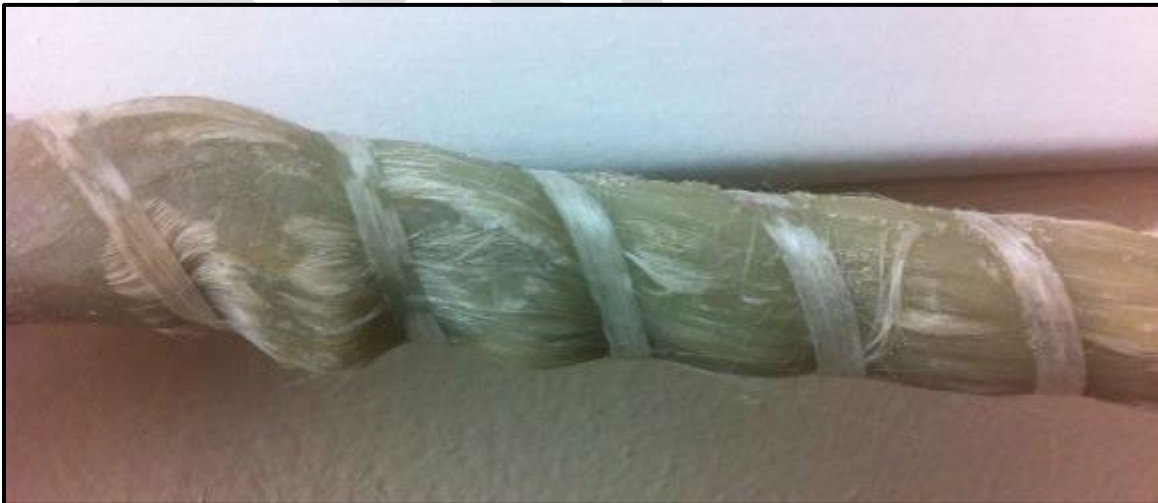
The following examples involve bars with bulges exceeding the bulging limit of 4mm or 25% of the bar diameter, whichever is smaller. These bulging bars cannot be repaired and are rejectable.

Figure 60 – Bulging fibres and inconsistent resin coating

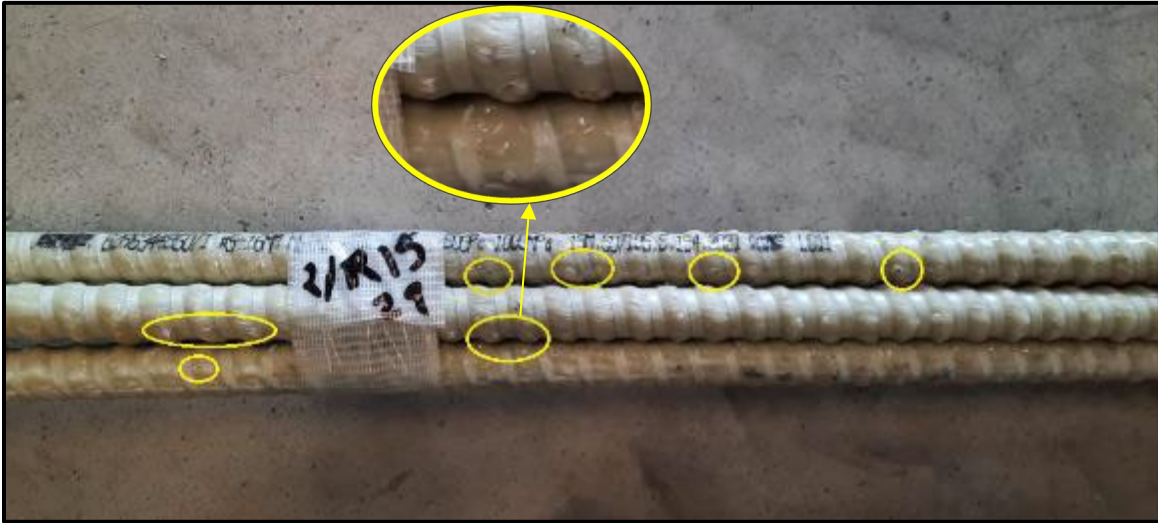
The bar in Figure 63 has multiple voids or air pockets along the surface. There is also a resin run along the ribs of the middle bar.

Figure 63 – Straight bar with voids/air pockets

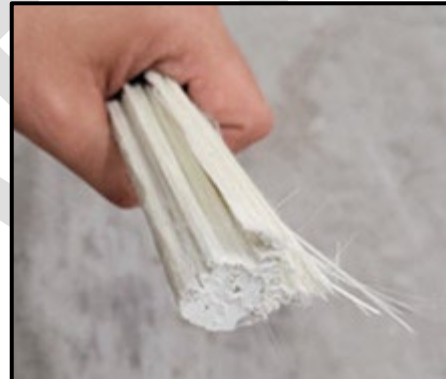
The bar in Figure 75 and Figure 76 has not been cut properly and the end is frayed. The manufacturer could repair this type of defect if sufficient bar length is available. This particular bar cannot be repaired because of other defects.

Figure 76 – Cut bar with frayed ends

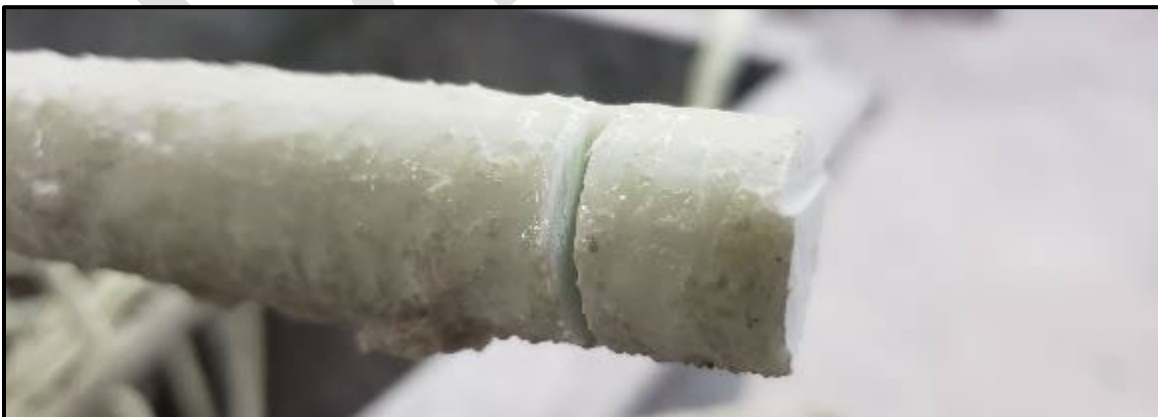
The bar in Figure 77 has a cut with a depth that exceeds the specification limits and is rejectable.

Figure 77 – Deep cut in rejectable bar

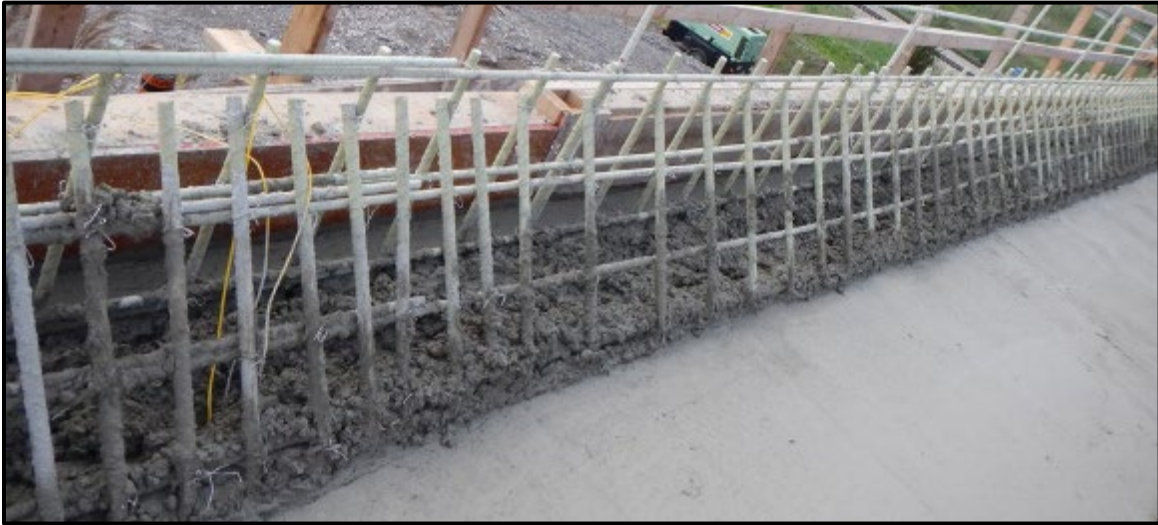
Concrete contamination is not acceptable and all of the bars in Figure 80 and Figure 81 should be rejected. Contaminating bars and then cleaning them is also not acceptable or 'preventative'. The examples shown here are particularly egregious with large quantities of paste and voided clumps of aggregate.

Figure 80 – Concrete contamination

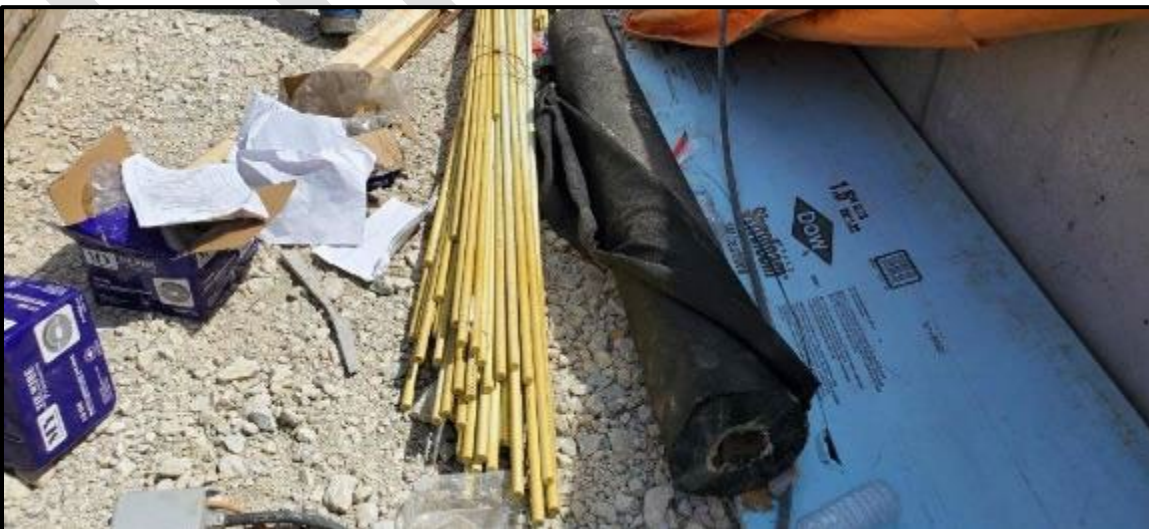
Examples of what could be considered detrimental discolouration from UV exposure can be seen in Figure 85 and Figure 86. There is an obvious discolouration of the exterior bars that were exposed to the sun when compared to bars that did not experience the same exposure from the same bundle.

Figure 85 – UV exposure discolouration

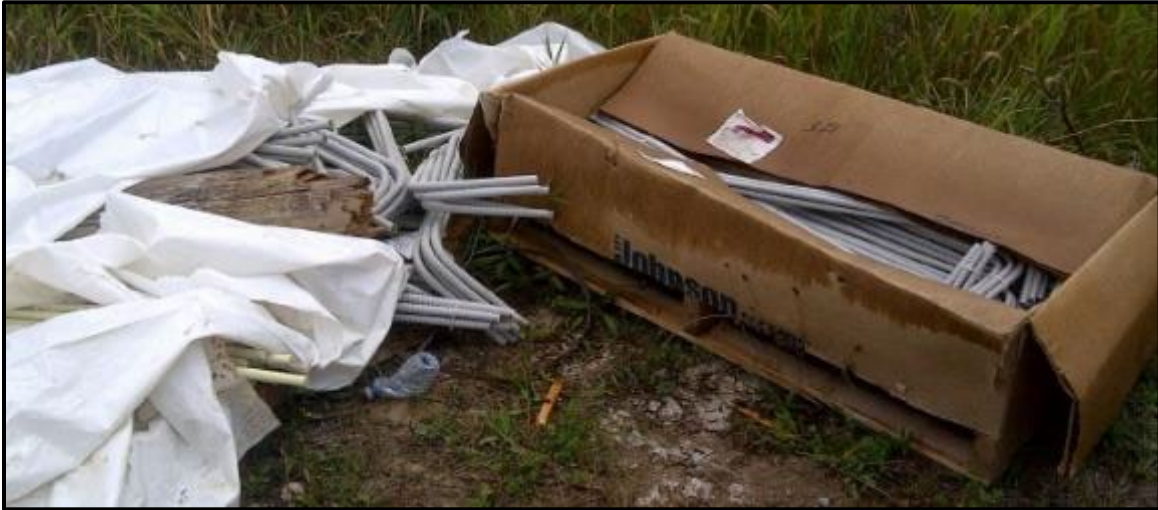
Bars, including bars installed in components, shall be covered with opaque, white polyethylene sheeting, or equivalent protective material during storage. The bars in Figure 89 and Figure 90 are stored well on acceptable cribbing but are not covered with sheeting. This may be considered acceptable if there is active work to lay bars. If bars are not being installed, or there are no plans to install more bars that day, they should be covered. The bars in Figure 88 have been left on the ground, this is not acceptable storage.

Figure 88 – Not acceptable storage of bars

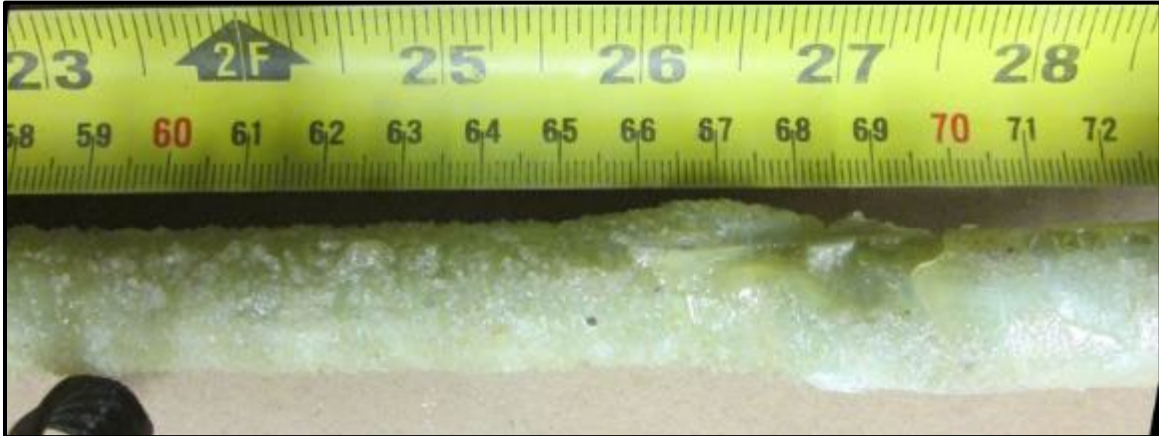
The defects in Figure 98 and Figure 99 are from mis-aligned tooling coming into contact with the bend. This defect is usually accompanied with a large bulging defect, not shown here.

Figure 99 – Mis-aligned tooling print into the bend

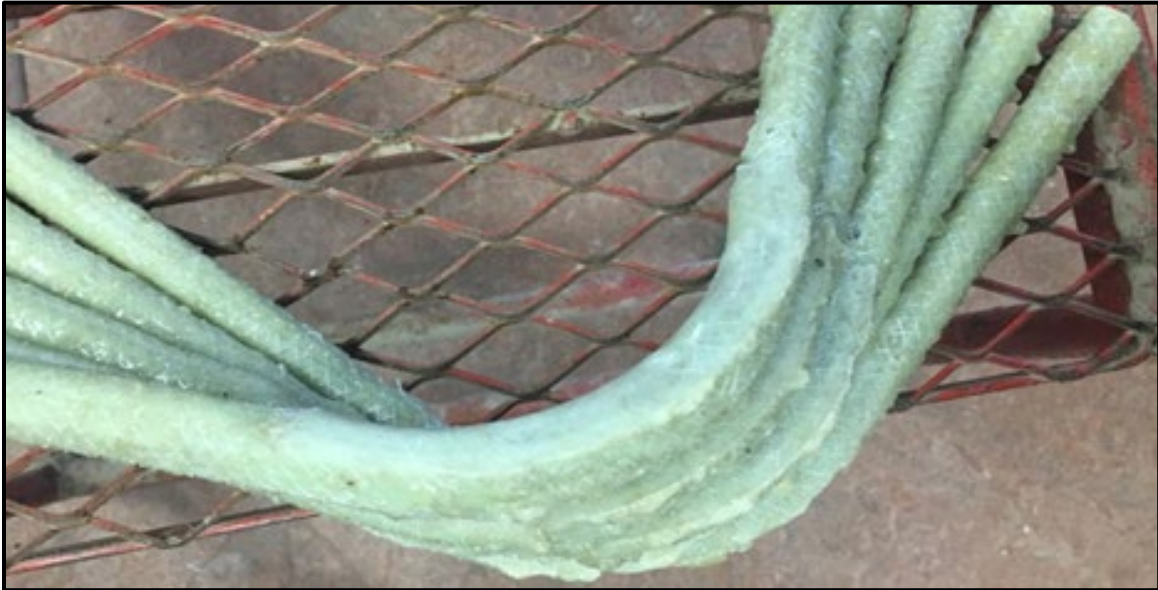
There is an excess of resin built up in multiple locations on the bars in Figure 101 to Figure 103. This inconsistent resin distribution causes the bar not to be homogeneous throughout its cross-section. The guideline for acceptability of excess resin or bulging of fibres on the inside of the bend is 4mm, or 25% of the bar diameter, whichever is smaller, beyond which the bar becomes unacceptable. This only applies to bulging or bumps, not flattening of the cross-section at the bend.

Figure 103 – Resin build-up on outer circumference of bend
