Posting Title: Update to Guidelines for Inspection and Field Acceptance of Glass Fibre Reinforced Polymer (GFRP) Reinforcing Bars

TCP #: 000-0092

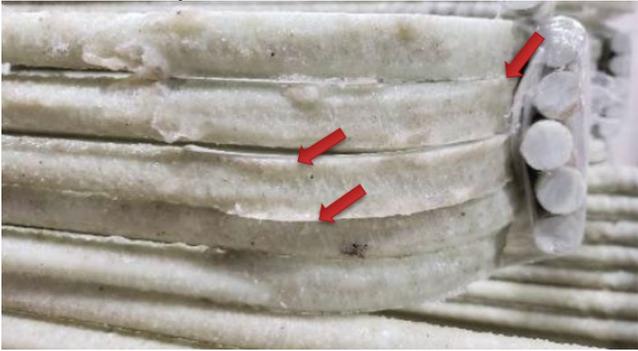
<p>Clause 4.2.3 Further clarifications needed with regards to acceptable vs nonacceptable flattening of the bar.</p> <p>Clause 4.2.3 <i>“It is acceptable for the inside surface of bent bars to be flat through the bend provided the flatness is uniform through the bend and there is no loss in cross sectional area of the bar”</i> Is there a guideline for site to identify acceptable cross-sectional area?</p> <p>Figure 23 is showing flattening at the outside of the bend, is this acceptable?</p>	<p>Some flatness of the inside radius of the bar is expected because of the forming process for bent bars. The degree of flatness is also dependent on the bend radius of bar, which is determined by design detailing and not the FRP manufacturer.</p> <p>Design instruction is provided in the <i>Structural Manual</i> and other standards and will be provided in the CDED to avoid small bend radii which result in excessive flattening or flattening of the outside of bar.</p> <p>There is no visual guideline provided for cross-sectional area of bar. The bar is expected to be round or almost entirely round, with an area that meets the requirements of CSA S807. As there is a strength reduction of bar throughout the bend, section loss is not acceptable.</p> <p>Figure 23 is in Section 4.1 which is for typical surface finish of bars. The surface finish of all the bars in the figure is acceptable. For defects, the bars would need to be evaluated on site from multiple viewing angles. From just this figure:</p>

<ul style="list-style-type: none"> • The 2nd bar is generally acceptable. There is a flat edge (top right arrow), but it appears to be at the end of bend and is likely just excess resin. • The 3rd bar is questionable. There is some excess resin with tooling marks shown with the double arrows below, and the outside face is slightly concave. Rejection would depend on where the bars are located within a structure, how often this irregular shape occurs in the production lot, and whether the flat edges are entirely excess resin or if the bar shape/fibres are also affected.

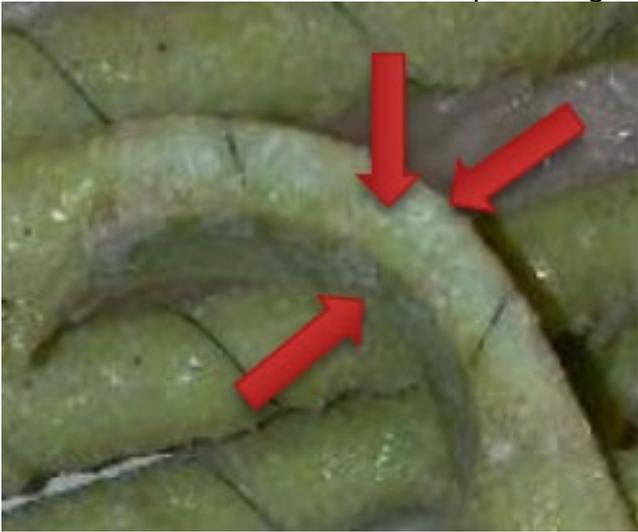
<p>5.1.4. Excessive Flattening / Non-uniform Finish; <i>The bends of the bent bars shown in Figure 61 exhibit excessive flattening about the curves. This condition cannot be repaired, and the bars must be rejected. Is there a guideline to identify “excessive flattening”</i></p>	<p>As above, this can be avoided with appropriate bend radii and should be addressed in design. No guidance is provided on when flatness becomes excessive, but bars should be round and not have square edges.</p>

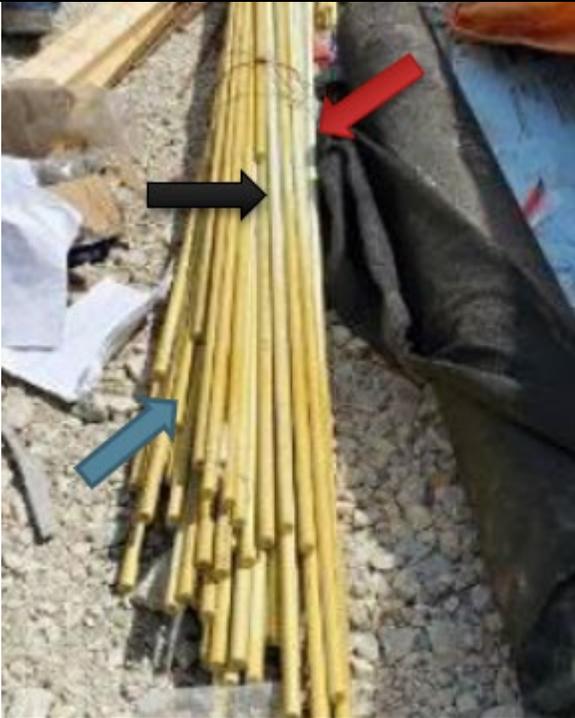
<p><i>light manipulation, but bars shall not be struck by tools such as hammers to remove concrete”</i></p> <p>This note prompts us to ask If use of vibrators is acceptable? Is there a time limit for concrete splatter removal?</p>	<p>shall be removed immediately while the concrete is still plastic without damaging the bars.</p> <p>It is preferable to prevent splatter contamination than to try and remove the plastic concrete. Covering bars with polyethylene sheeting meets requirements for protection of bars from UV exposure and can also prevent concrete splatter contamination.</p> <p>The use of vibrators to consolidate plastic concrete is acceptable. Brief contact of the vibrator with the reinforcing is assumed; the vibrator should not be used to deliberately ‘rattle’ the reinforcement cage.</p>
<p>4.2.6. Discolouration; Further clarifications needed with regards to images provided for acceptable vs nonacceptable discolorations</p> <p><i>“Unacceptable discolouration from UV exposure or manufacturing processes can typically be identified from <u>nonuniform</u> colouration. “The note is clear however the images from acceptable and nonacceptable bars are confusing. Example: Acceptable Figure 51, 52, vs Nonacceptable Figure 85, 86 they all show similar colors and the discoloration appear uniform</i></p>	<p>Figure 51 and 52 are listed under 4.3 Surface Finish and are not demonstrating discoloured bars.</p> <p>Figure 44 in 4.2.6 shows different coloured bars from the same production lot. This difference is not a result of UV exposure and each bundle of bars is generally uniform in appearance.</p> <p>Figure 85 has discoloured bars within the same bundle from the same lot. You can see the production colour of the bar from the red arrow and the UV discoloured condition in the blue arrow. There are also visible transition points around the black arrow where some portion of bar was protected from UV exposure, and other sections of the same bar were not.</p>
