PART 2 – DETAILED VISUAL INSPECTION

2.5.6 Steel – Substructures and Superstructures

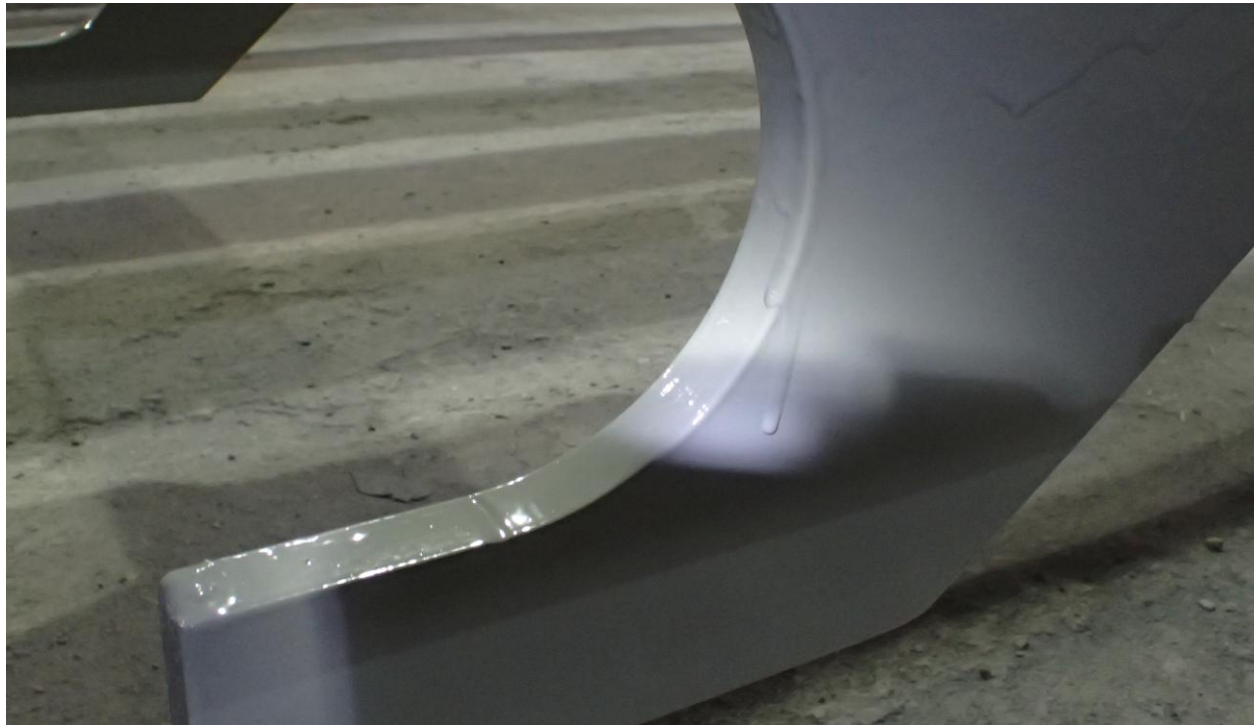
Figure 2.5.5.11 Runs and Sags

Application-Related Defects	Bridging	Coating bridges across tight corner or debris forming void. Void can trap moisture and oxygen		ALL	
	Edge Defects	Coating pulls away from sharp edges and corners. Due to insufficient application of coating at edge		ALL	
	Shadows	Coating is applied too thin in the shadow of a rivet, bolts, or other abrupt change in surface		ALL	
	Overspray	Some paint particle outside spray pattern dry prior to full coating. Leads to some absorbed solvent and a more porous surface		ALL	
Pin holing	Air bubbles trapped in coating creating voids. Caused by holding spray gun too close		ALL		
Runs	Downward movement of paint. Caused by over-thinning or depositing too much paint at one time		ALL		
Sags	Like runs, the downward movement of 'curtain' of paint		ALL

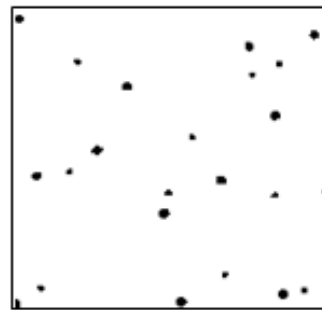
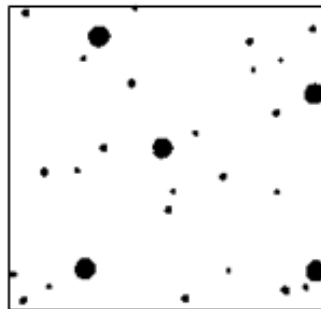
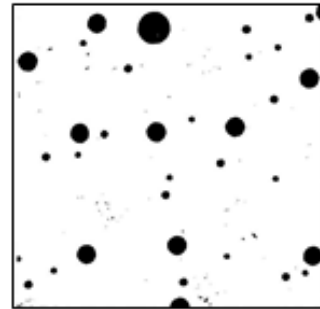
Condition State: Excellent
Category 1: No Rust

Condition State: Good
Category 2: Light Surface Rust

Condition State: Fair
Category 3: Medium Surface Rust

Condition State: Poor
Category 4: Severe Surface Rust

Figure 2.5.5.12 Rust Condition Rating Categories for Coatings

DEFECT		CONDITION STATE		
		GOOD (LIGHT)	FAIR (MEDIUM)	POOR (SEVERE)
Rust Condition Rating		Rust condition rating is a visual rating of the surface appearance and is based on ASTM D610 sketches and is also shown in Figure 2.5.5.12 Rust Condition Rating Categories for Coatings		
		Rust Condition Rating 2	Rust Condition Rating 3	Rust Condition Rating 4 or more
Coating-Related	Checking or Cracking	Fine system of minute cracks in a checkerboard pattern. Caused by weathering and exposure during curing		
			ALL	
	Cracking	Linear pattern of crack penetrated through coating. Results from weathering, continuing polymerization or shrinkage		
			ALL

Pinpoint Rusting	Rusting visible at point locations. Caused by insufficient coating thickness on peaks of blast cleaned substrate
		Rate based on appearance and Rust Condition Ratings.

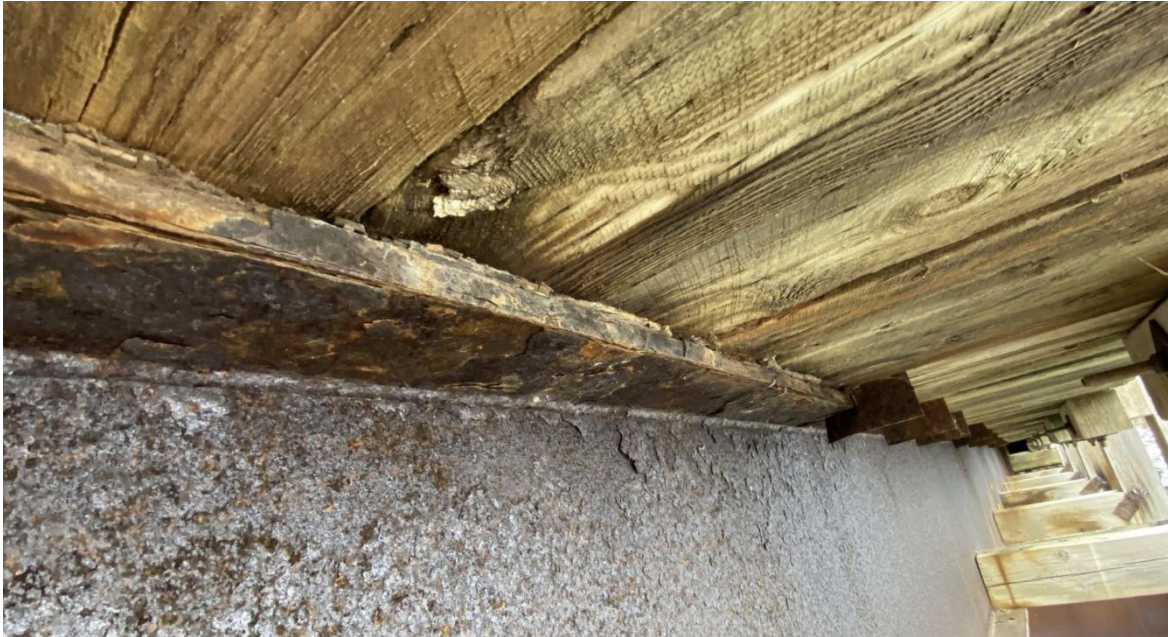
Figure 2.5.6.1 Medium Corrosion of Steel Beam

Rust on carbon steel is initially fine grained, but as rusting progresses it becomes flaky and delaminates exposing a pitted surface. The process thus continues with progressive loss of section.

Corrosion in steel is illustrated in Figure 2.5.6.1 and Figure 2.5.6.2.

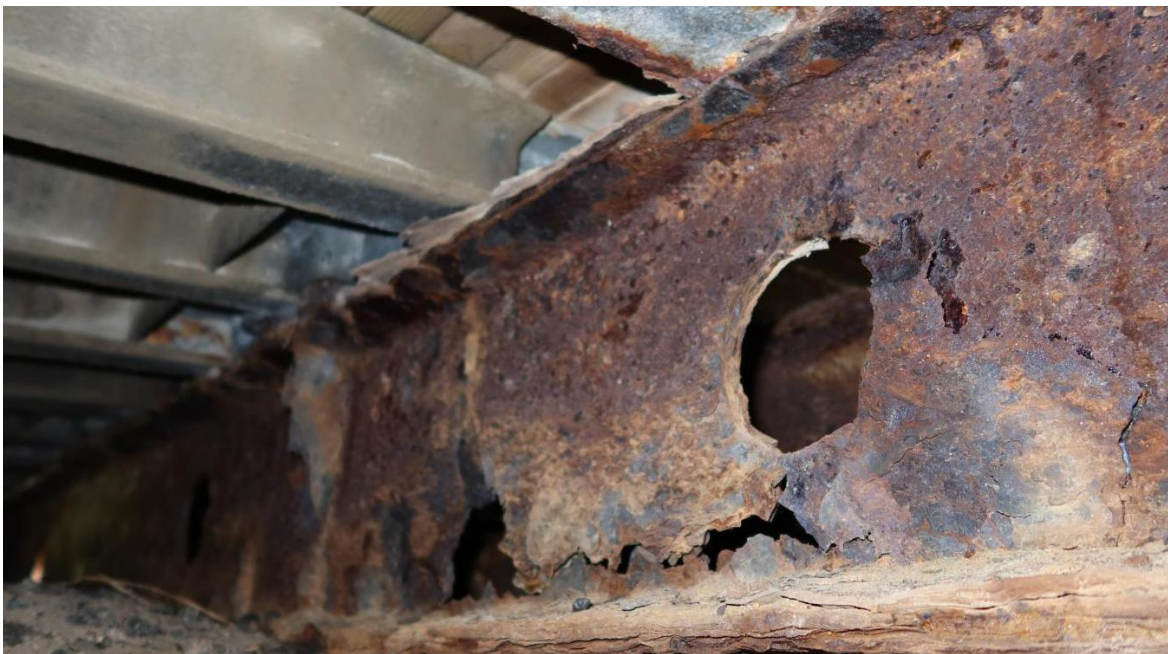
Figure 2.5.6.2 Severe Corrosion of Steel Beam

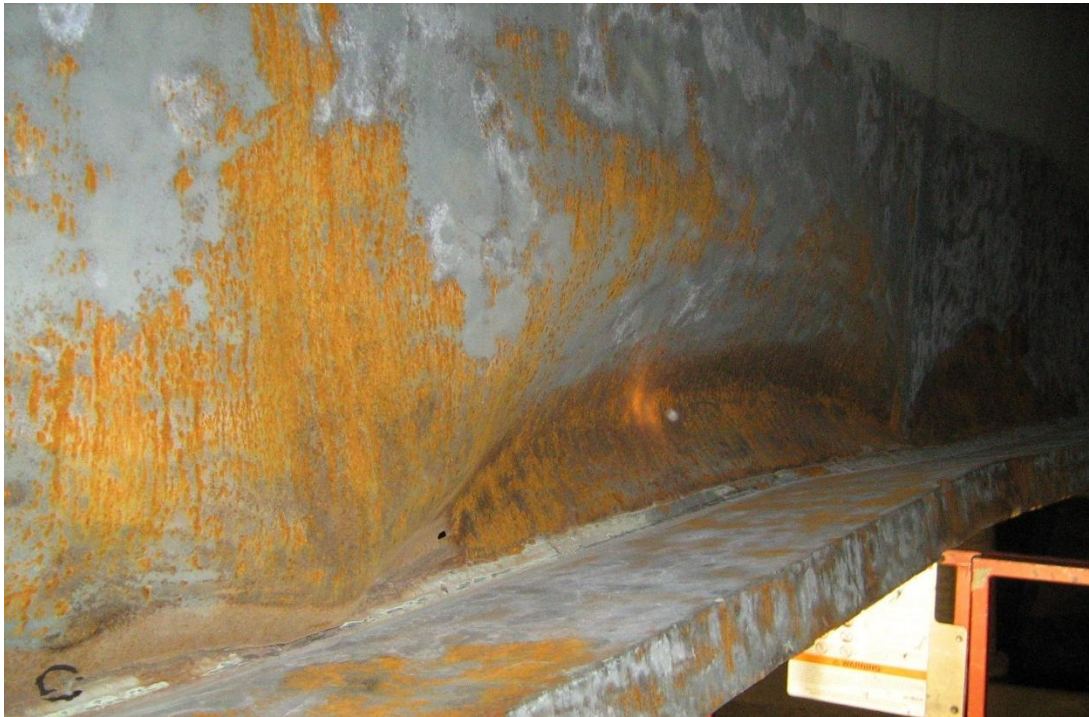
Figure 2.5.6.3 Severe Deformations Caused by Impact

Permanent deformation of steel members can take the form of bending, buckling, twisting or elongation, or any combination of these. Permanent deformations may be caused by overloading, vehicular collision, or inadequate or damaged intermediate lateral supports or bracing. See Figure 2.5.6.3.

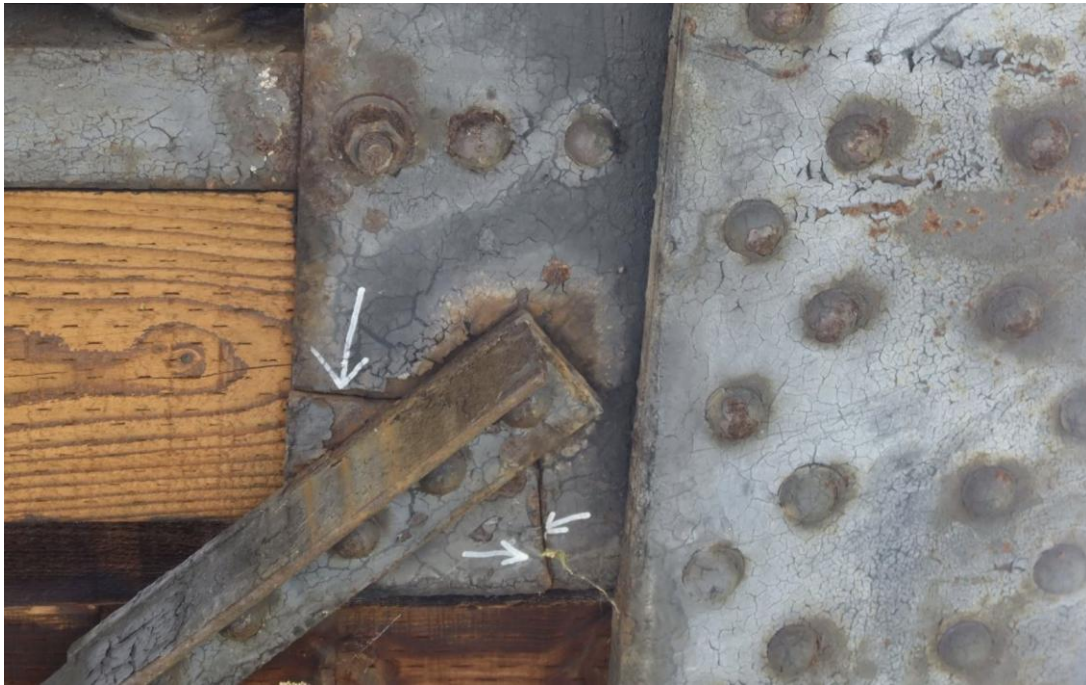
Figure 2.5.6.4 Cracks in Gusset Plate

Cracking in a gusset plate is shown in Figure 2.5.6.4.

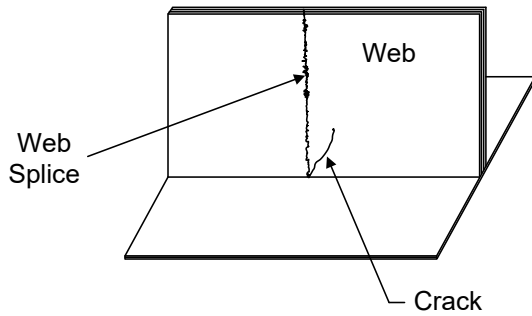
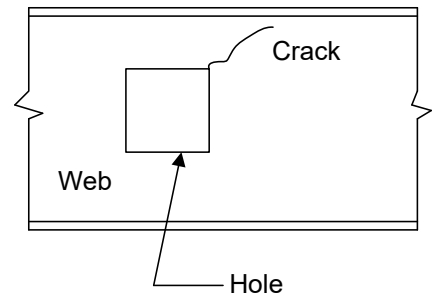
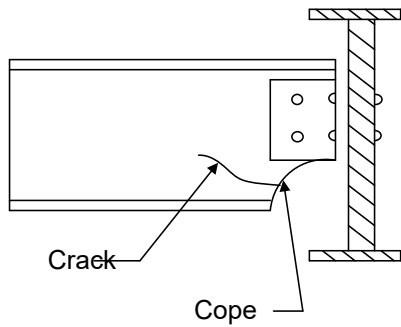
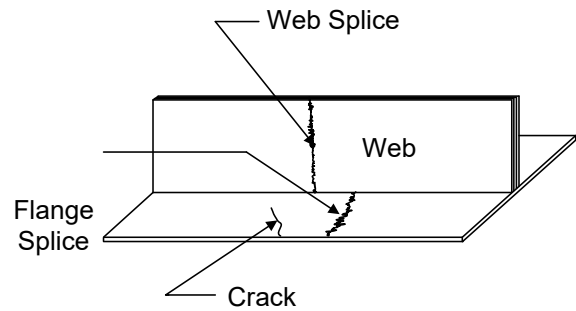
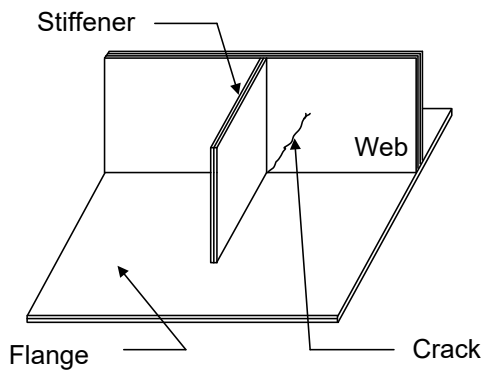
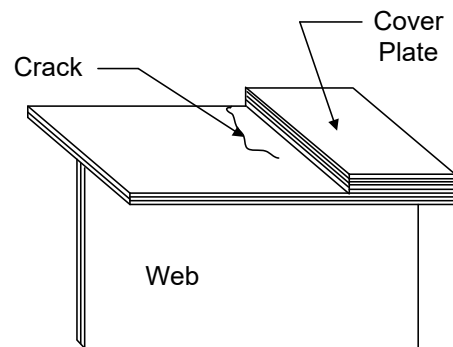
Crack in Web at Web Splice

Crack at Hole in Web

Crack in Cope of Web at a Connection

Crack in Flange at Flange Splice

Crack in Web at Stiffener

Crack at End Weld of Flange Cover Plate

Figure 2.5.6.5 Common Crack Locations in Steel

Common locations susceptible to fatigue cracking are illustrated in Figure 2.5.6.5 and Figure 2.5.6.6. As cracks may be concealed by rust, dirt or debris, the suspect surfaces should be cleaned prior to inspection.

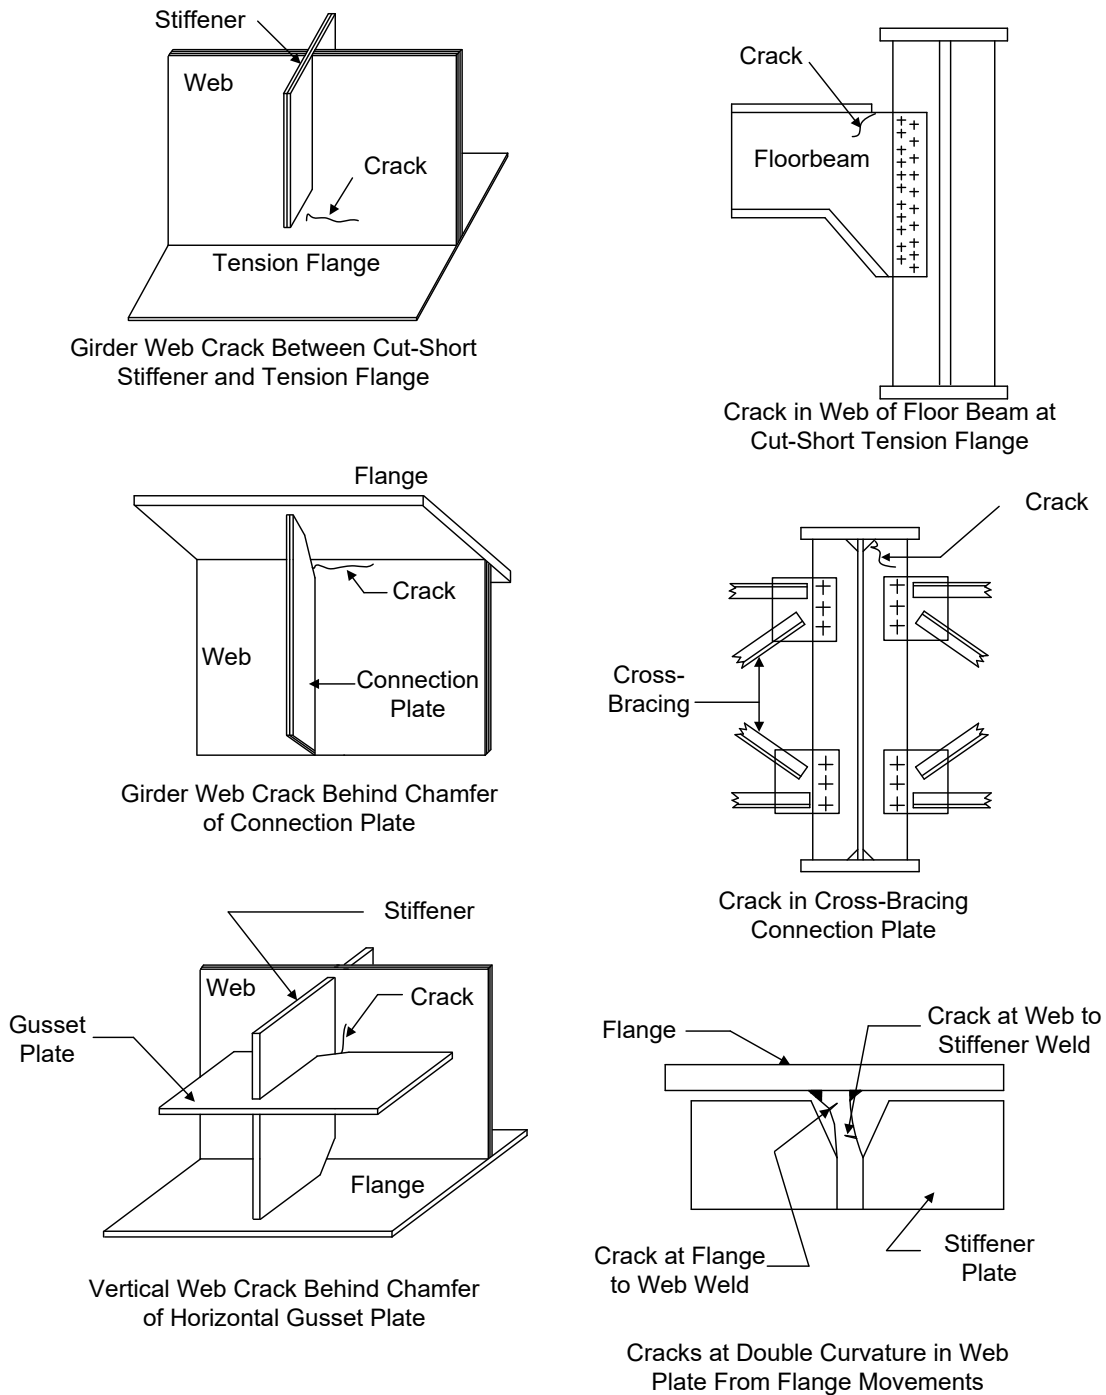
Figure 2.5.6.6 Common Crack Locations in Steel (cont.)

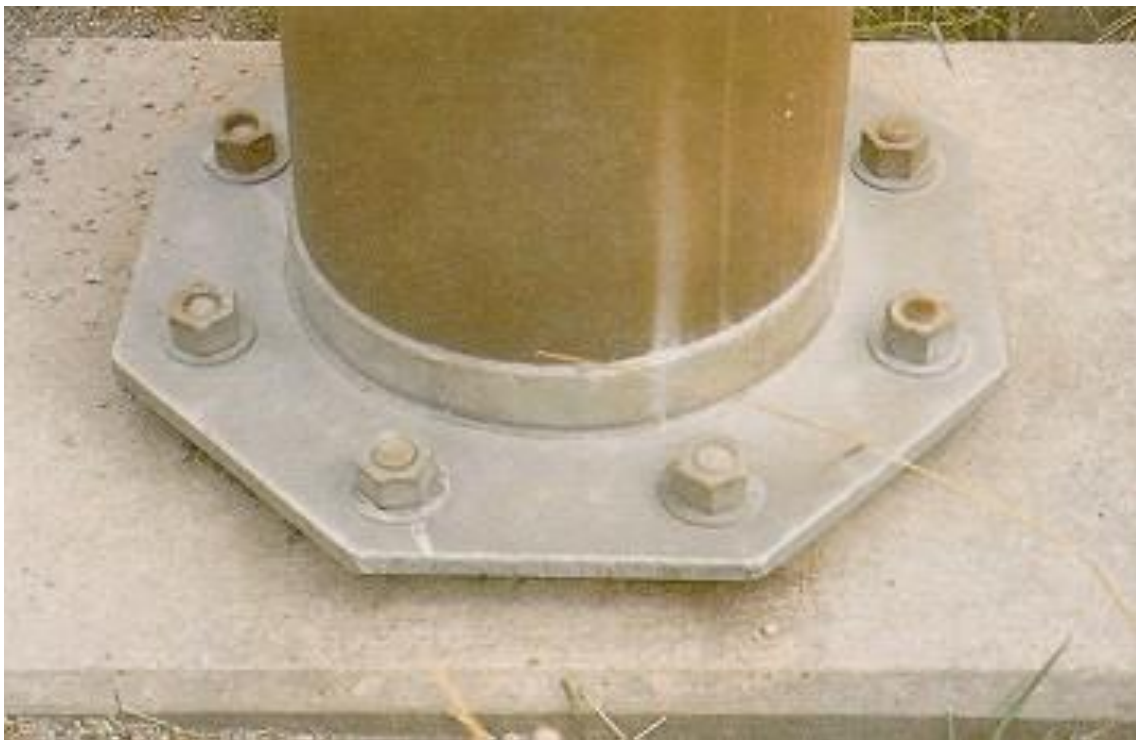
Figure 2.5.7.1 Light Corrosion

CHEMICAL CORROSION refers to the corrosion which takes place when aluminum comes in contact with concrete. When this happens a chemical reaction takes place between the aluminum and lime in the concrete which leads to progressive corrosion of the aluminum and loss of section. An inert spacer or bitumastic coating should be used between the concrete and aluminum to prevent chemical corrosion.

Figure 2.5.7.1 shows typical corrosion in aluminum.

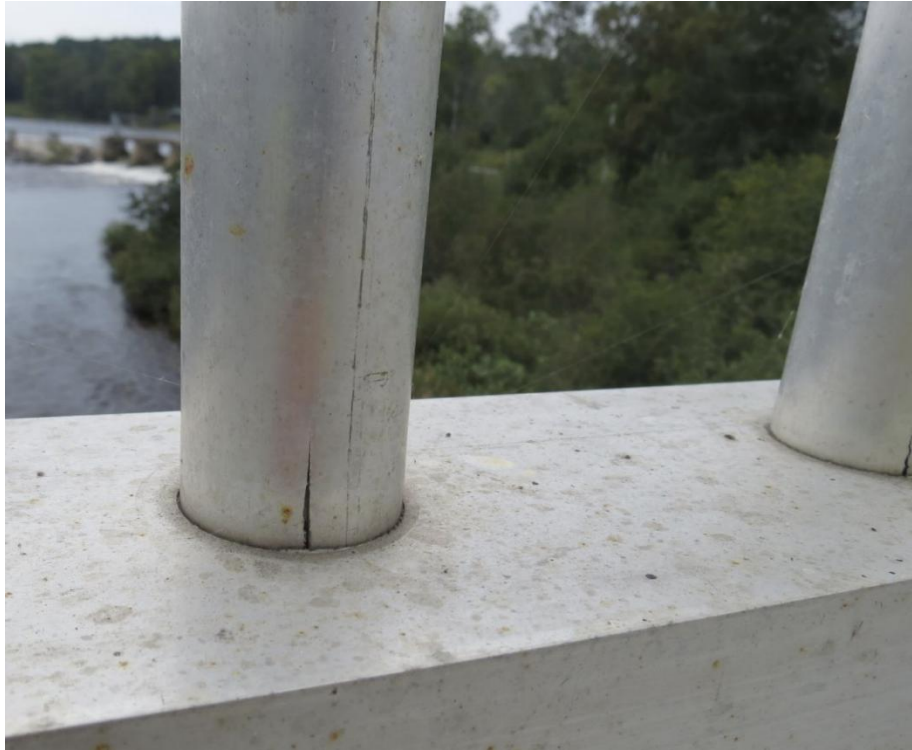
Figure 2.5.7.2 Cracks on an Aluminium Railing

A crack is a linear fracture in the aluminum which may extend partially or completely through the material. Cracks normally develop as a result of fatigue followed by brittle fracture and excessive corrosion. Cracks may also be produced by freezing of entrapped water. Cracks initiate from either the inside or the outside surface of a member and become visible as hairline cracks on the surface. As cracks may be concealed by corrosion by-products, dirt or debris, the suspect surfaces should be cleaned prior to inspection. A crack in an aluminum component is illustrated in Figure 2.5.7.2.

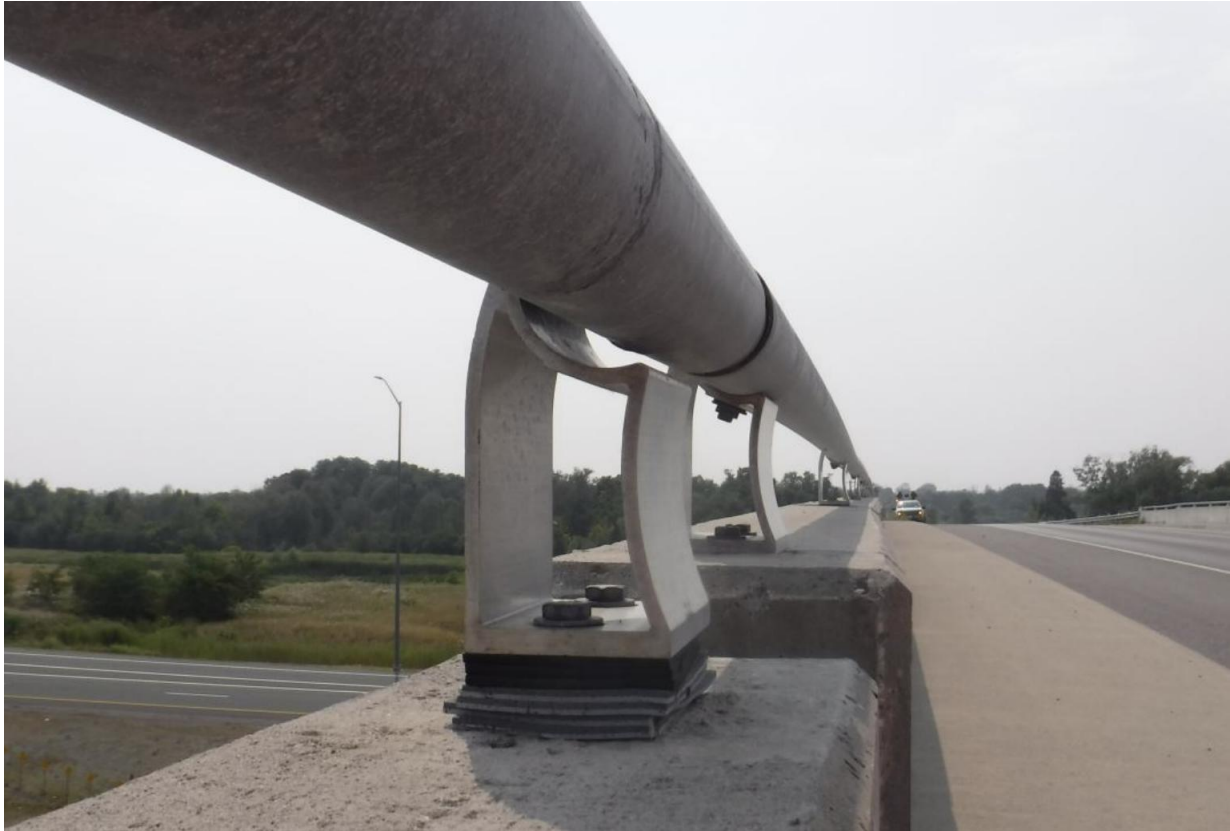
Figure 2.5.7.3 Missing Bolt on Aluminium Hand Railing

Figure 2.5.7.3 shows an example of a missing bolt on hand railings.

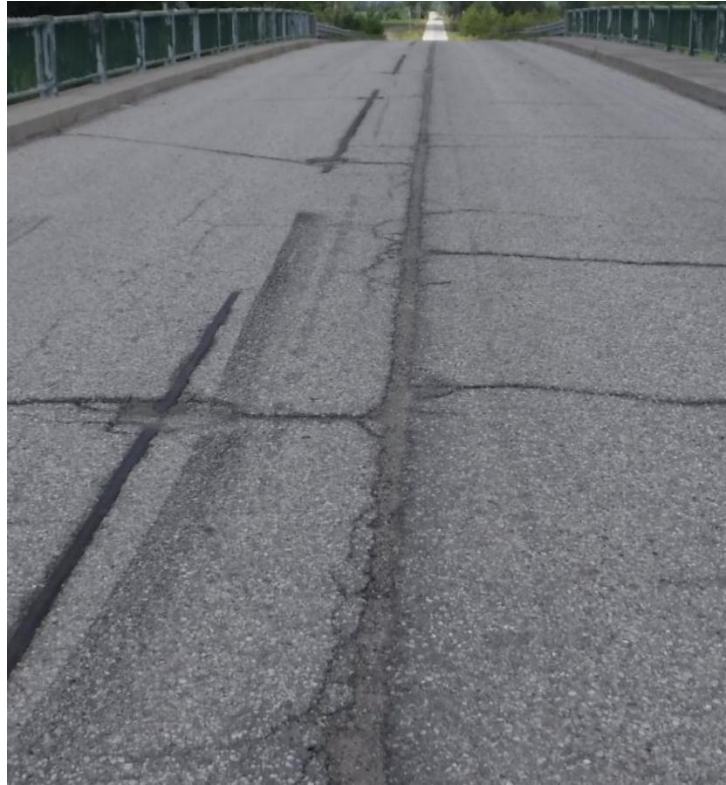
Figure 2.5.8.1 Wide Transverse and Longitudinal Cracks

The various types of pavement cracks are illustrated in Figure 2.5.8.1 to Figure 2.5.8.5.

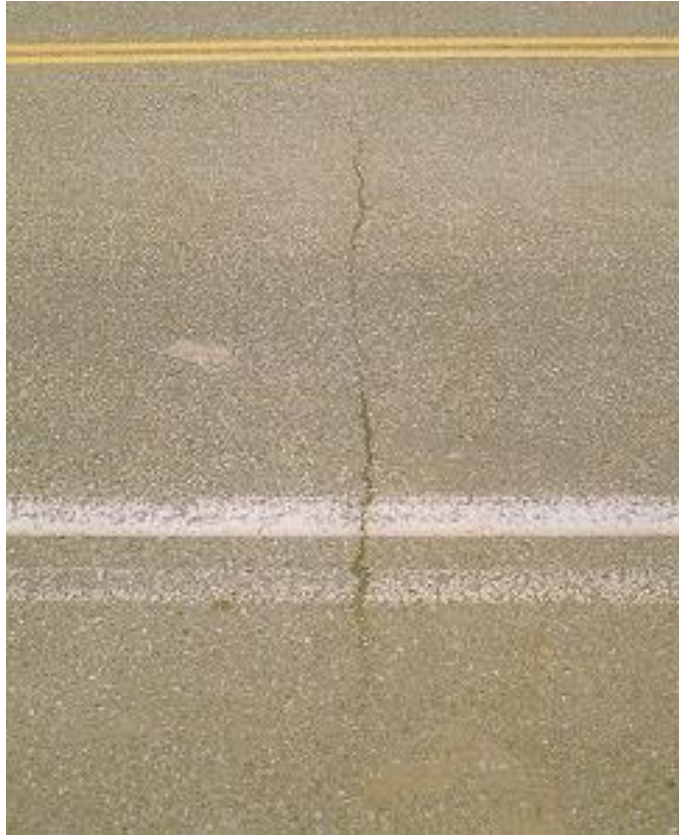
Figure 2.5.8.2 Medium Transverse Crack

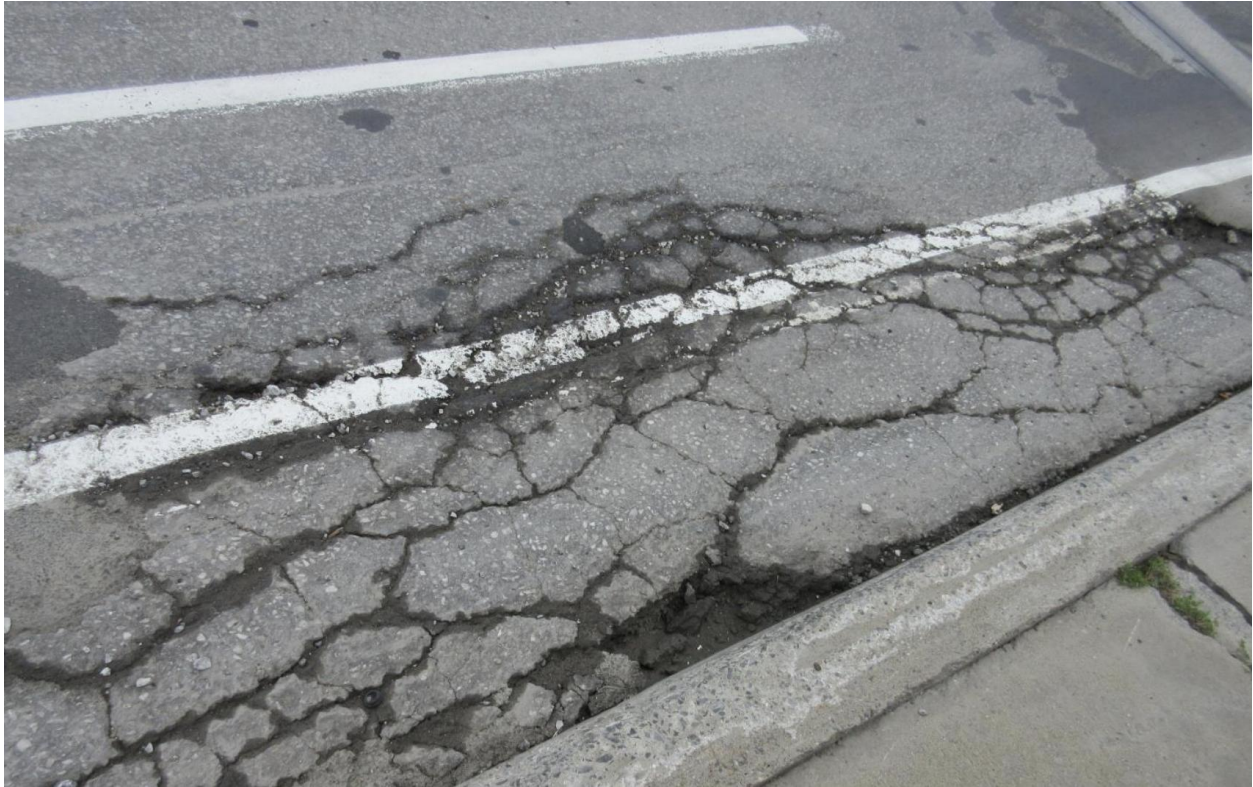
Figure 2.5.8.3 Severe Alligator Cracking

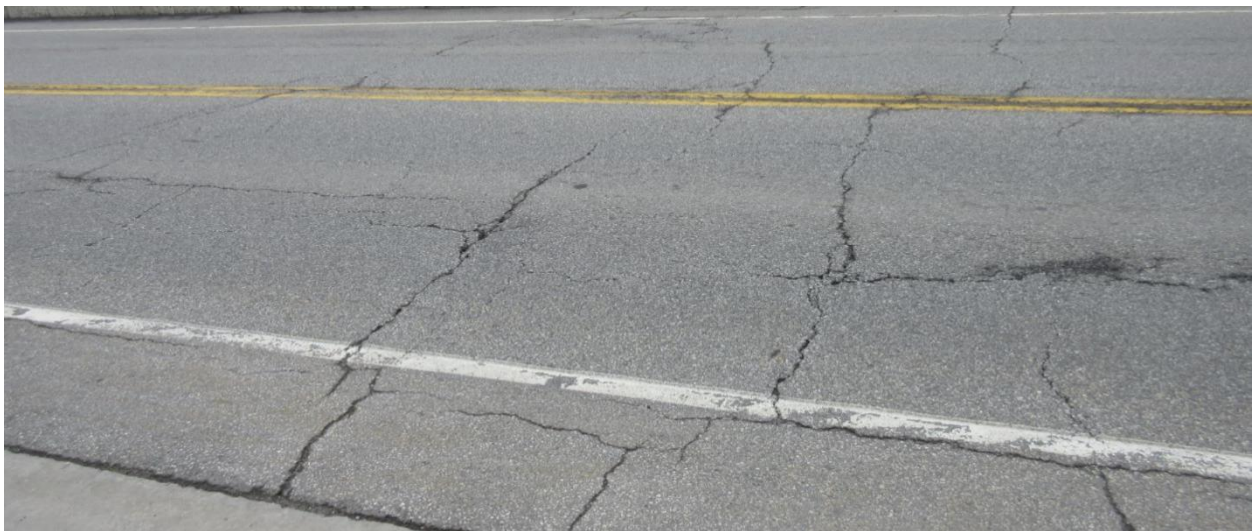
Figure 2.5.8.4 Map Cracking

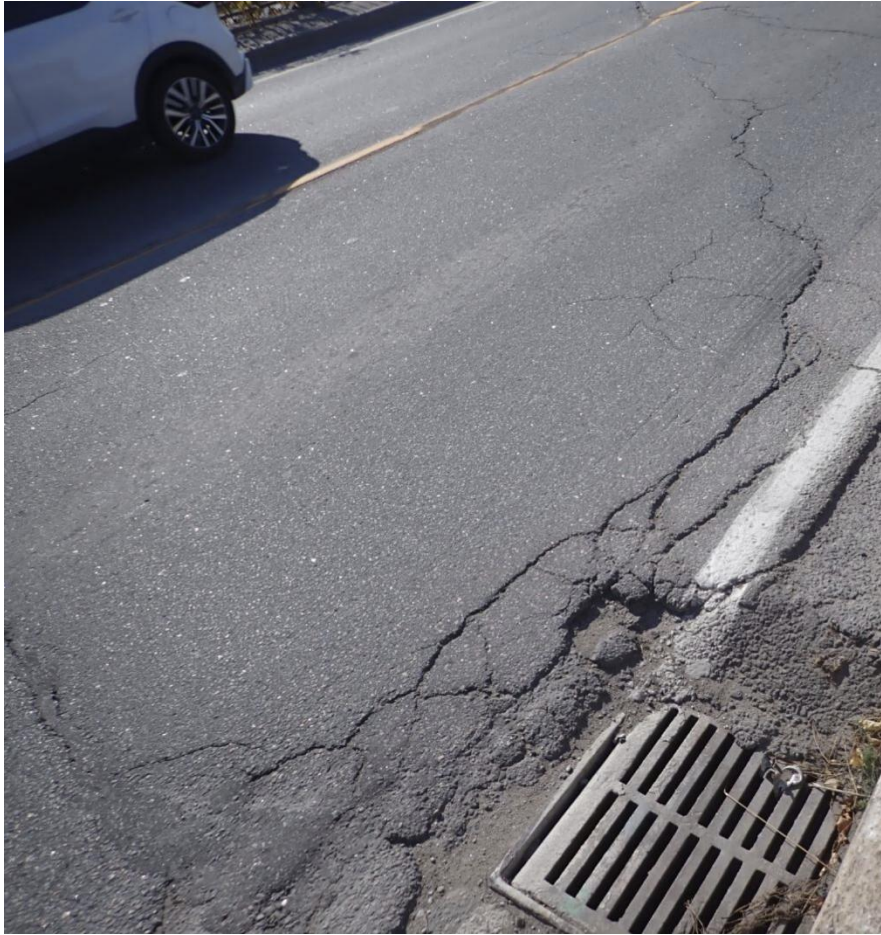
Figure 2.5.8.5 Edge Cracking from Catch Basin

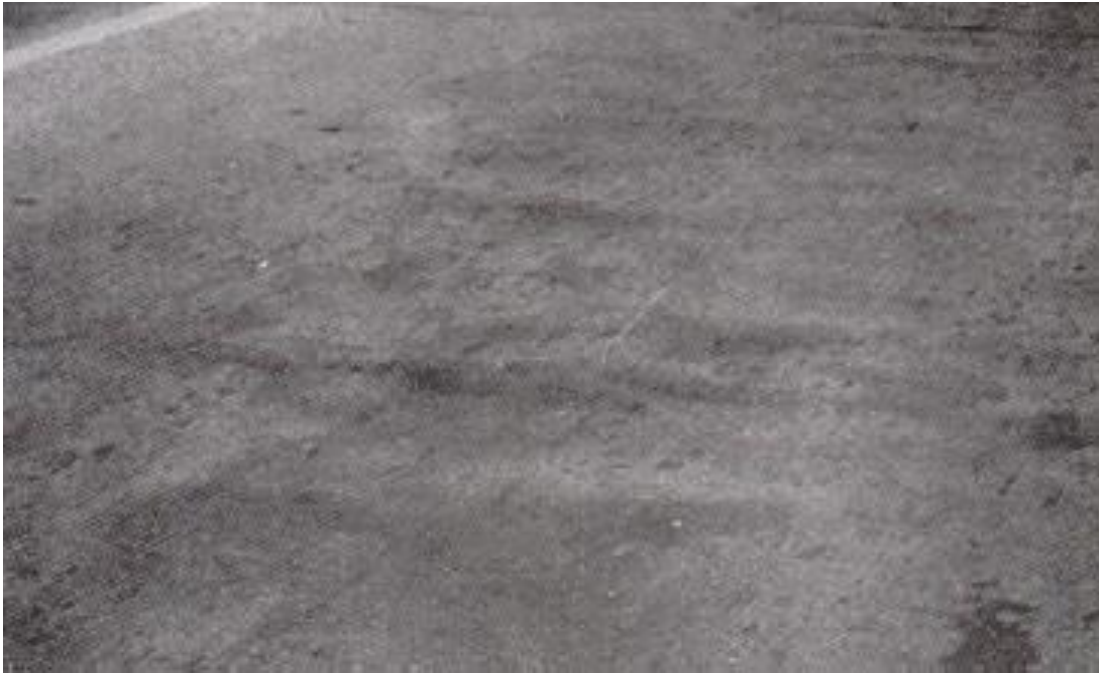
Figure 2.5.8.6 Severe Rippling

Rippling is the formation of transverse undulations in the pavement surface consisting of closely spaced valleys and crests. Rippling is the result of poor bond of the pavement to the surface below with the subsequent action of wheel friction and braking forces moving the pavement 'mat' forwards, backwards and sideways.

Rippling of an asphalt pavement is illustrated in Figure 2.5.8.6.

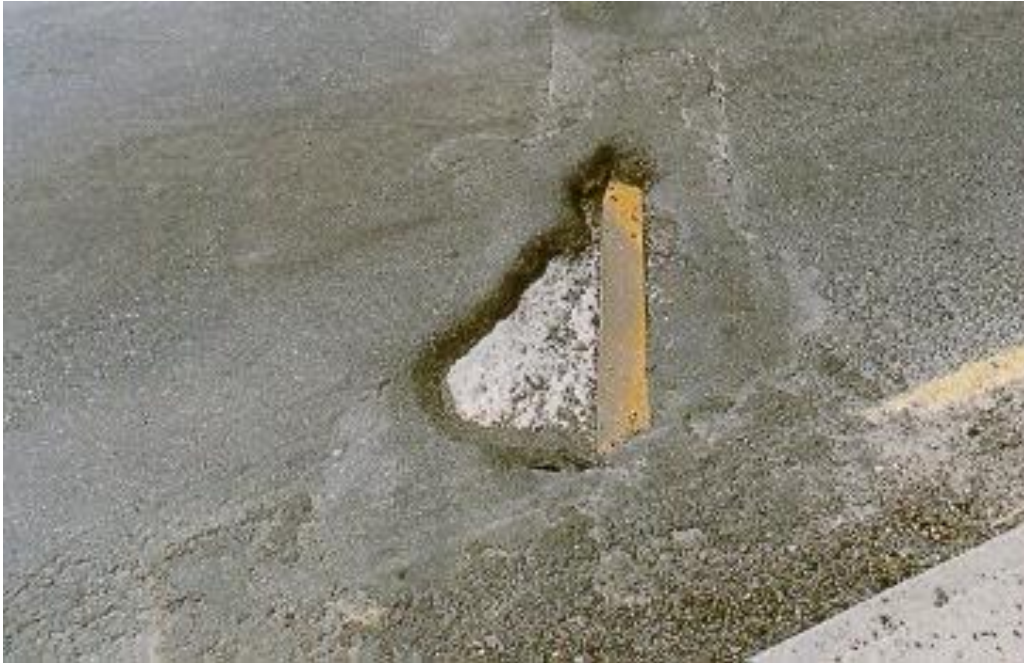
Figure 2.5.8.7 Severe Pothole

A typical example of a pothole is illustrated in Figure 2.5.8.7.
